Project EASA.2008.C19

Burnthrough Resistance of Fuselage

***BURNTHROUGH RESISTANCE OF FUSELAGE
(EASA SERVICE CONTRACT NUMBER EASA 2008.C19)***

Issue 5

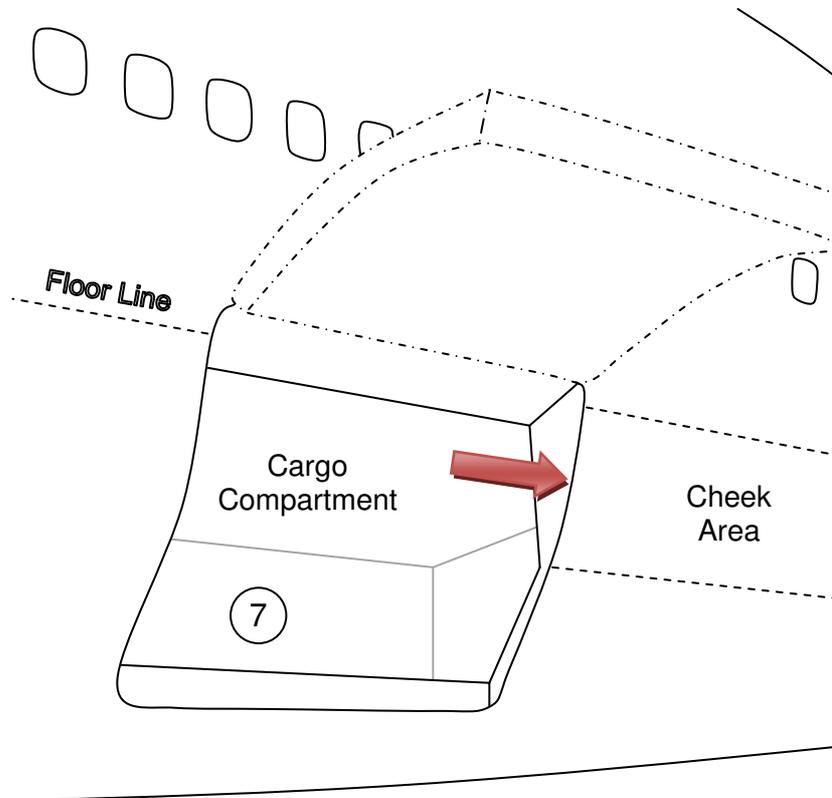
Figure 5 Potential Fire Entry Path through the Cargo Door into the Cheek

An additional fire path (7) in the lower fuselage relates to the cargo compartment door, as illustrated in Figure 5.

If fire burns through the cargo door skin, it can either penetrate the interior skin of the door and enter the cargo compartment, or penetrate the door sidewall or top panel and enter the cheek area. Fire entering the cargo compartment is covered by fire path (5), however, if the cargo access door does not have a cargo liner tested to Appendix F Part III, fire could enter the cheek area.

To prevent the fire entering the cheek area through the cargo access door, it must be ensured that either the door itself, or the sidewall and top panel around the door are protected from burnthrough. A similar situation also exists for other access doors in the lower fuselage, such as for equipment bays.

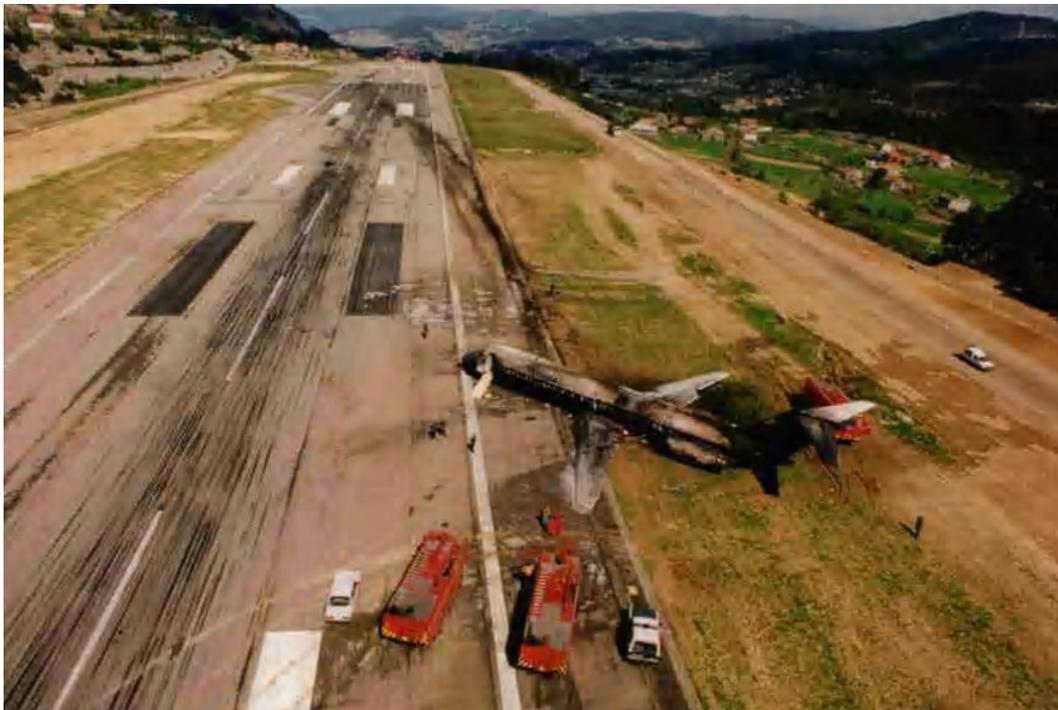
Figure 6: Burnthrough Accident: DC-9-32, Vigo, Spain, March 21st 1994

This accident occurred at Vigo Airport, Spain on March 21st 1994 and involved a McDonnell Douglas DC 9-32 aircraft. The aircraft was too low on approach. The main undercarriage contacted approach lights and upward sloping ground just ahead of the runway, detaching the main undercarriage legs and part of the right hand wing fuel tank. Leaking fuel ignited and the fire followed the aircraft to where it stopped just to the side of the runway. When the aircraft stopped, the fire passed to the left side and affected practically the whole of the exterior of the plane, causing heavy damage.

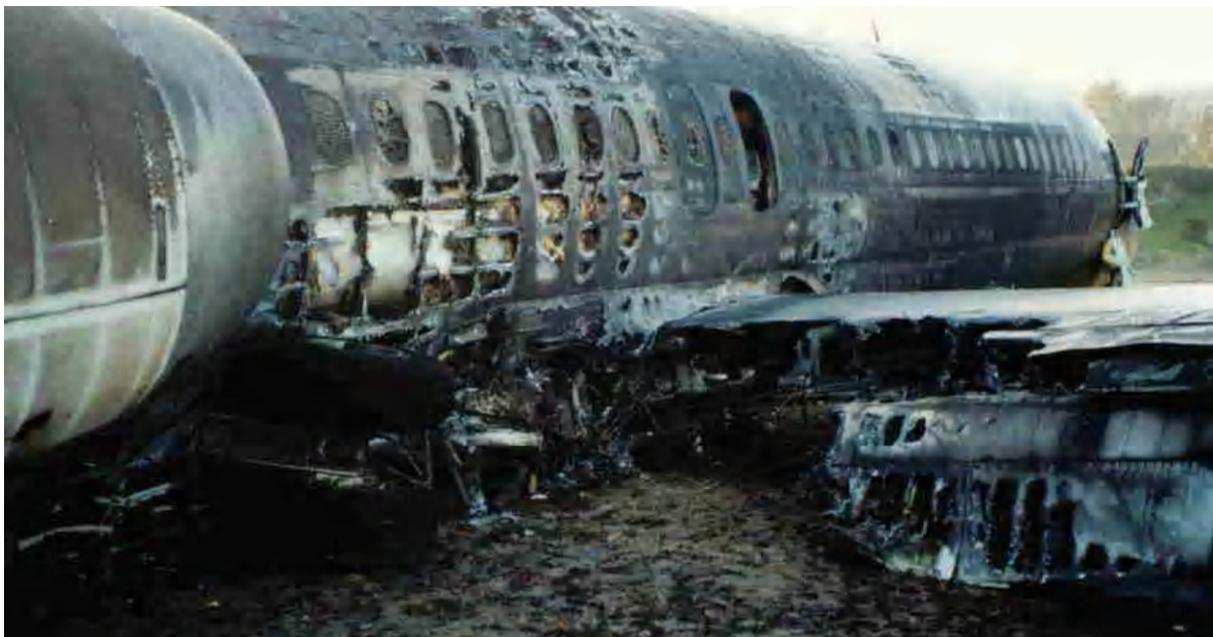
Figure 7: Vigo DC 9-32 Skin Burnthrough of Lower and Upper Fuselage

The extent of fire damage to the exterior of the starboard rear fuselage is shown in Figure 7 and Figure 8. The intense fire burned through the lower fuselage skin revealing the thermal acoustic insulation. Two of the fuselage frames were burned through. The upper half of the fuselage was burned through around and above the cabin windows. However, the extent of burnthrough of the upper fuselage is significantly less than through the lower fuselage.

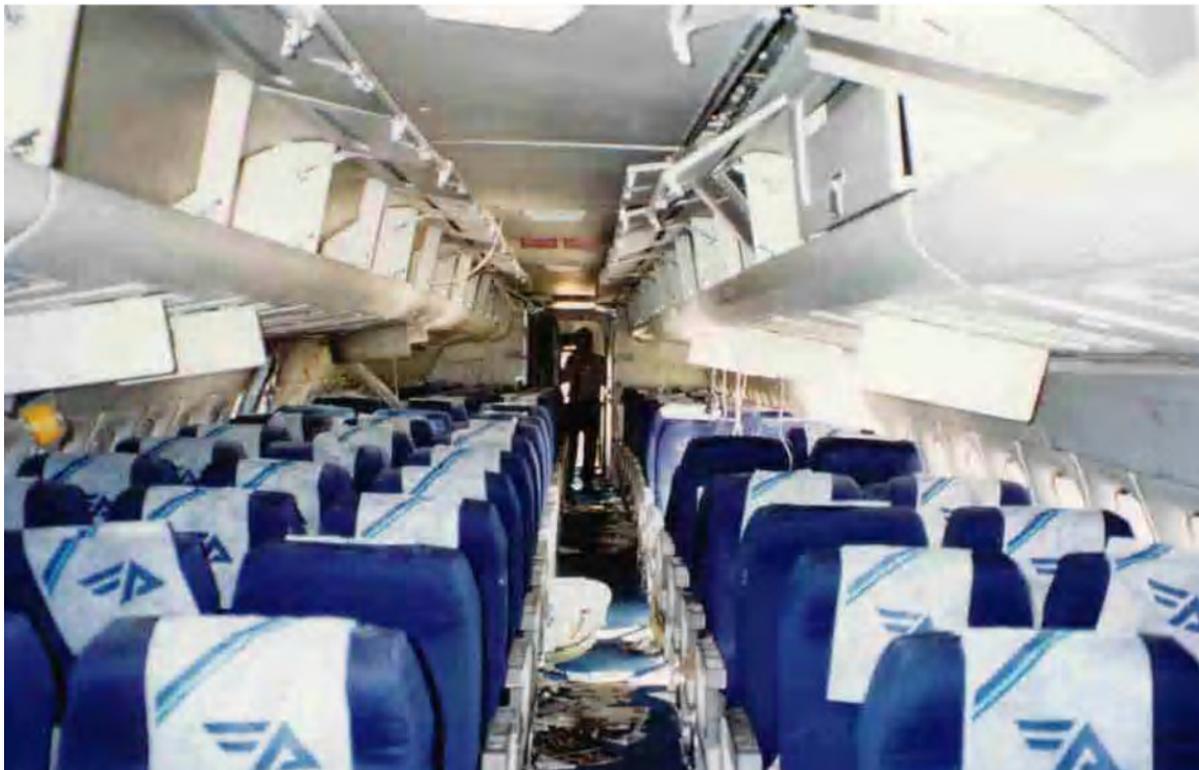
Figure 9: Vigo DC 9-32 Minimal Fire Damage to Cabin Interior

The cabin interior suffered minimal damage considering the intensity of the fire - see Figure 9. The interior fire damage would have been worse had the fire not been extinguished so rapidly.

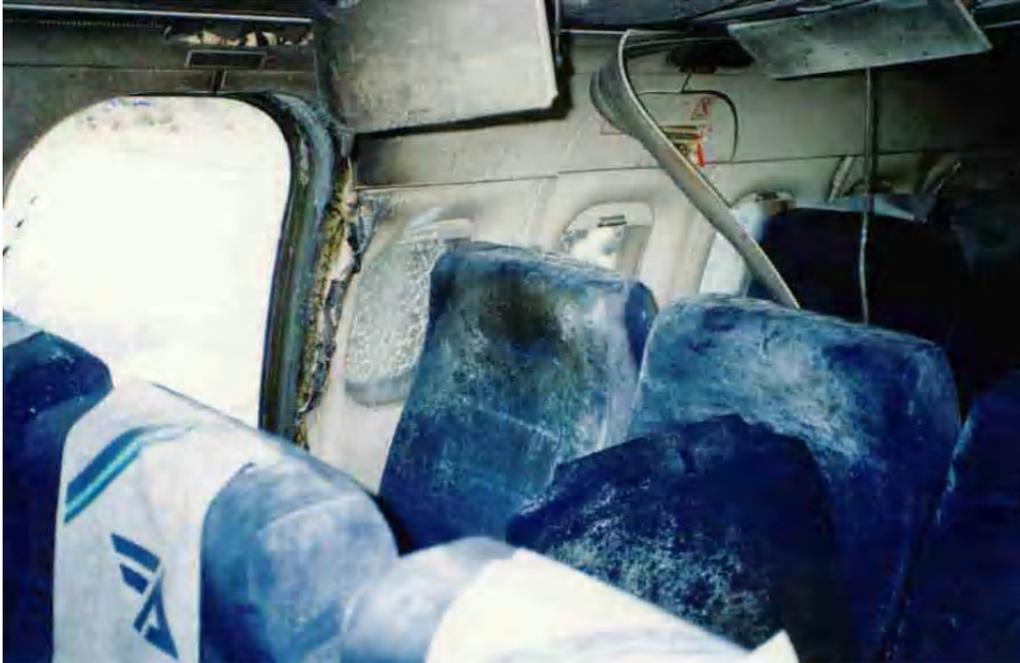
Figure 10: Vigo DC 9-32 Scorching Near Starboard Overwing Emergency Exit

The starboard Type III overwing exit, opened during the evacuation, allowed fire to enter the cabin and locally scorch the interior materials - see Figure 10.

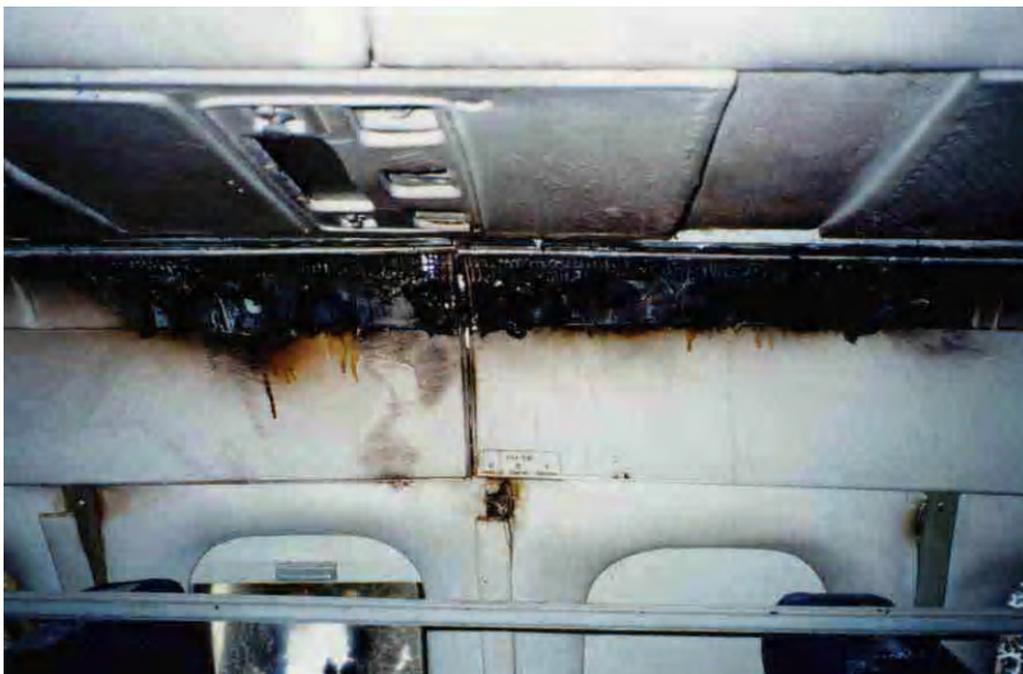
Figure 11: Vigo DC 9-32 Localized Fire Damage Due to Upper Fuselage Burnthrough

Figure 11 shows fire damage to the interior cabin materials above the level of the cabin windows. The Spanish accident investigation authority CIAIAC has confirmed the internal fire damage was caused by the external burnthrough above the windows and not from fire entering the Type III Overwing Exit opened during the evacuation.

It is evident that in this accident the fire burned through the upper fuselage skin, burned some of the cabin lining materials, and penetrated the cabin in significantly less than 5 minutes.

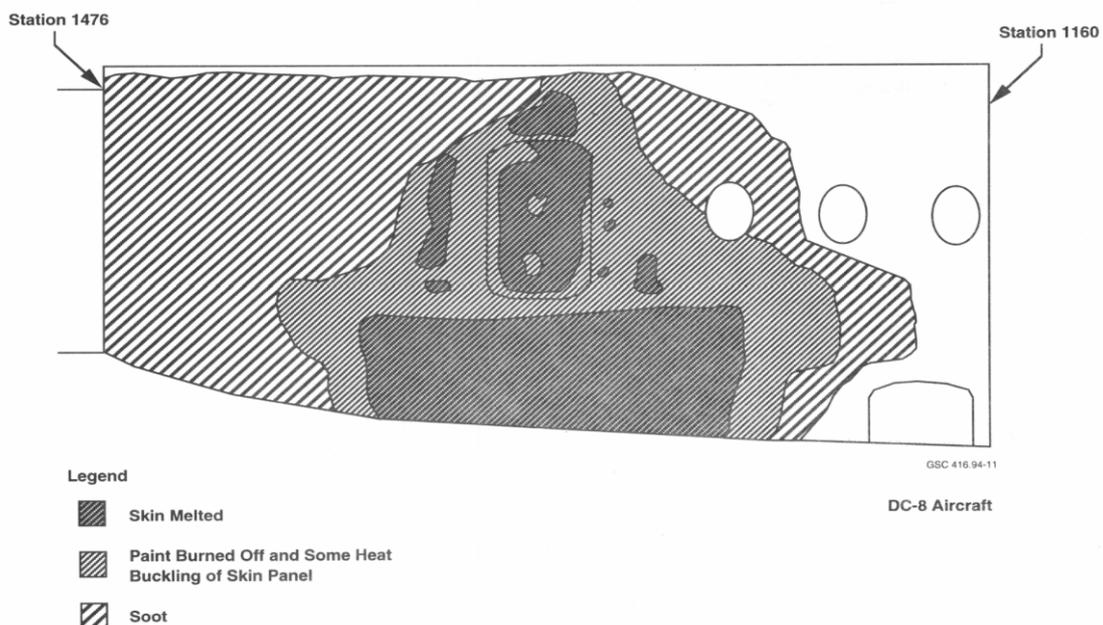
“The smoke and fire that entered the cabin came through the air conditioning return grills located on the sidewall at the floor level. These grills are open into the cheek area on each side of the cargo compartment. This area forms a duct that channels the exhaust air to the outflow valves located in the empennage crawlthrough aft of the cargo compartment. The pool fire melted the skin in the cheek area, opening a path to the grills. The fire in the overhead did not travel up through the sidewalls or through the ventilation ducts. The skin above the door was penetrated directly by the pool fire plume. Here the insulation was dislodged, allowing access to the overhead.”

Observation 1.1 The elapsed time from when the pool fire had fully established to when smoke began pouring from the floor grills was 44 seconds. In this time the lower fuselage skin had melted in the cheek area. **Test 1 indicates the capability of a fuel fire to melt the lower fuselage skin in around 44 seconds.**

Observation 1.2 The elapsed time from when the pool fire had fully established to when extinguishing commenced was 1 minute and 46 seconds. In this time the skin above the door had melted. **Test 1 indicates the capability of a fuel fire to melt the upper fuselage skin within 1 minute and 46 seconds.**

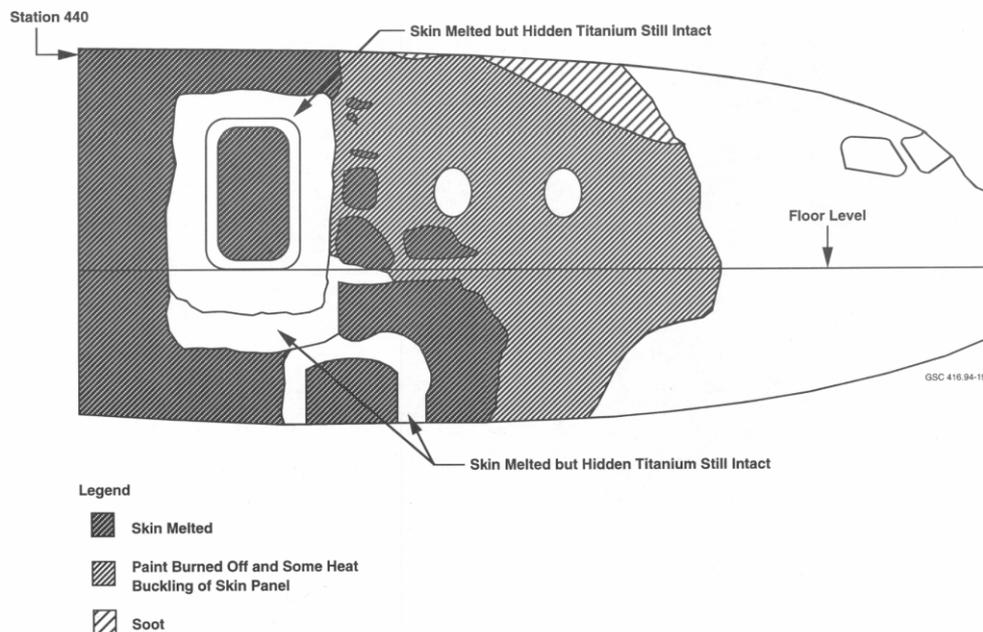
“The smoke initially penetrated the cabin through the floor grills. This was quickly followed by smoke and fire penetration through the starboard service door. Penetration into the cargo compartment was achieved through the cargo door.”

Observation 2.1 The elapsed time from when the pool fire had fully established to when smoke began pouring from the floor grills was 41 seconds. Although it is not stated explicitly within the test report, it is likely that the smoke reached the floor grills via melted skin rather than the cargo compartment door. **Test 2 indicates the capability of a fuel fire to melt the lower fuselage skin in around 41 seconds.**

Observation 2.2 The elapsed time from when the pool fire had fully established to when extinguishing commenced was 3 minutes and 15 seconds. In this time, the skin damage extended from ground level up to the centre or the top of the aircraft. **Test 2 indicates the capability of a fuel fire to melt the upper fuselage skin within 3 minutes and 15 seconds.**
