## Annex B: Results on composite plates

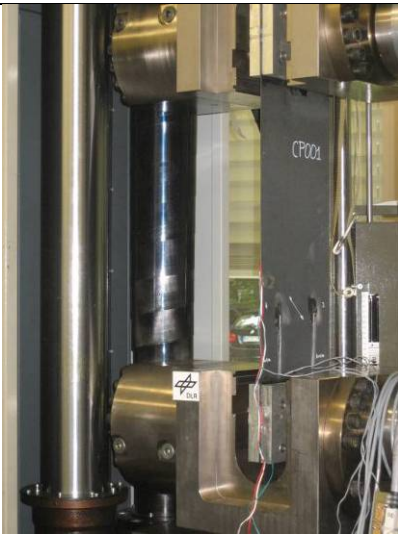
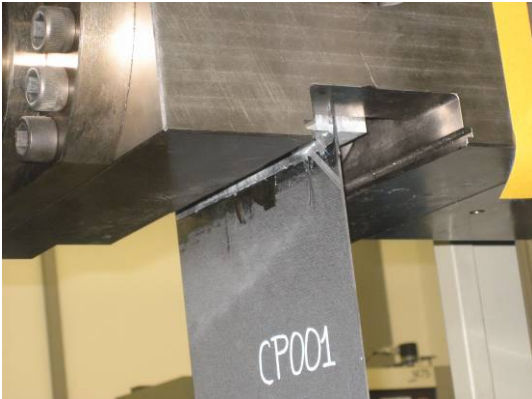
| <br> | <p>The residual strength test on the undamaged test plate could not be conducted up to ultimate failure as the plate failed in the tabs. As a result, optimization on the tabs/bonding were carried out with test plates CP007a und CP007b.</p> |

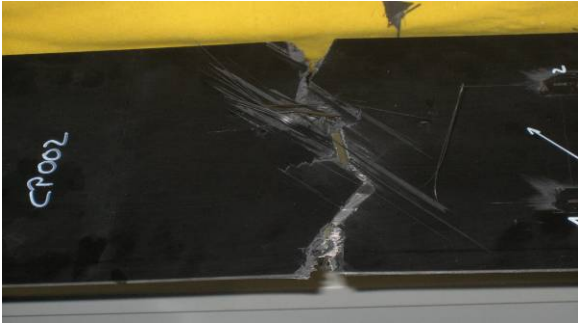
| | <p>Failure load= 208.8 kN</p> <p>Residual strength factor: 0.48</p> |

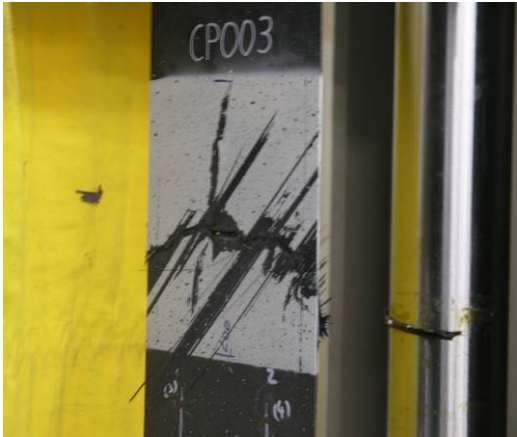
| <p style="text-align: center;">Plate after the test</p> | <p>Failure load= 160.3 kN</p> <p>Residual strength factor = 0.37</p> |

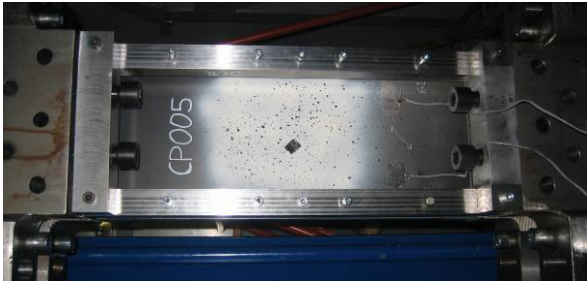
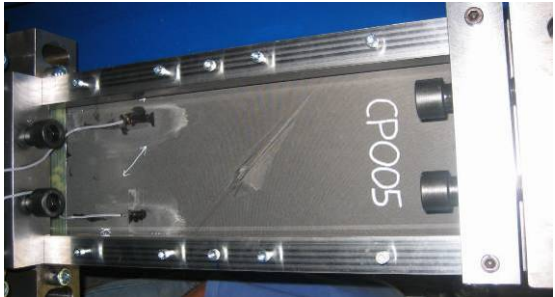
| Notch damage (square hole) | |

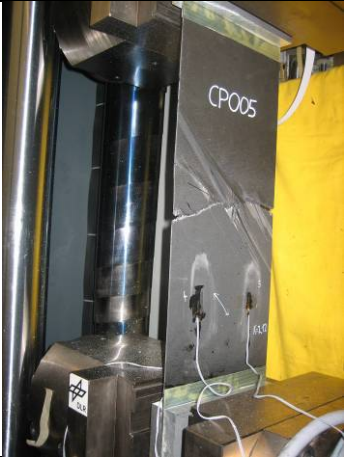
| | <p>Failure load= 215.05 kN</p> <p>Residual strength factor = 0.49</p> |

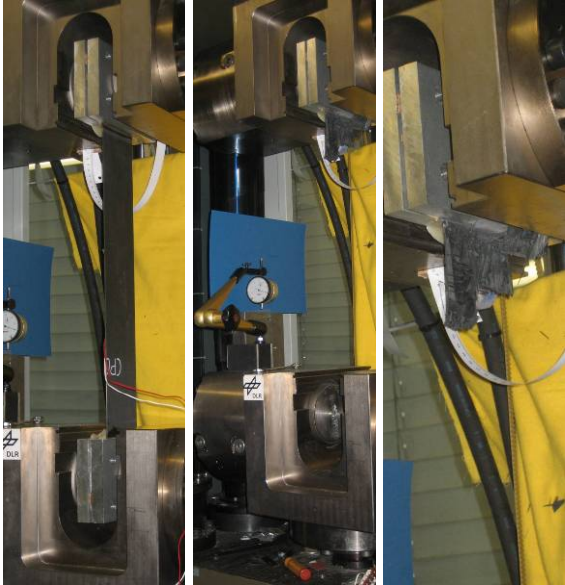
| <p>Pictures of the test plate after failure</p> | <p>A new “tabs/bonding” concept has been investigated in order to be able to conduct the test until the failure of a 200 mm wide undamaged plate. One of these concepts consists using a new adhesive (Epikote Resin 02306) to bond the aluminium tabs to the carbon test plate.</p> <p>Failure in composite gauge length.</p> <p>Failure load= 217.8 kN (1.54% strain) for a 100 mm wide test plate</p> <p>Estimated failure load (200 mm wide test plate) = 435.6 kN</p> |

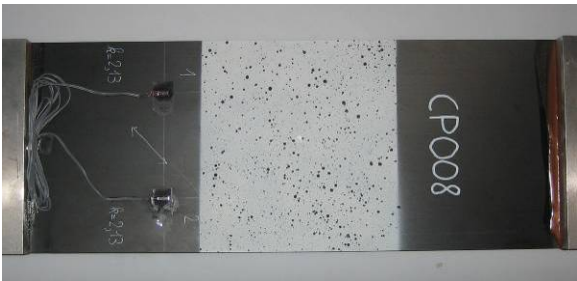
| No damage at front, delamination damage back | |

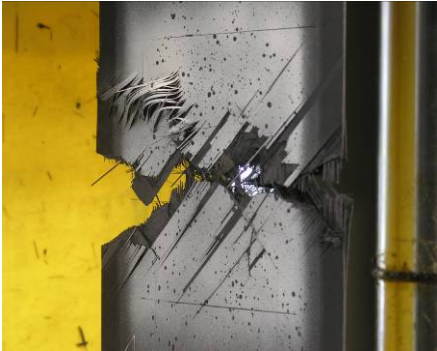
| | <p>Failure load= 287.1 kN<br/> Residual strength factor = 0.66</p> |

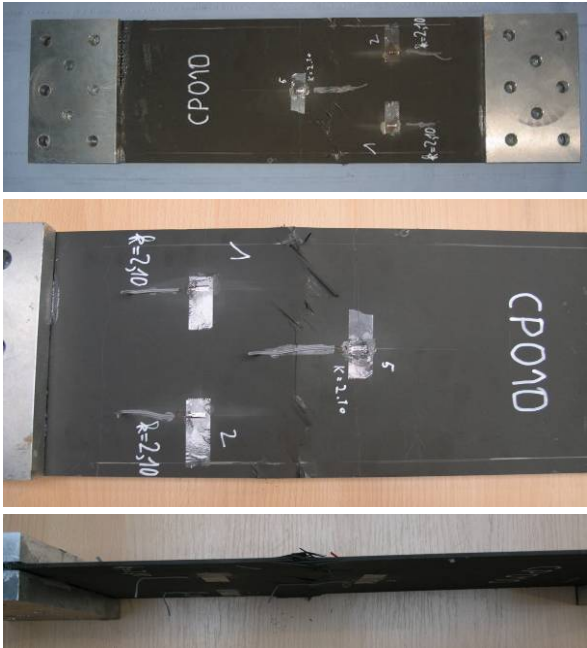
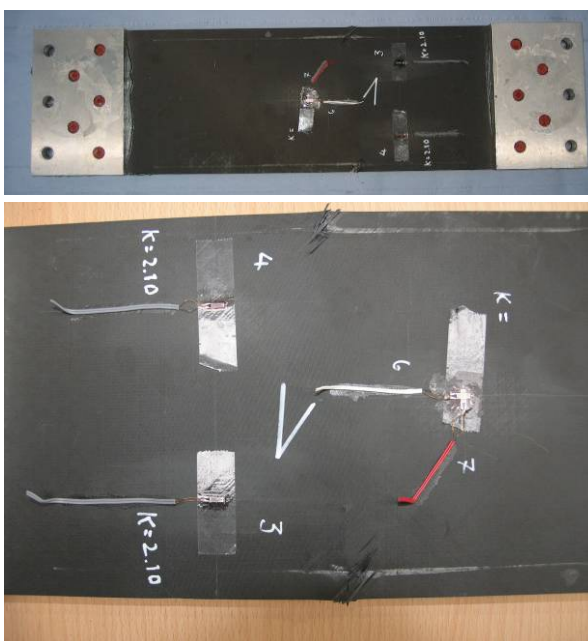
| <p>Buckle load: 38 kN (0.08% strain)</p> <p>Failure load= 132.4 kN</p> <p>Residual strength factor = 1</p> | |

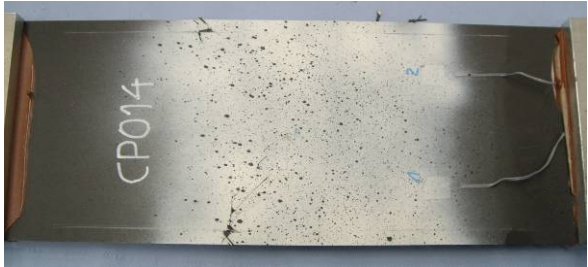
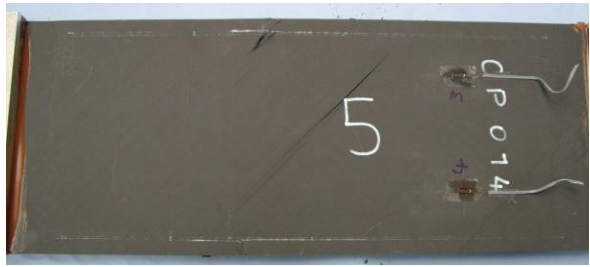
| <p>Failure load= 111.7 kN</p> <p>Residual strength factor = 0.84</p> | |

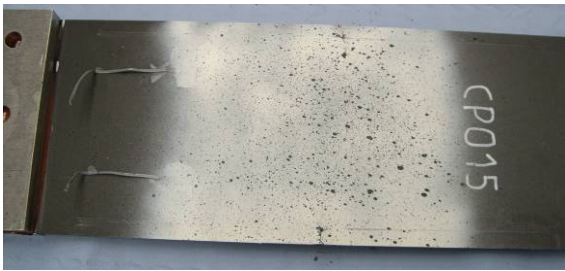
| <p>Failure load= 88.4</p> <p>Residual strength factor = 0.67</p> | |

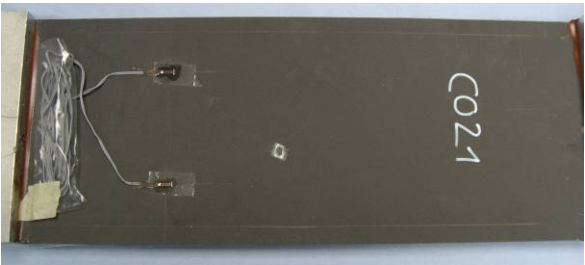
| <b>Impact on concave face / Cube stopped / Front face damage and delamination at back face</b> | |

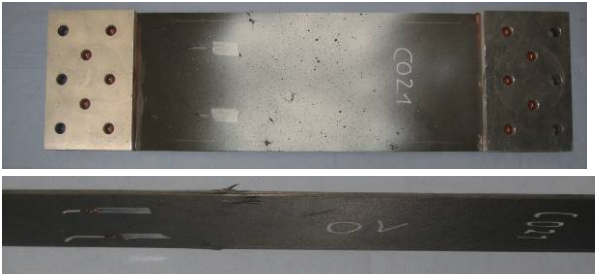
| <p>Failure load= 124.9 kN</p> <p>Residual strength factor = 0.94</p> | |

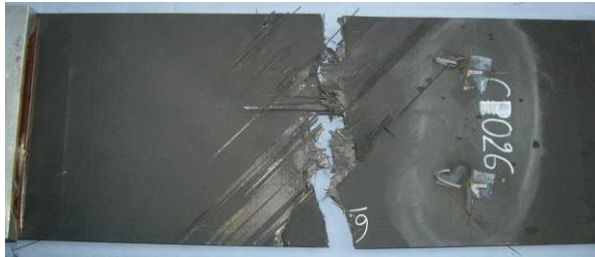
| <p>Failure load= 211.1 kN</p> <p>Residual strength factor = 0.49</p> | |

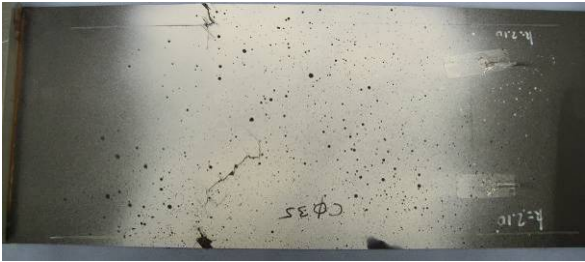
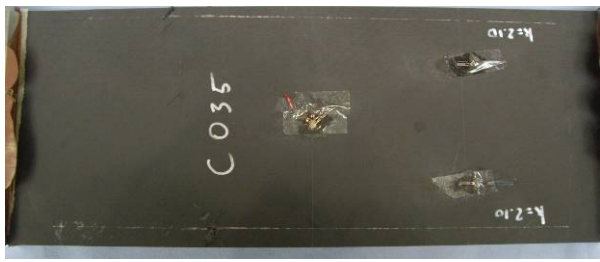
| Failure load= 119.1 kN | |

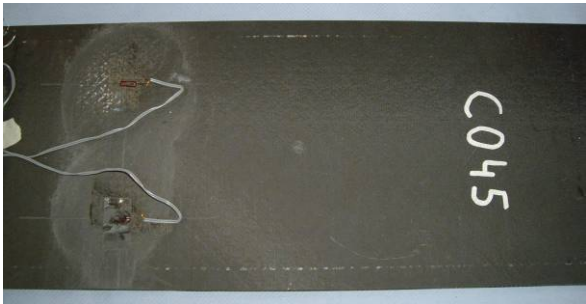
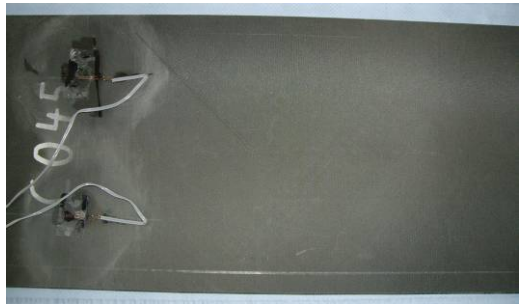
| <b>C045</b> | |
|---|---|
| Rebound, delamination at back face | |

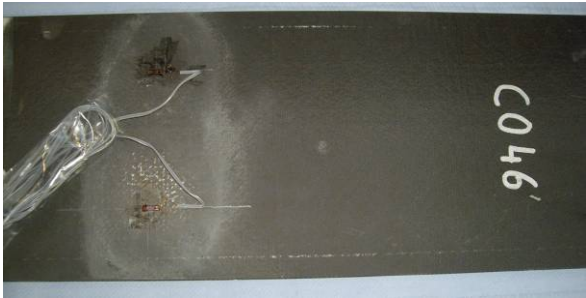
| Rebound, delamination at back face | |

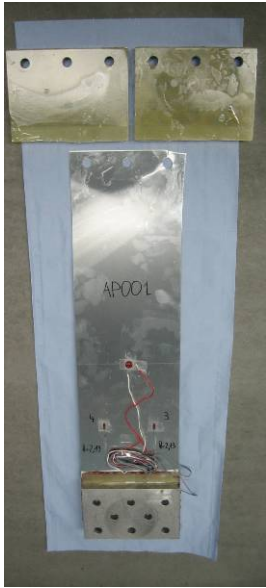
| | <p><b>Bearing failure in the tabs !!</b><br/> Failure load= 158 kN<br/> Residual strength factor = 1.0</p> |

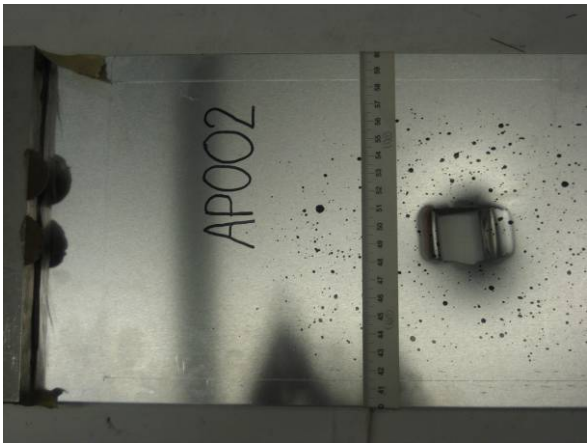
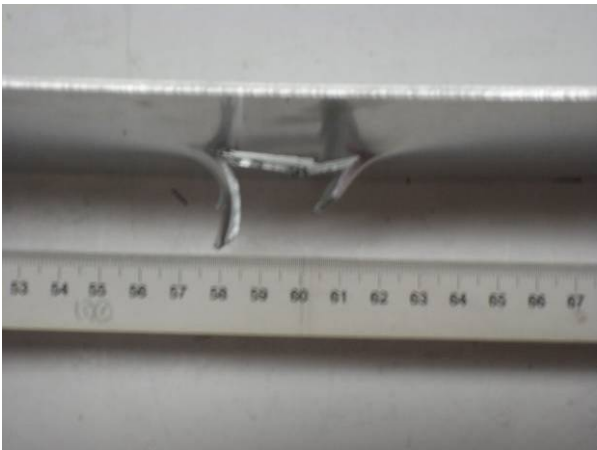
| Beam passed through / rectangular notch ~ 30 mm | |

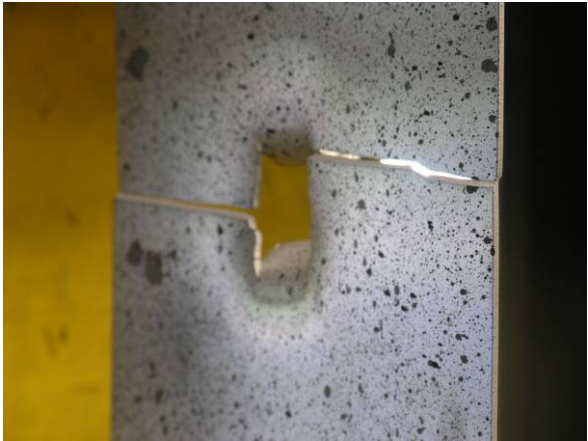
| | Failure load= 138.4 kN<br>Residual strength factor = <b>0.76</b> |

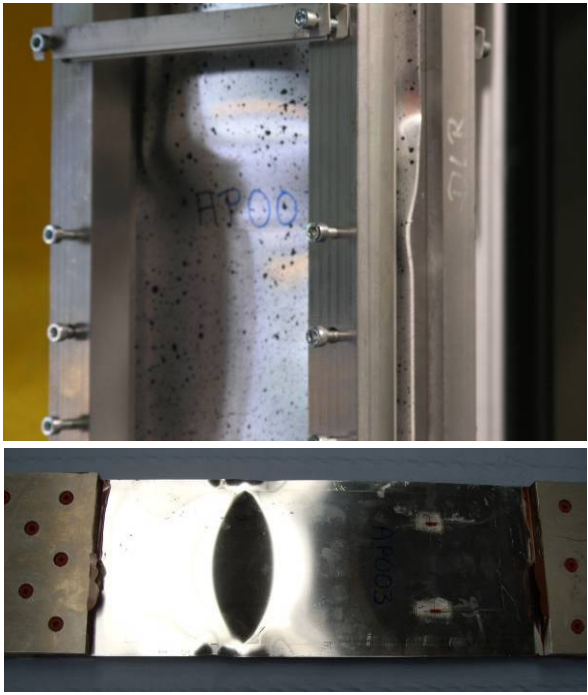
| | <p>Buckle load: 20 kN<br/> Max. load= 58.6 kN (3-cell buckle) / No ultimate fracture<br/> Residual strength factor = 1.0</p> |

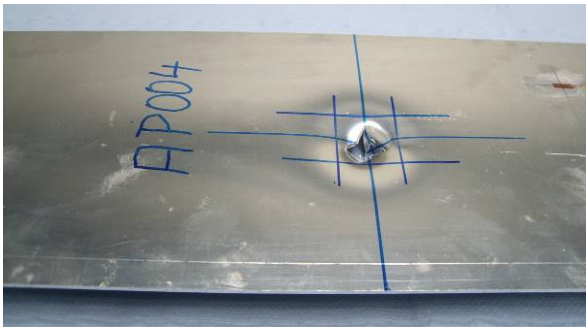
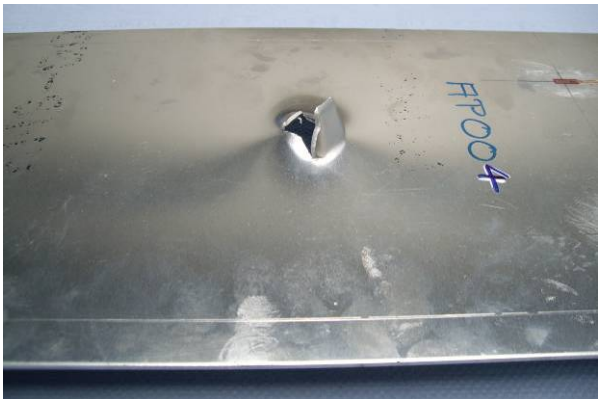
| Impact on convex side / Cube passed through / Square hole with plastic deformation | |

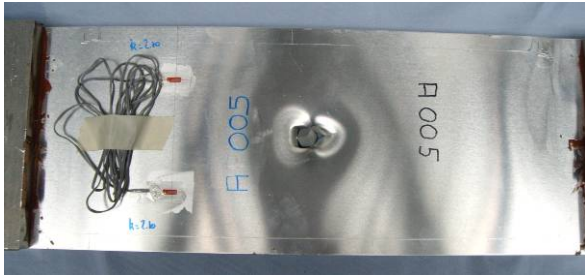
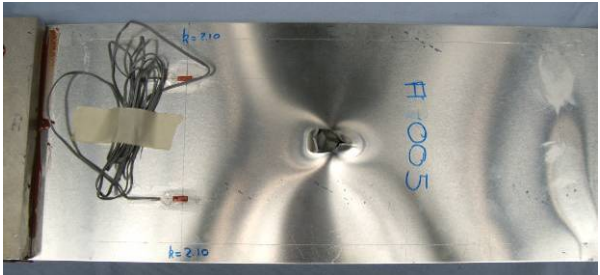
| Impact on convex face / Cube stopped in plate / square hole with plastic deformation | |

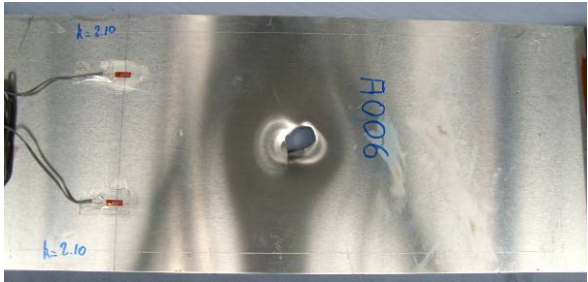
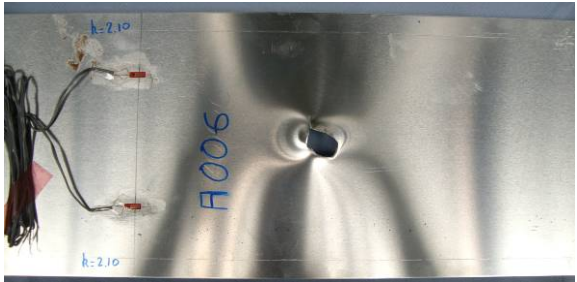
| Cube passed through plate / large square hole with plastic deformation | |

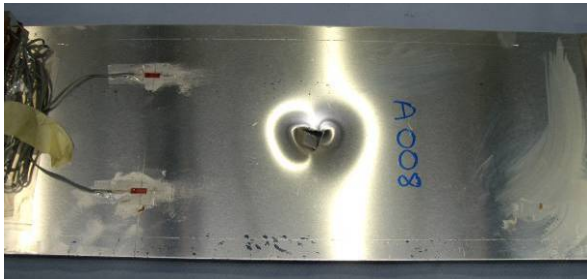
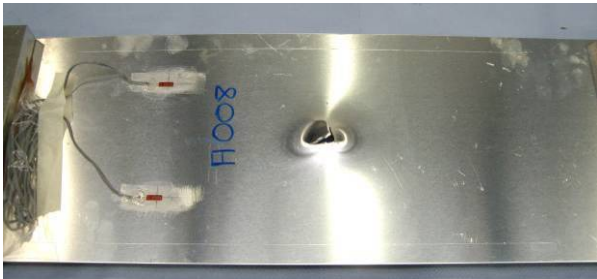
| Cube stopped by plate / crack with plastic deformation | |

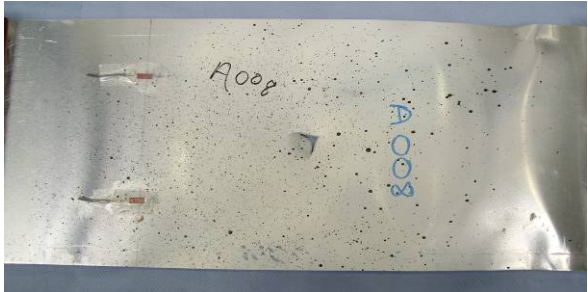
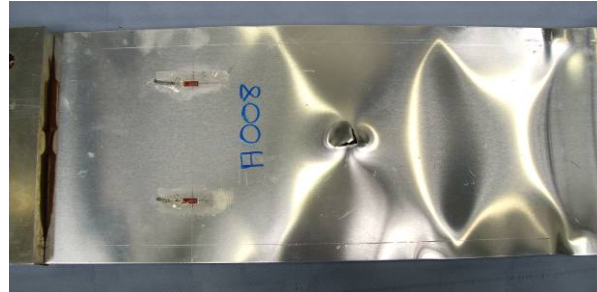
| Extended rails<br>Max. load = 56.9 kN<br>Residual strength factor = 0.996 | |

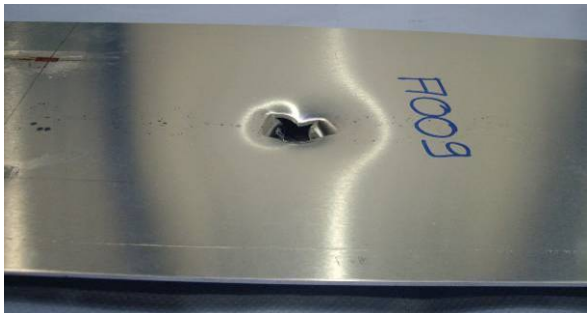
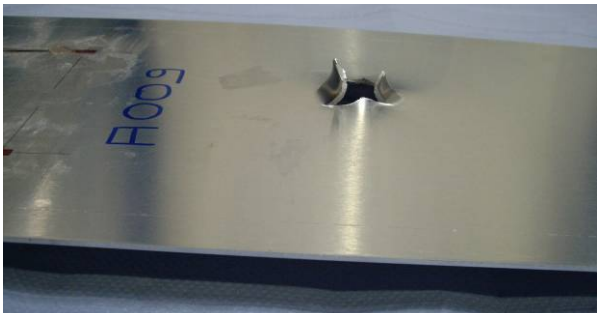
| Cube passed through plate / large square hole with plastic deformation | |

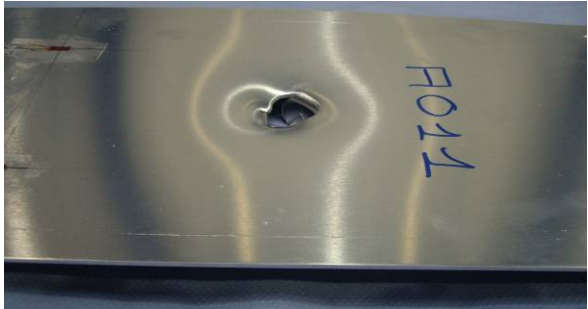
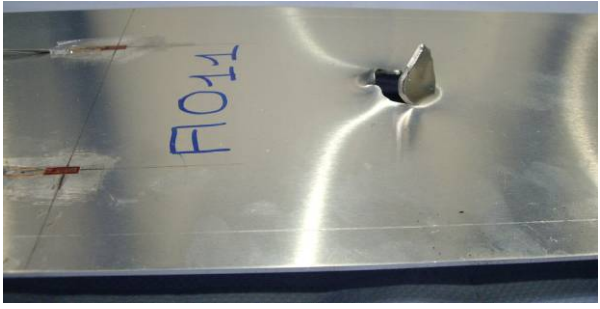
| Impact on concave face / Cube passed through / large square hole with plastic deformation | |

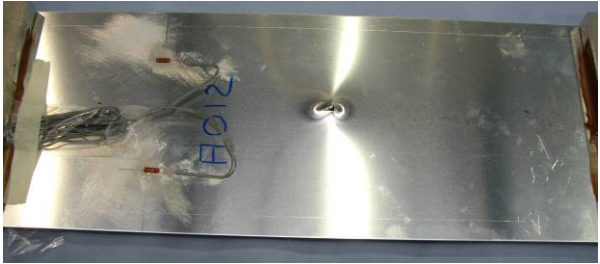
| Cube stopped with rebound/ indentation with very small crack from cube corner | |

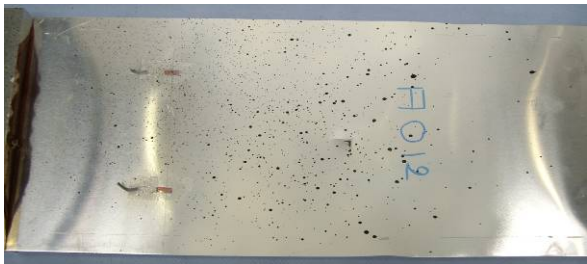
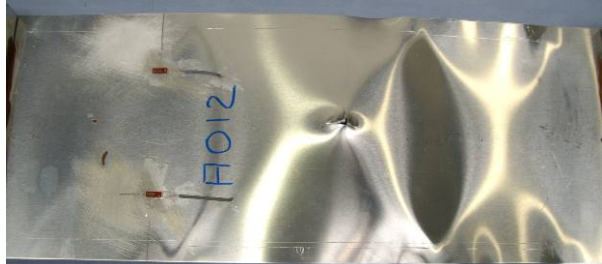
| Extended rails, rail bolt deformed<br>Max. load= 55.7 kN<br>Residual strength factor = 0.98 | |

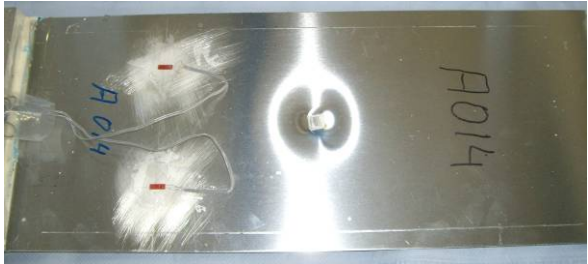
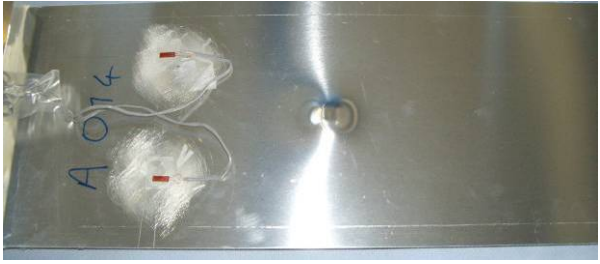
| Rebound / indentation with small edge crack (23 mm) | |

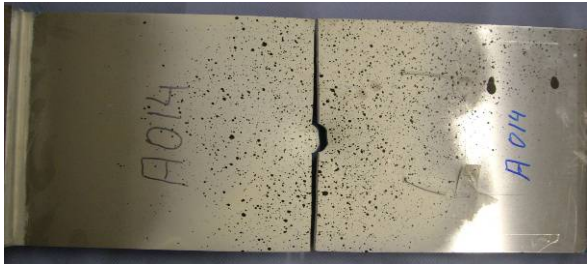
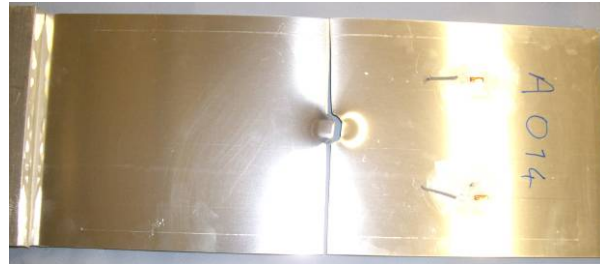
| Max. load= 144.4 kN<br>Residual strength factor = 0.82 | |

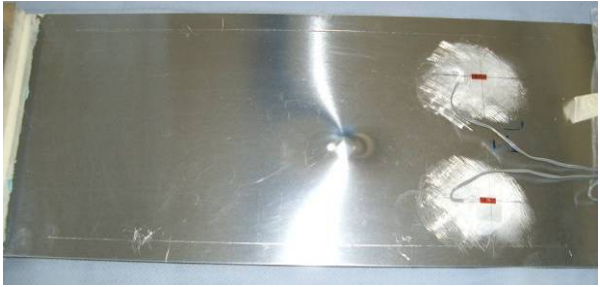
| Rebound / indentation with no crack | |

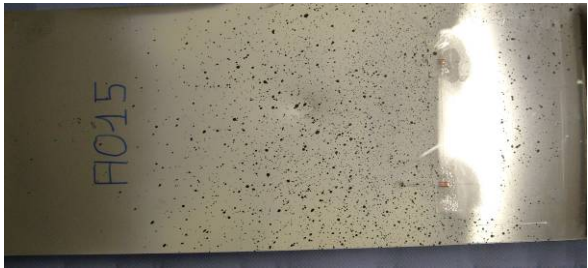
| Large plastic deformation in the QS test<br>Max. load= 163.0 kN<br>Residual strength factor = 0.92 | |

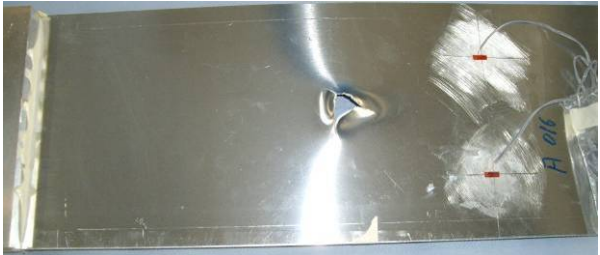
| Cube passed through / Notch damage, square hole (35 mm) | |

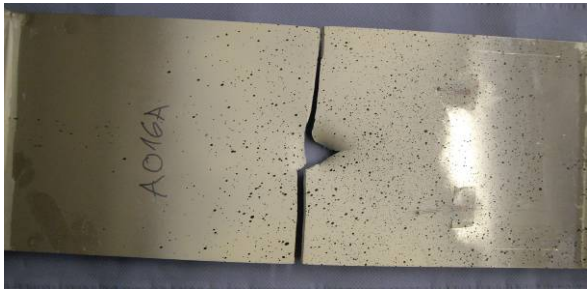
| Max. load= 123.7 kN<br>Residual strength factor = 0.70 | |

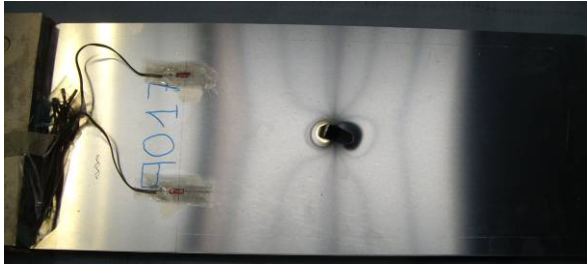
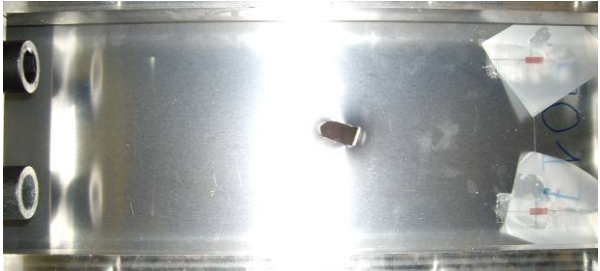
| Cube passed through / Notch damage, square hole (15 mm) | |

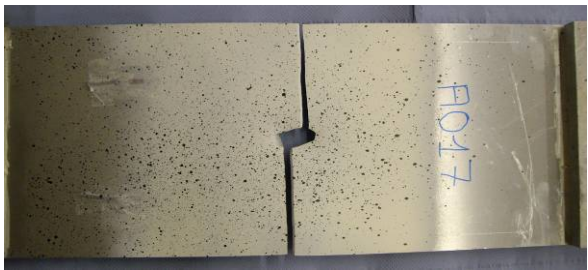
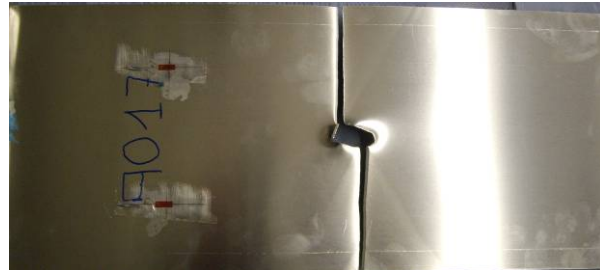
| Max. load= 148.4 kN<br>Residual strength factor = 0.84 | |

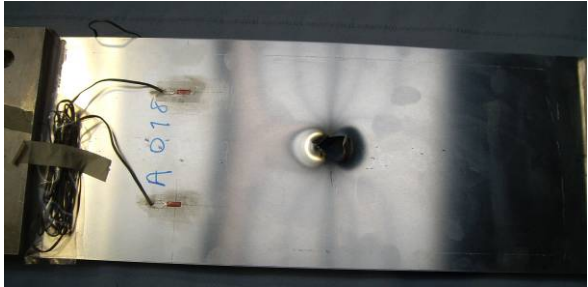
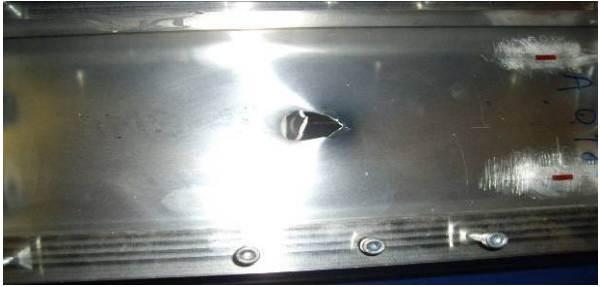
| Cube passed through / Notch damage, square hole (23 mm) | |

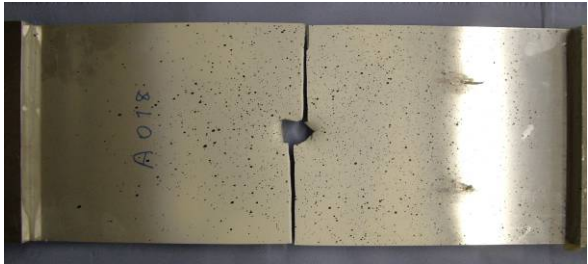
| Max. load= 151.7 kN<br>Residual strength factor = 0.86 | |

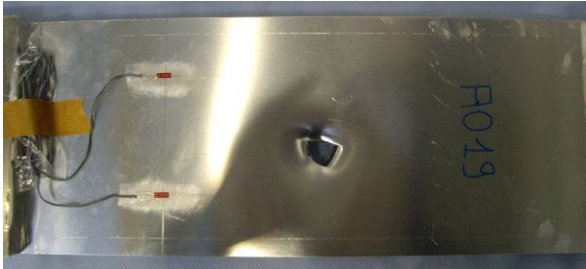
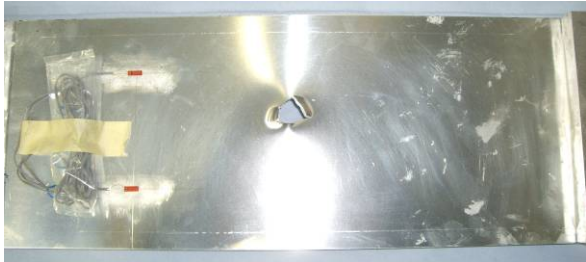
| Cube passed through / Notch damage, square hole (23 mm) | |

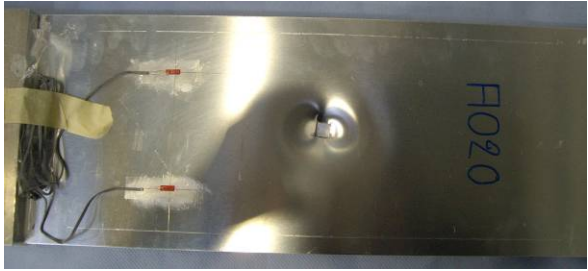
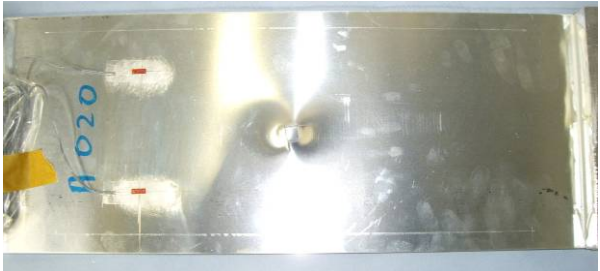
| Cube rebounded / Indentation with 3 cracks, 12 mm in size | |

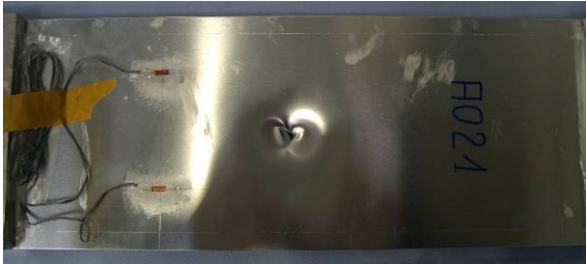
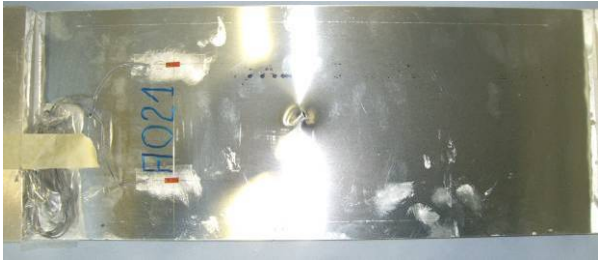
| Cube rebounded / Indentation with 20 mm wide crack | |

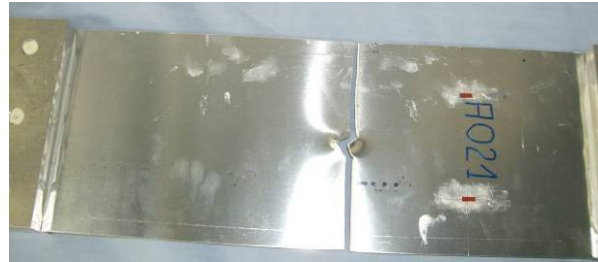
| Max. load= 143.8 kN<br>Residual strength factor = 0.82 | |
