**EASA**  
European Aviation Safety Agency

Final Report EASA\_REP\_RESEA\_2007\_3

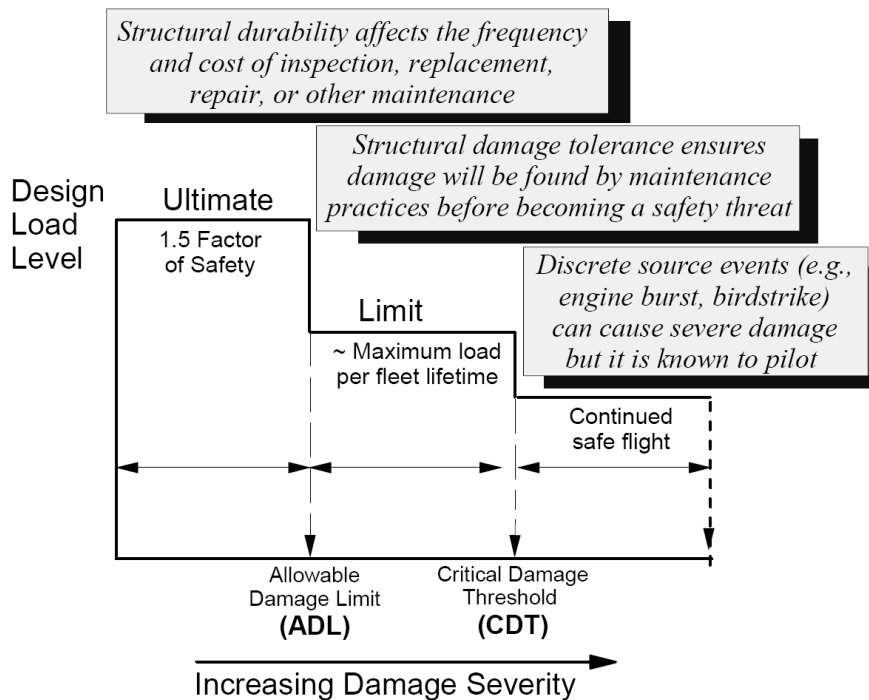
Figure 1: Design load and damage considerations for durability & damage tolerance (Figure 7.2.1(a) in [8]).

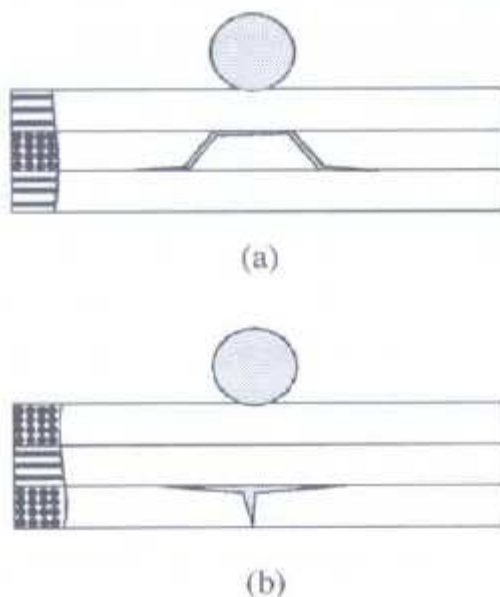
Figure 2: Two types of matrix cracks: a) shear crack, b) tensile crack [source: [14]].

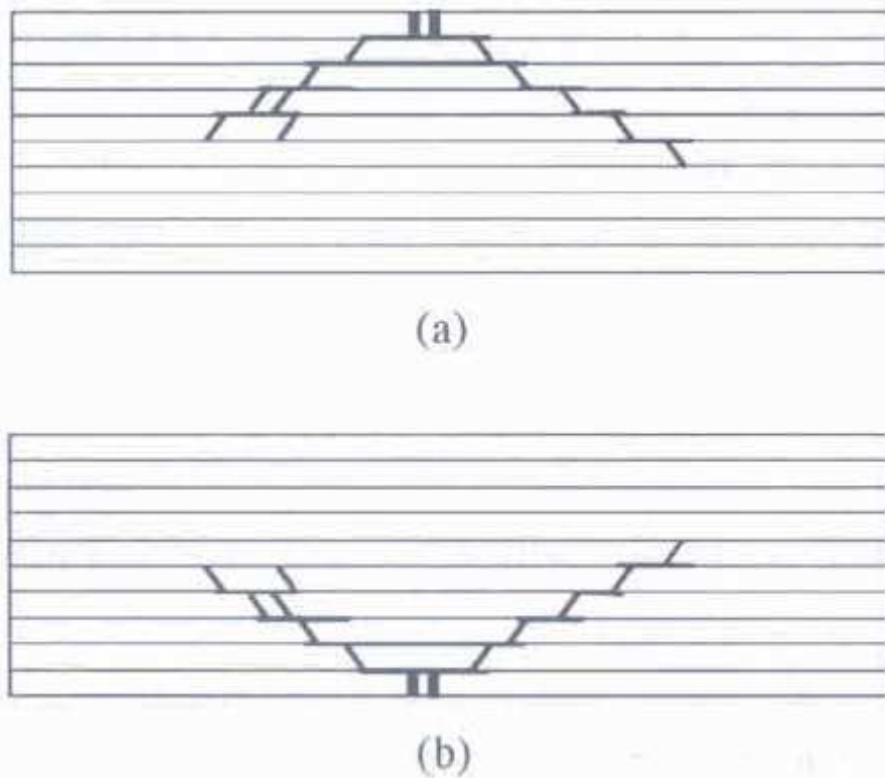
Figure 3: Pine tree (a) and reversed pine tree (b) damage patterns [source: [14]].

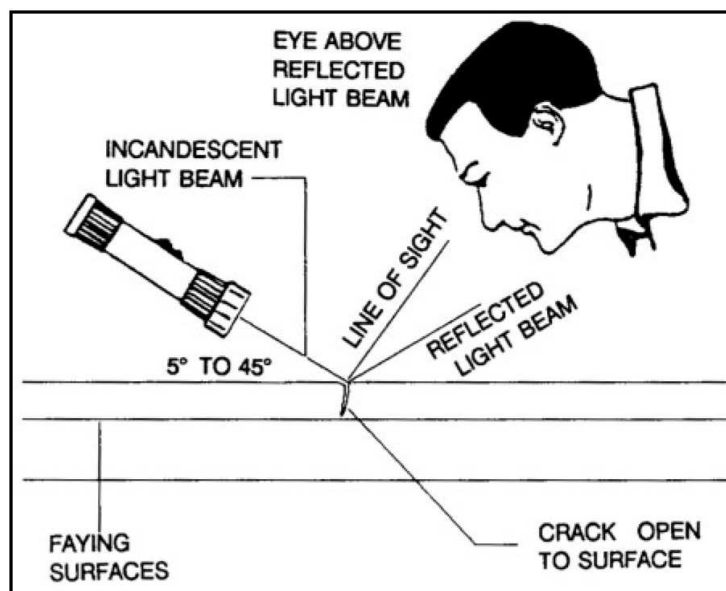
Figure 4: Using a flashlight to inspect for surface cracks (source: [15]).

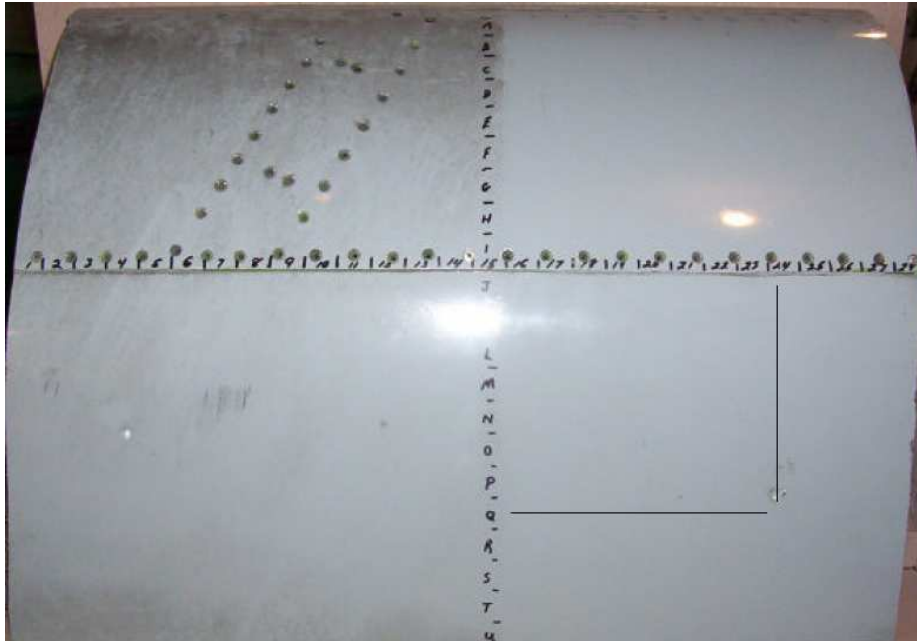
*Figure 5: Inspection specimen A with dent at grid point Q24. Left side of the panel was left dirty, the other side was cleaned. The horizontal marks (presumably) define the border between the upper side and the lower side of the panel.*

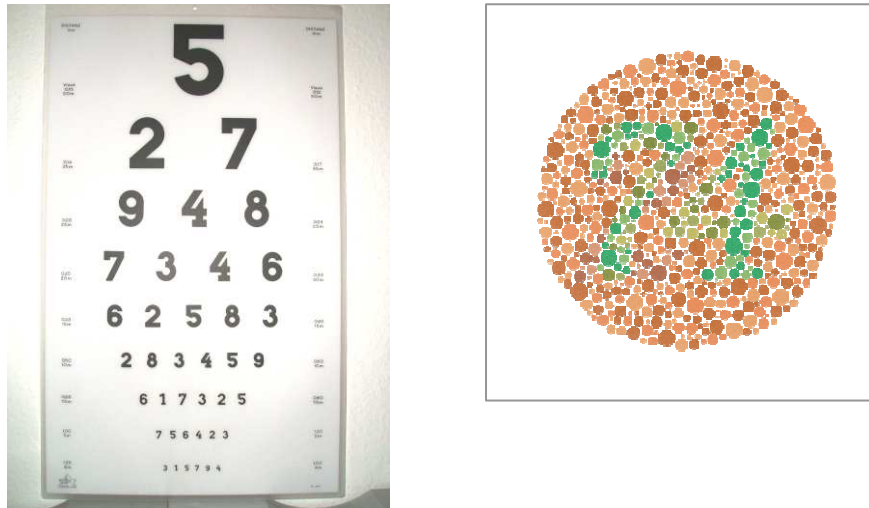
*Figure 6: Eye chart for determination of the test persons' visual acuity and Ishihara colour plate for colour vision testing.*

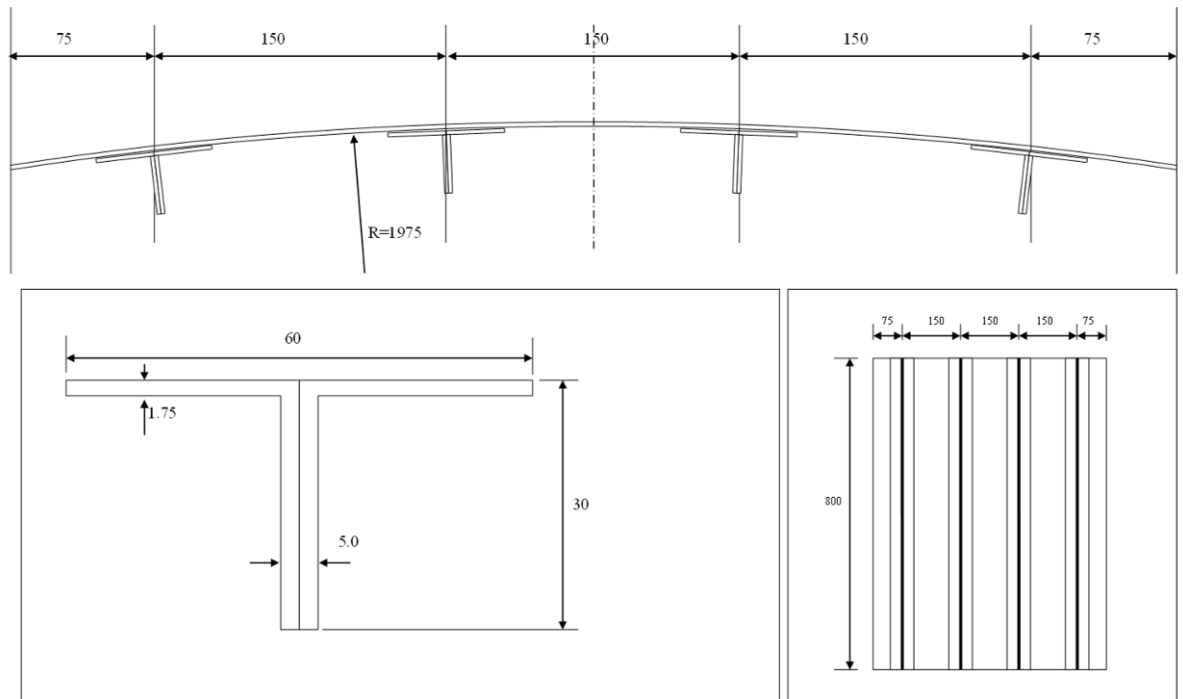
Figure 7: Design of the test structure

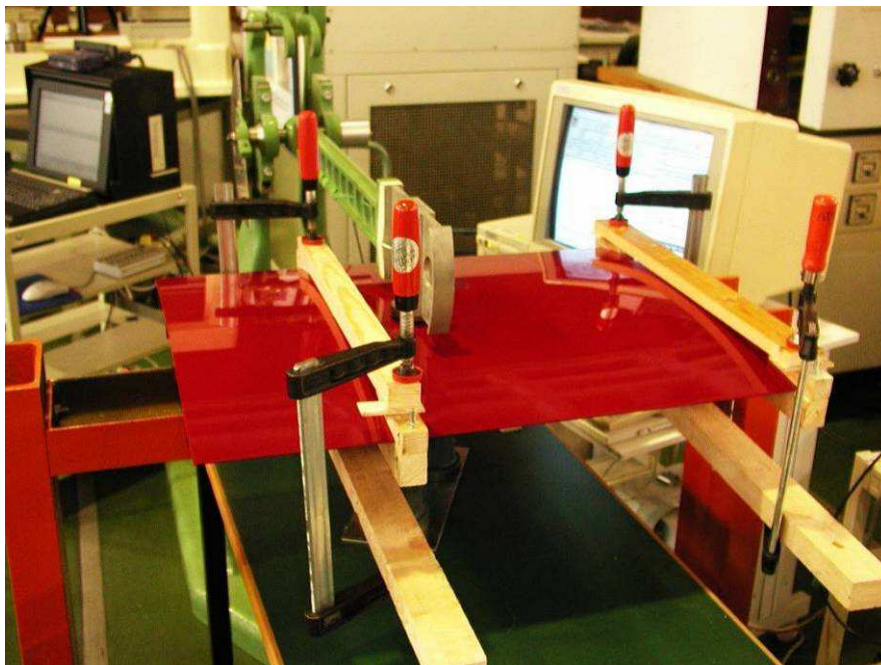
*Figure 14: Panel secured against jumping out of the supports before impacting.*

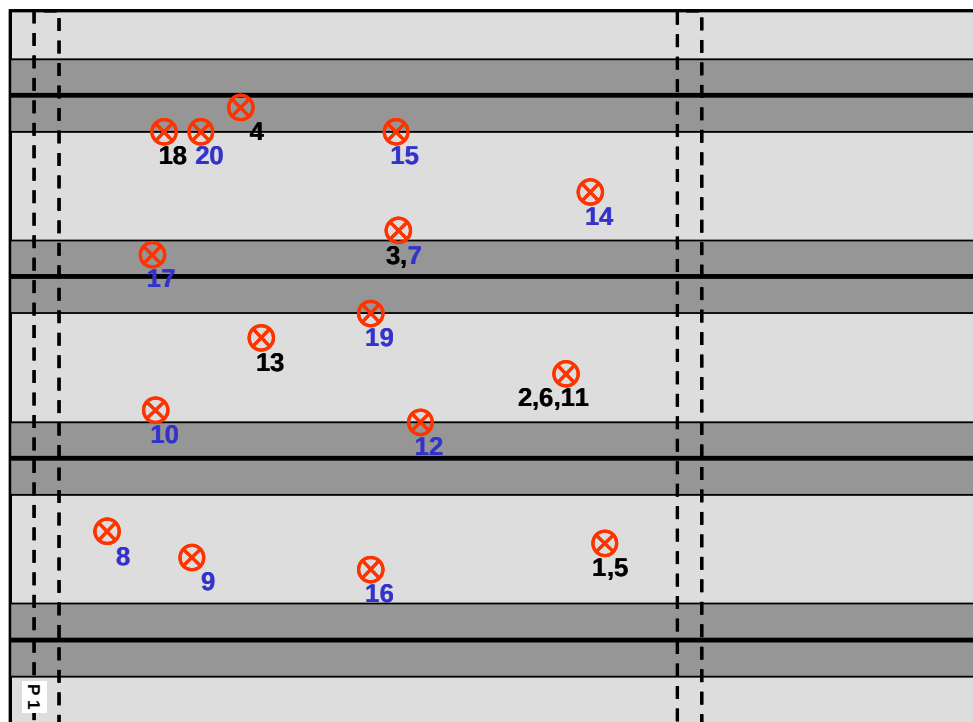
Figure 15: Impact locations, numbered in chronological order (see Table 4), for panel 1.

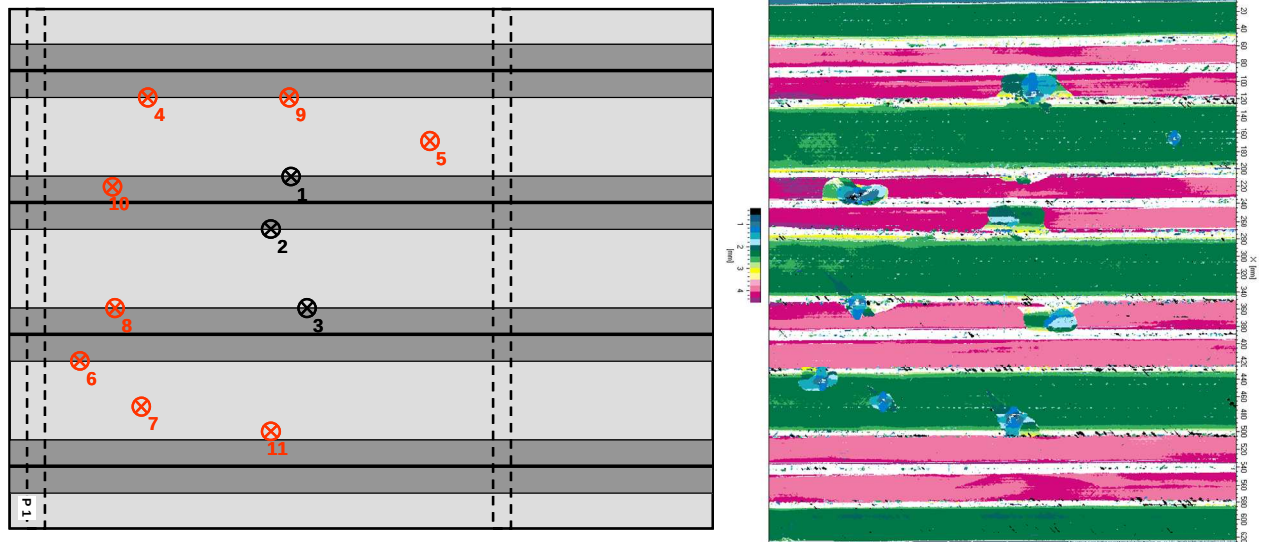
Figure 16: Impacts on panel 1 with NDT result. Impacts are numbered according to Table 5. Left border of NDT results corresponds to left edge of the panel.

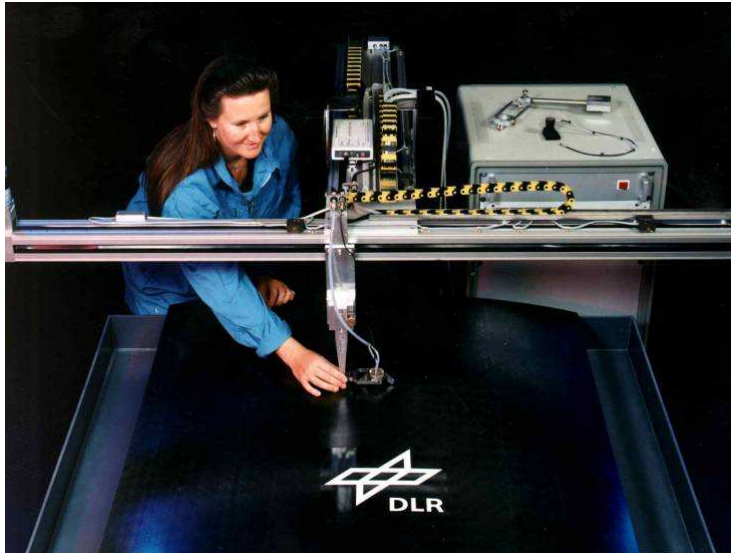
Figure 19: The ultrasonic scans were conducted with a stationary high resolution device using water coupling.

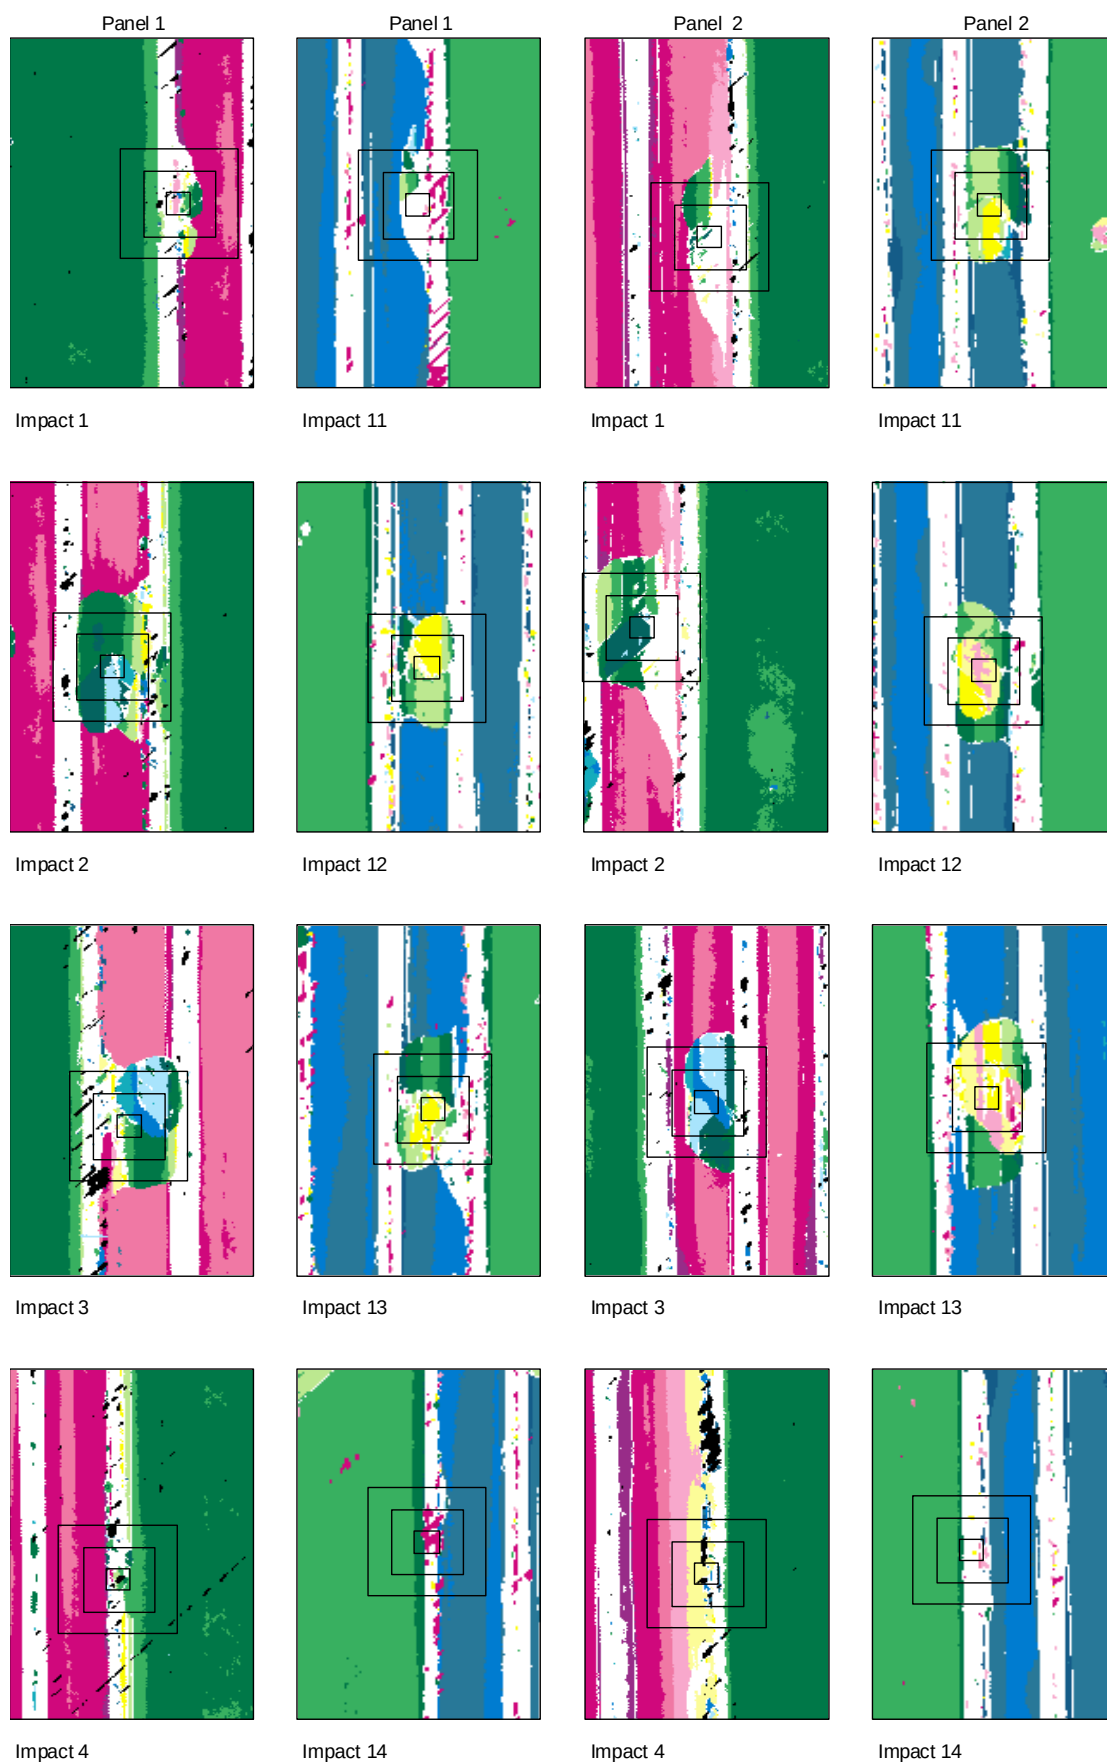
Table 7: Individual damages with superimposed damage category grid (Figure 20)

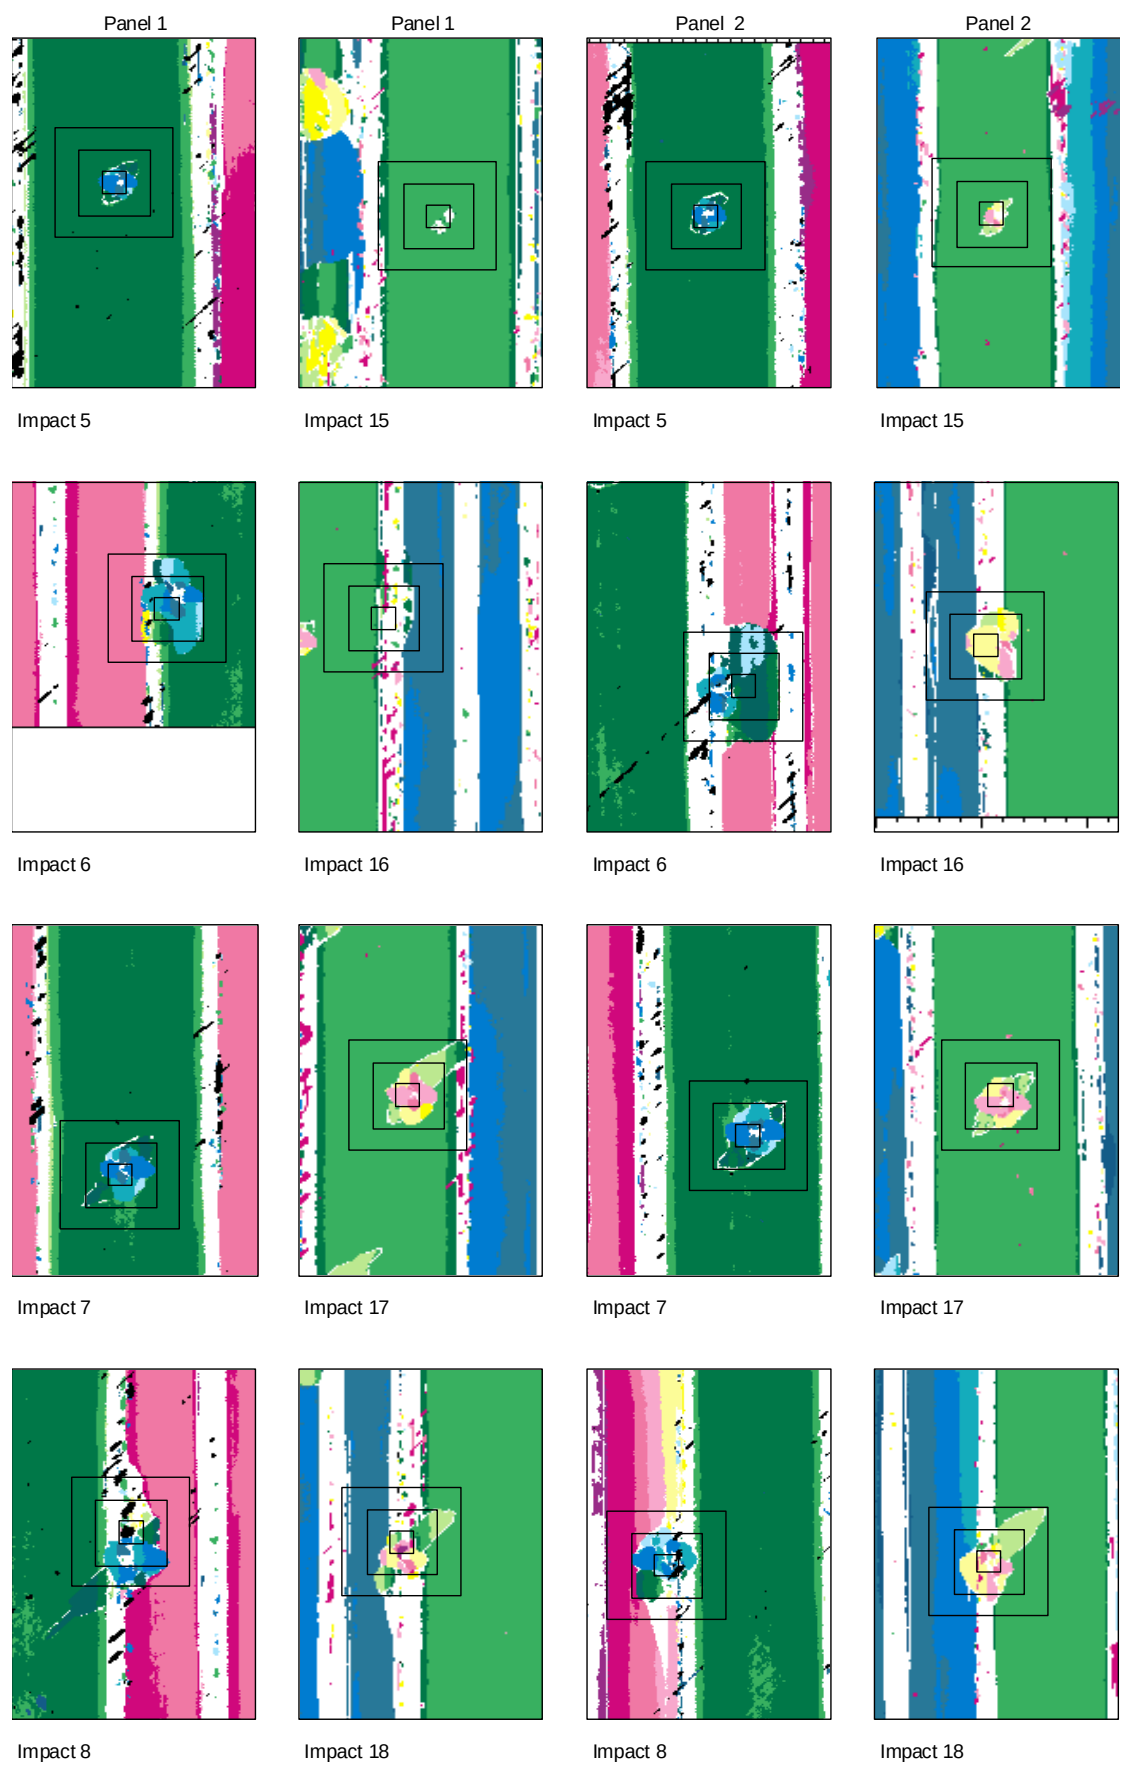
Table 8: Individual damages with superimposed damage category grid (Figure 20)

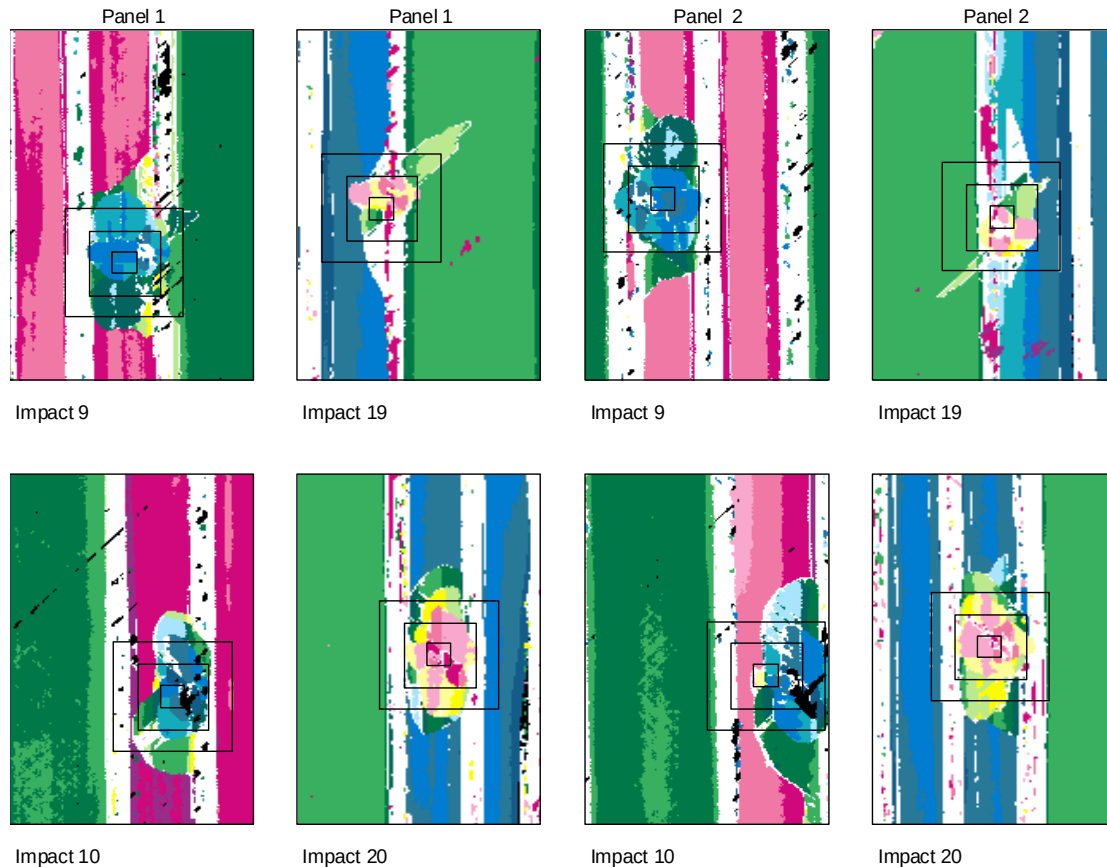
Table 9: Individual damages with superimposed damage category grid (Figure 20)

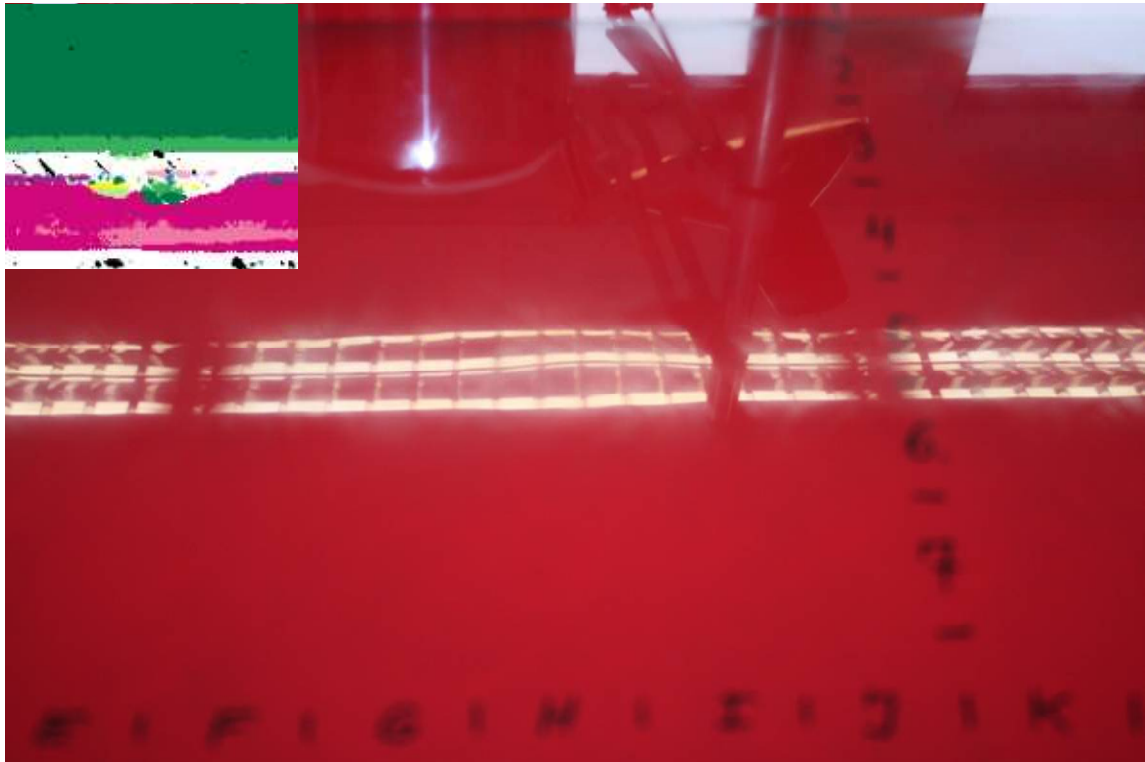
Figure 21: Panel 1, impact No. 1, at H5.

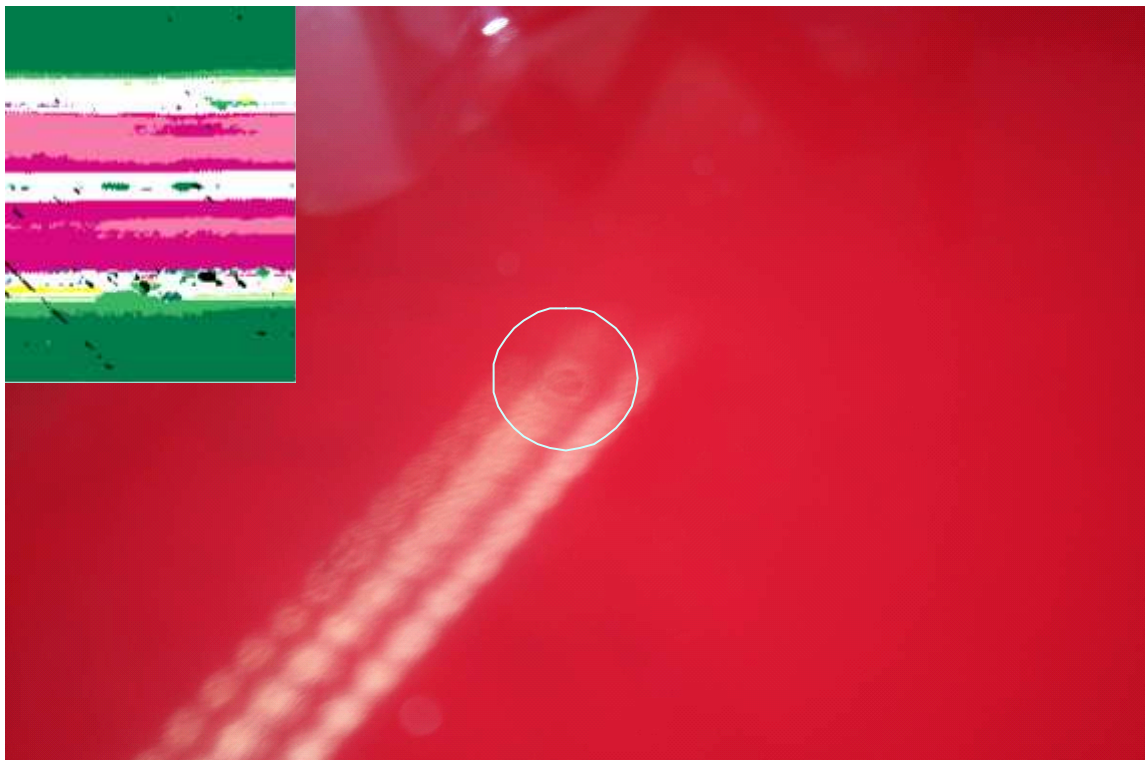
Figure 24: Panel 1, Impact No. 4. This impact did not cause internal damage in panel 2, but left a visible marking on the painted surface of both panels. The marking on panel 1 is located in the center of the circle above. The markings survived the application and removal of dirt.

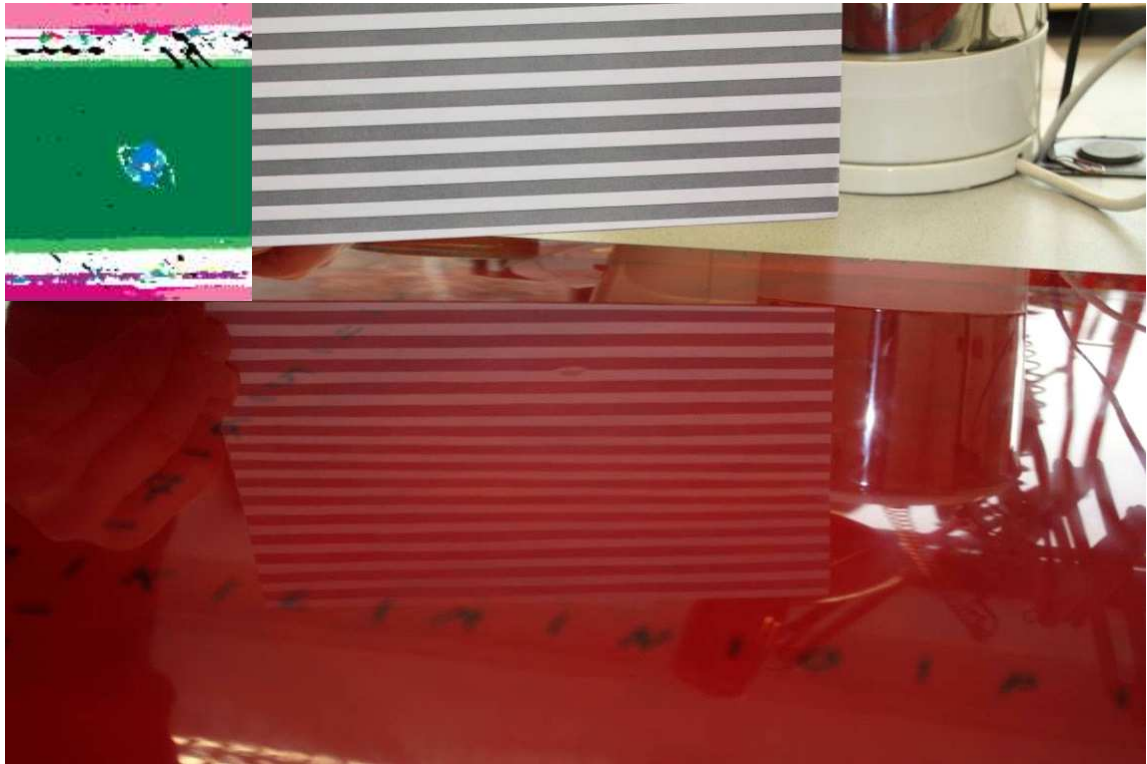
Figure 25: Panel 1, Impact No. 5

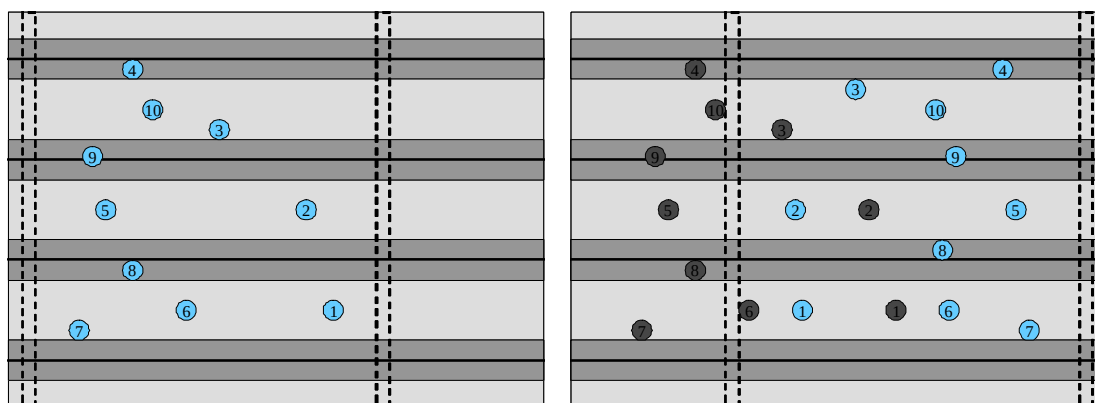
Figure 30: New impacts (light blue colour on right hand side picture) were introduced after revarnishment of the panels in between the old impacts (light blue colour on left hand side and dark grey colour on right hand side).

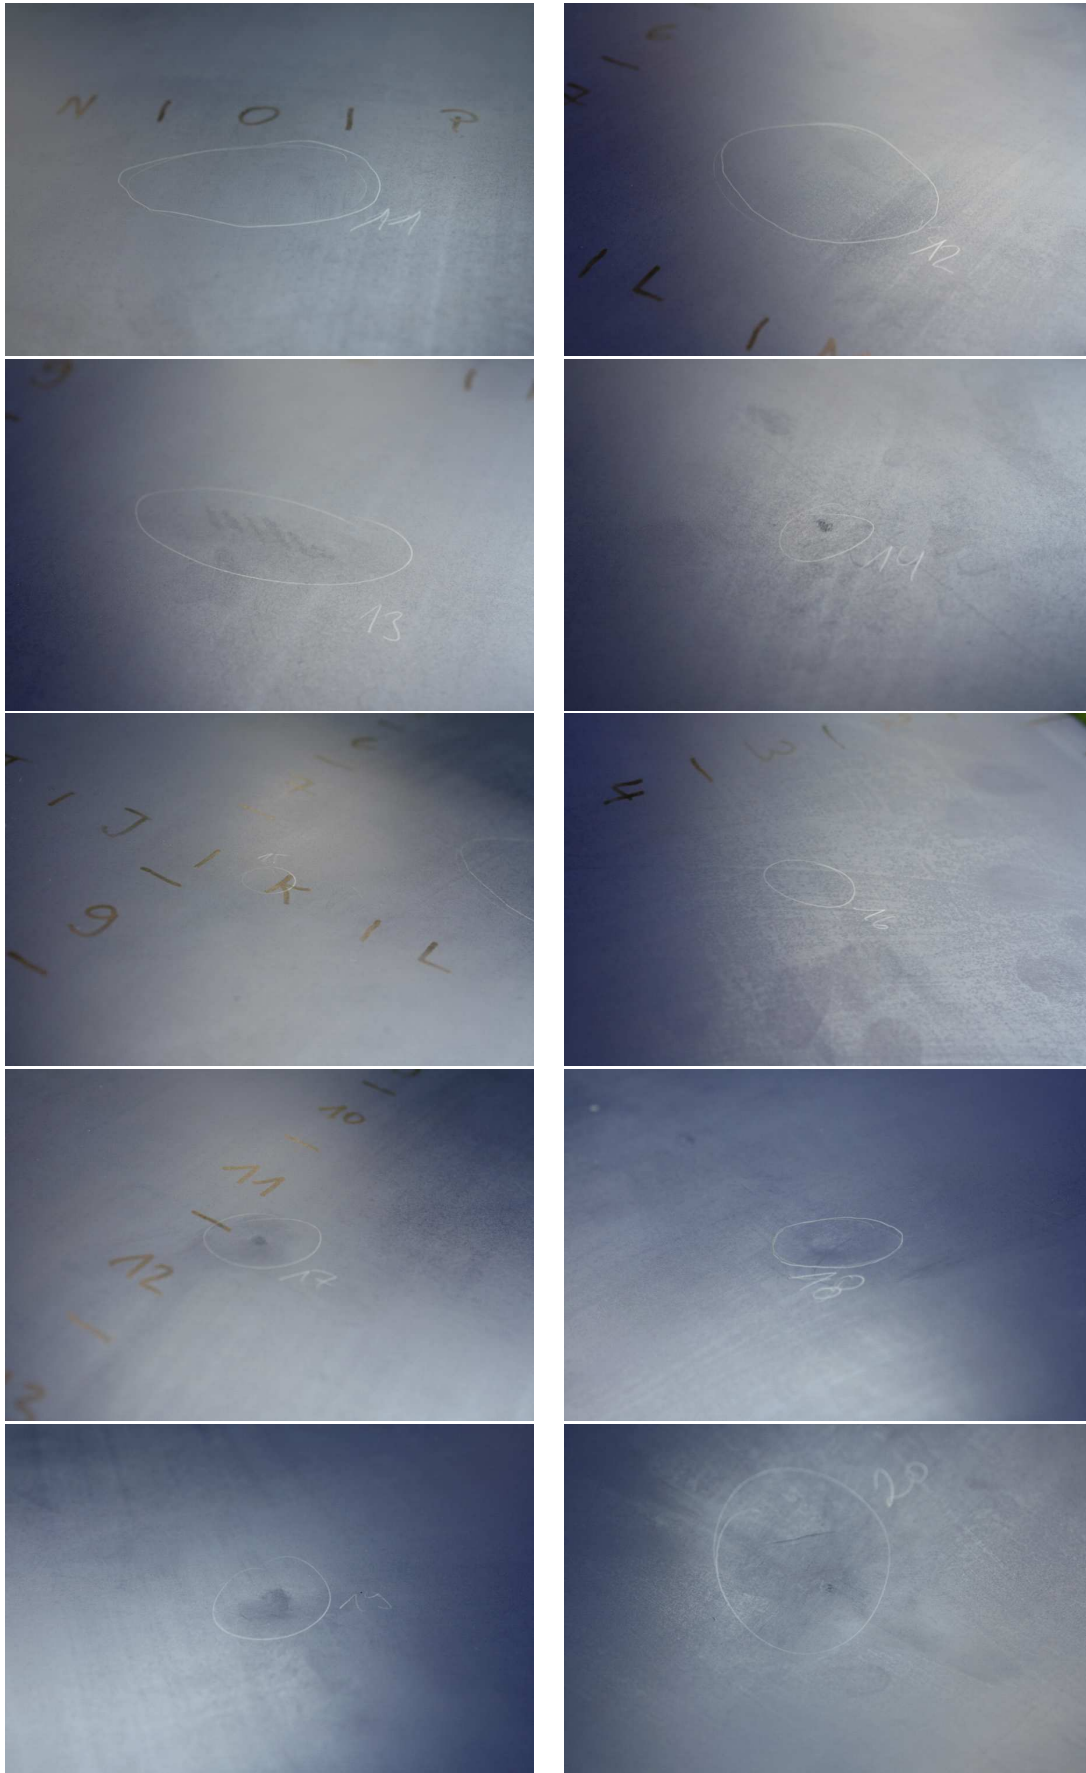
Figure 31: Impact locations 11-20 on panel 1 after impacting. The size of the markings on the panel does not correspond to size of internal damage.

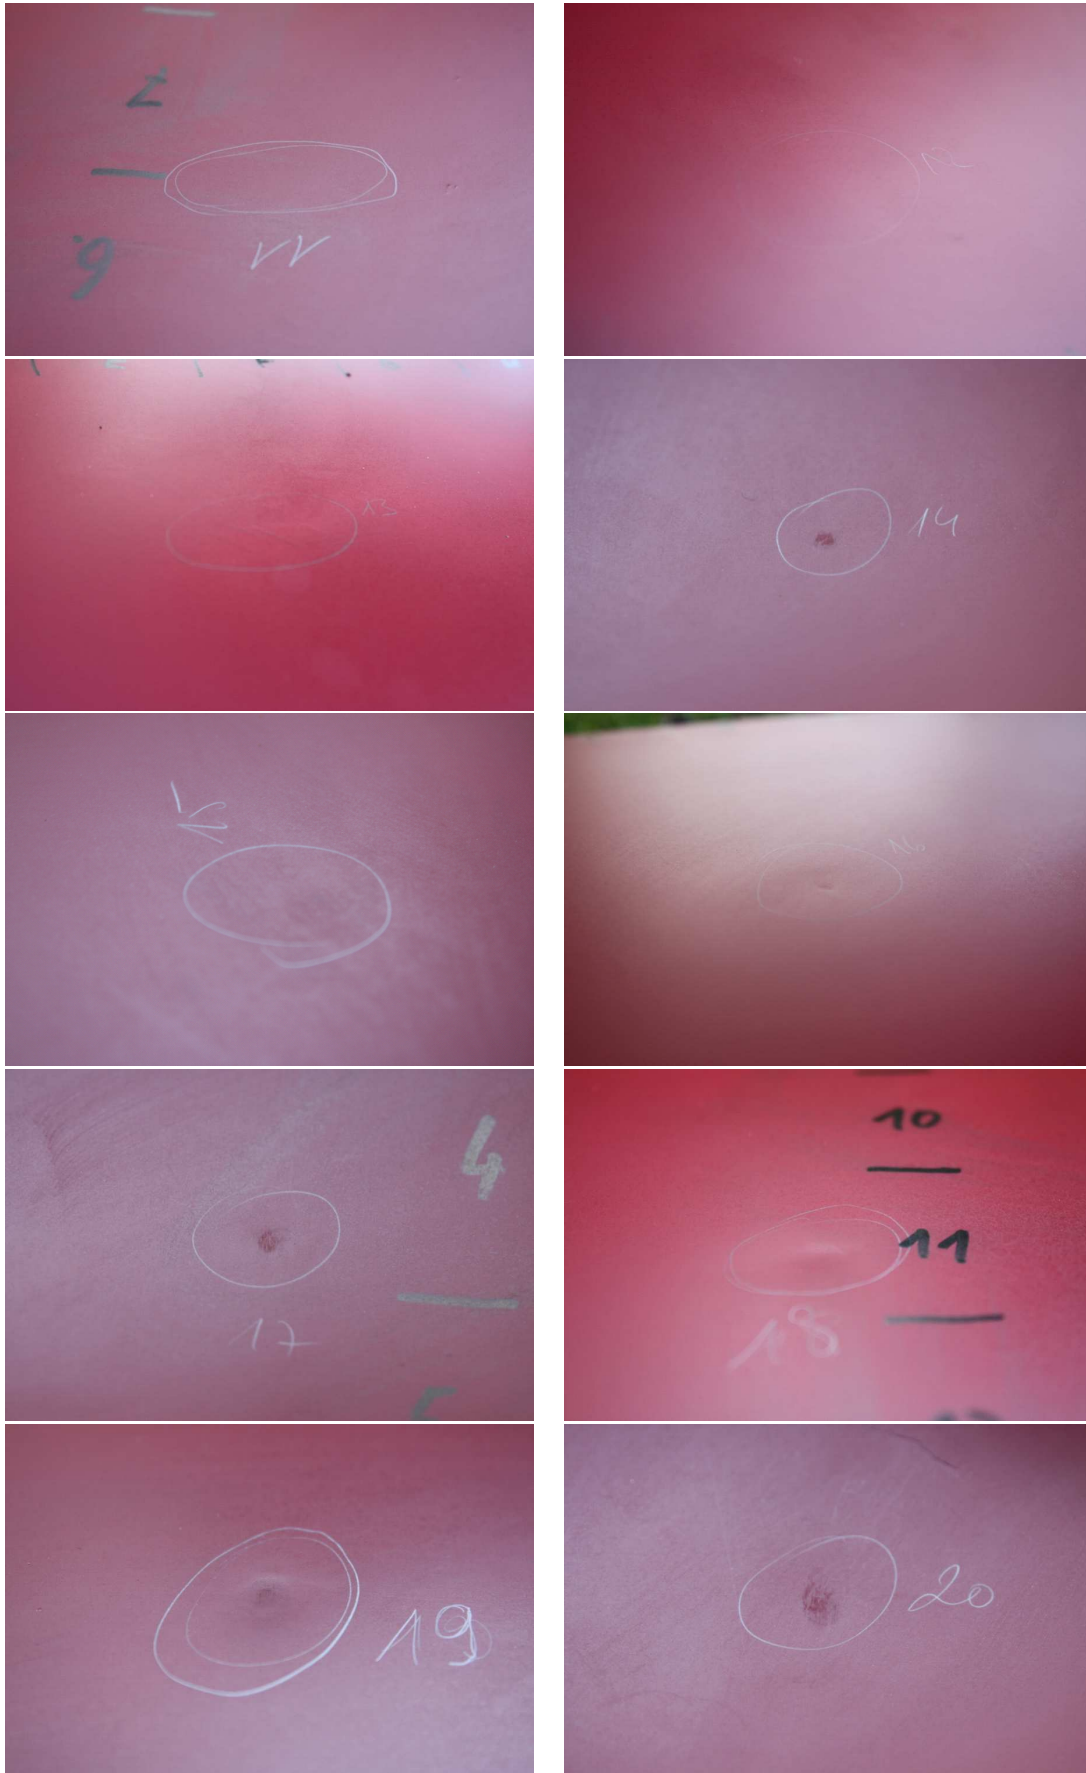
Figure 32: Impact locations 11-20 on panel 2 after impacting. The size of the markings on the panel does not correspond to size of internal damage.

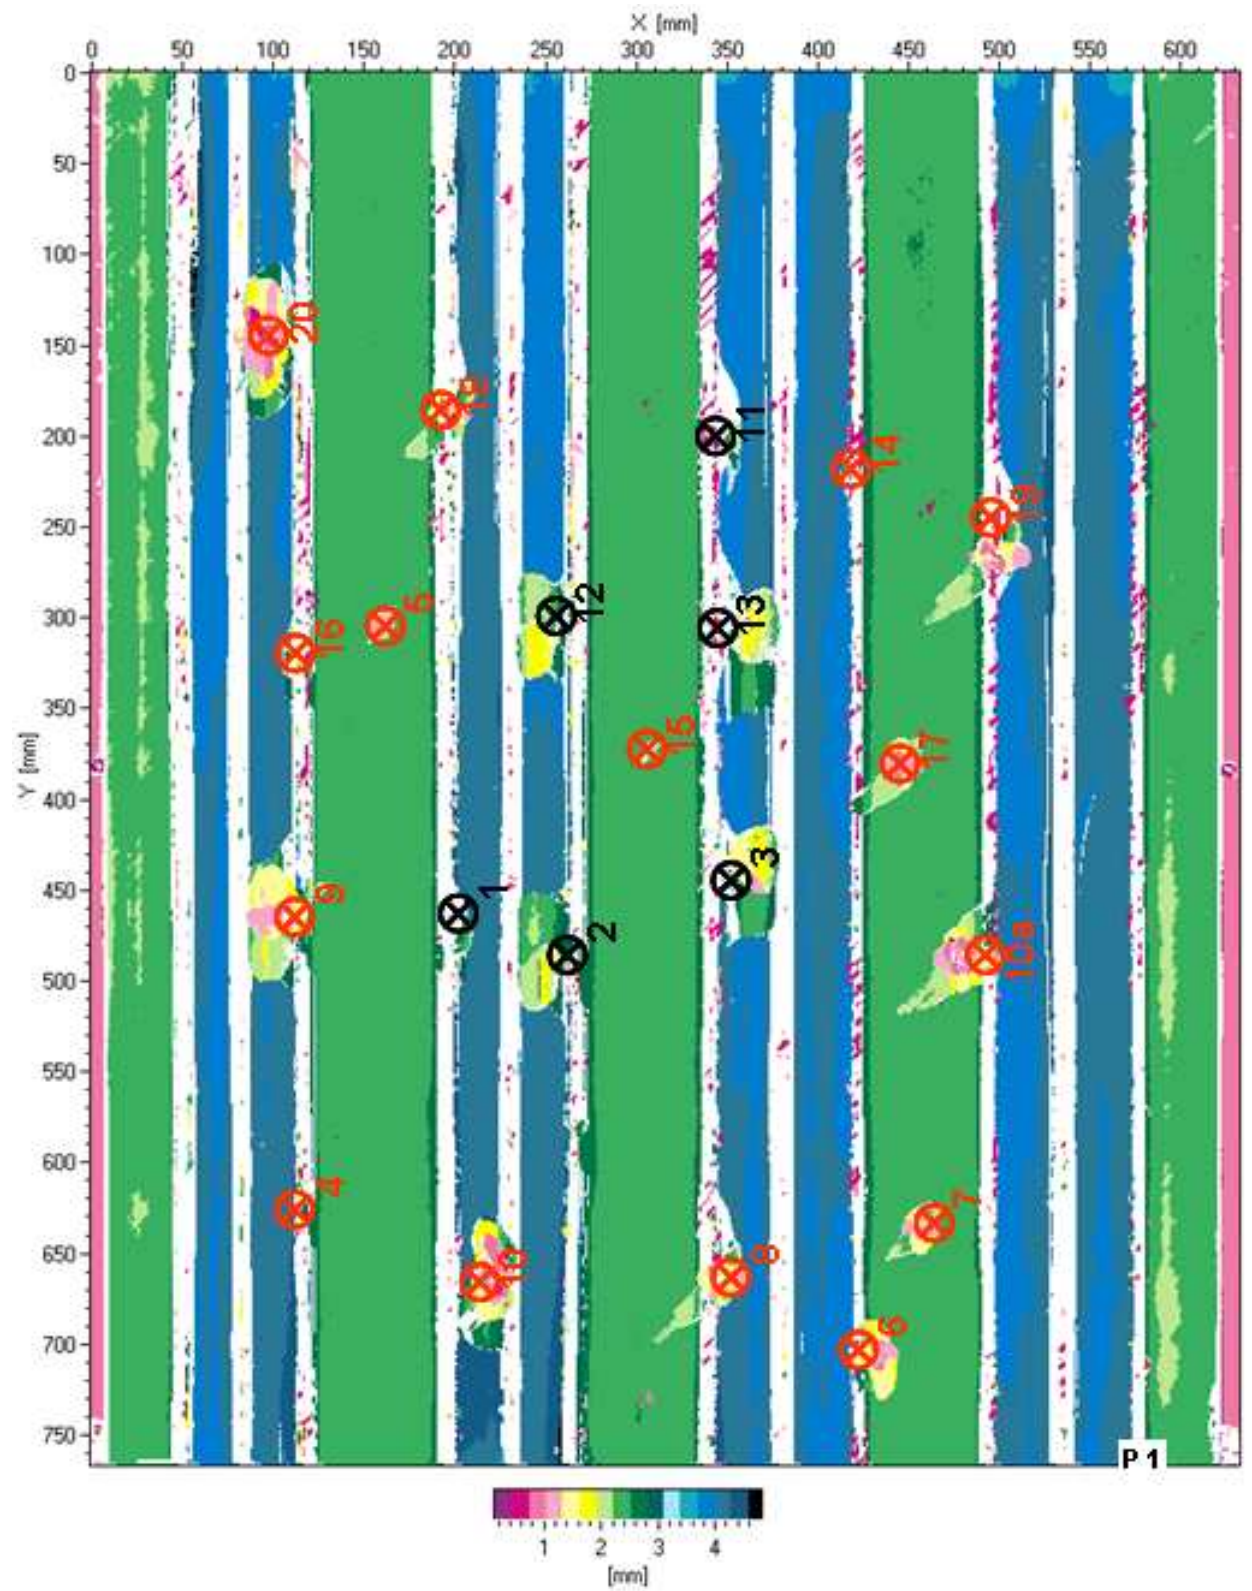
Figure 33: US-scan of panel 1 after 21 impacts.

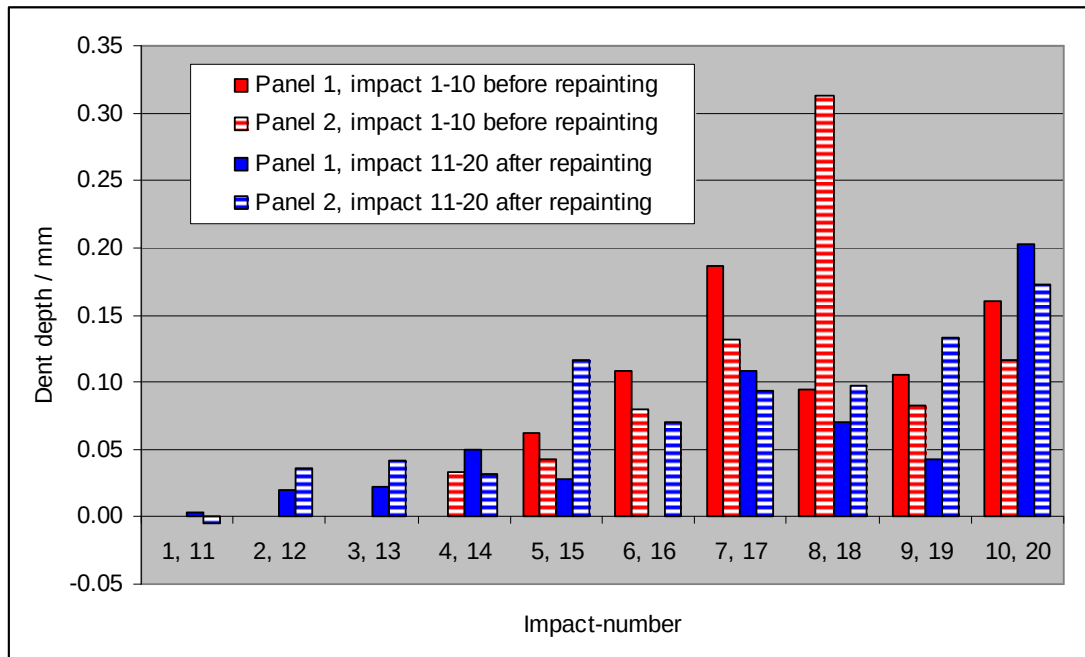
Figure 38: Influence of the repainting process on creation of dents. Comparison of dent depths of newly introduced impacts after repainting (impact No. 11-20) to dent depths of impacts No. 1-10 on the first panel coating.

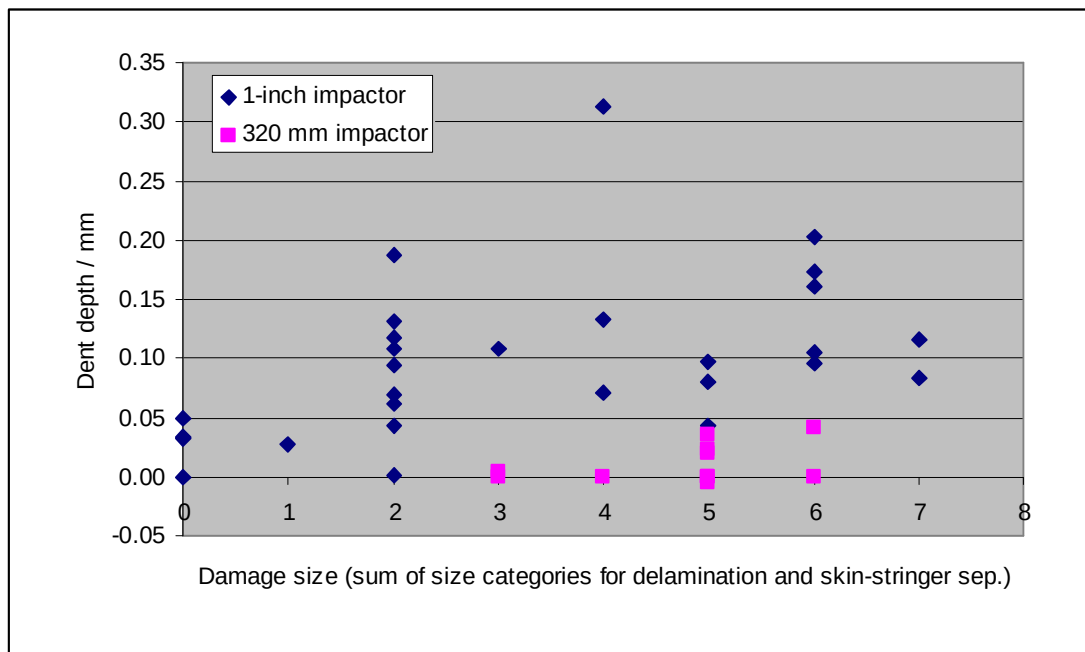
Figure 39: Damage size vs. depth of the permanent indentation. The damage size was determined by US-scanning, see Table 6.

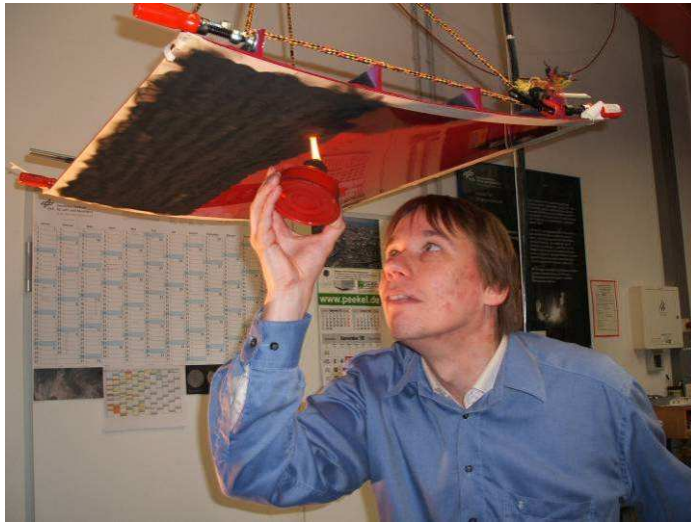
*Figure 41: Application of paraffin oil soot on panel 1 with red glossy coating. The paraffin flame had no effect on the glossy coating.*

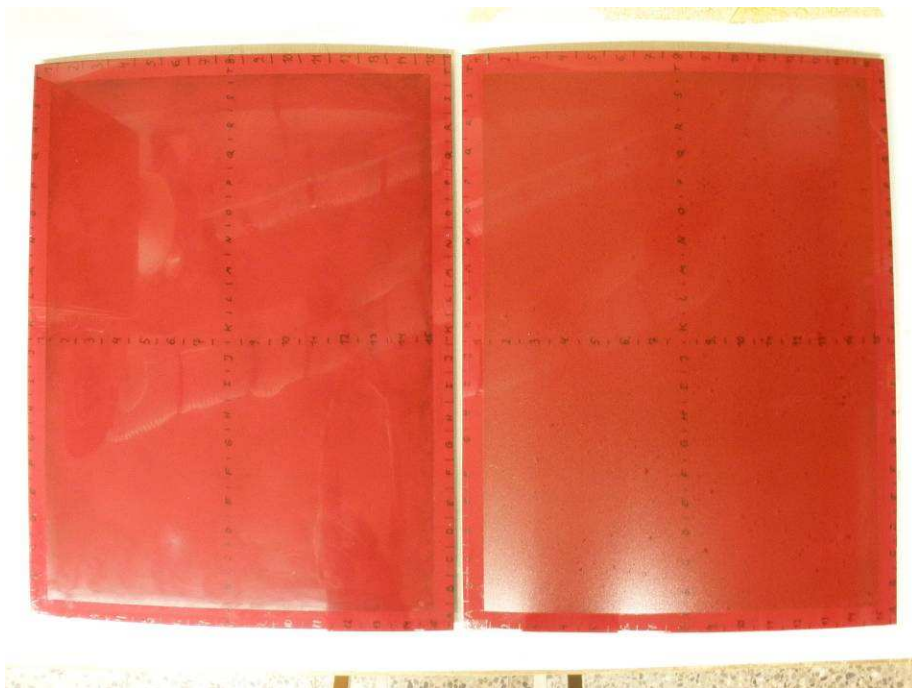
*Figure 44: Comparison of gloss appearance for oil film / soot dirt (left hand side) and coffee stains/right hand side).*
