**EASA**  
European Aviation Safety Agency

Final Report EASA\_REP\_RESEA\_2007\_3

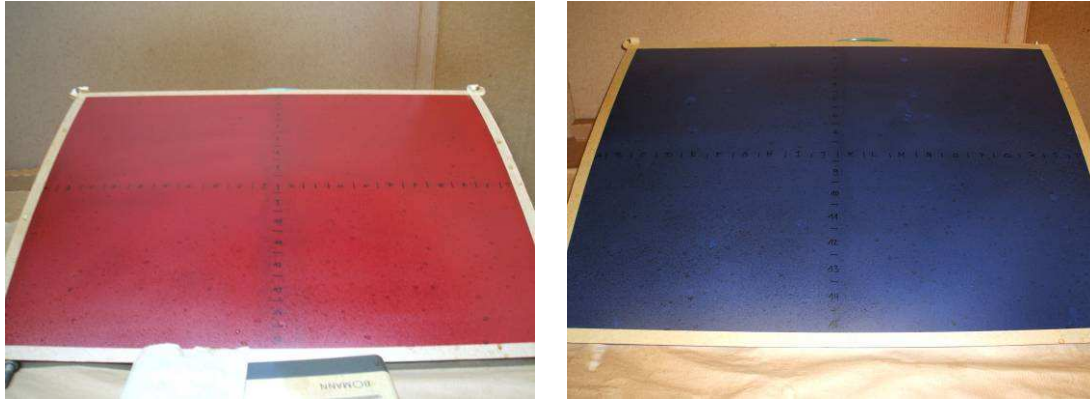
*Figure 45: Figure 1 coffee stain on the blue / red matt panel surfaces.*

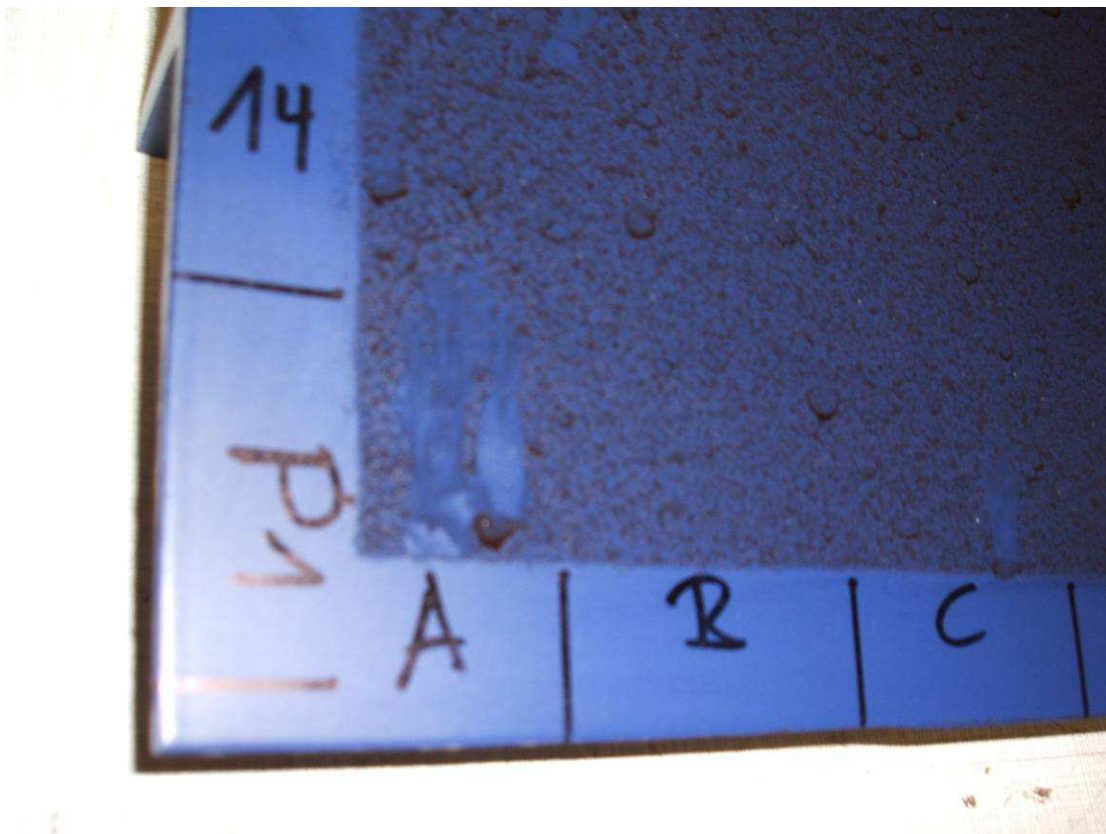
*Figure 46: Close-up of coffee stains on panel 1.*

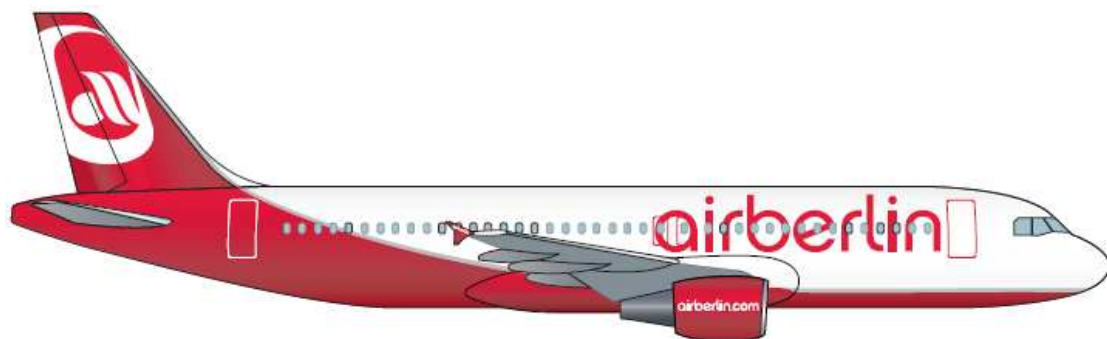
*Figure 47: Air Berlin livery*

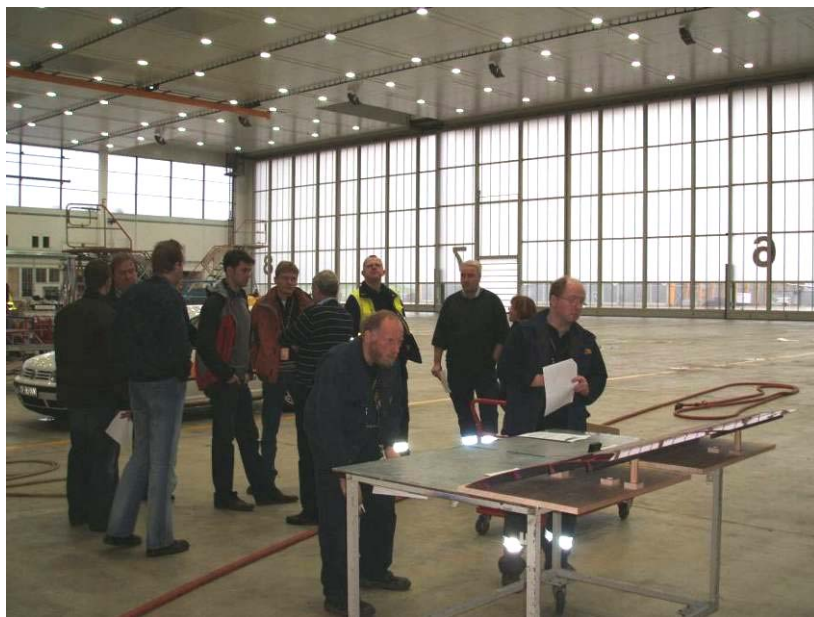
*Figure 48: Lighting of a hangar at Lufthansa Technik on 24 Nov 2008.*

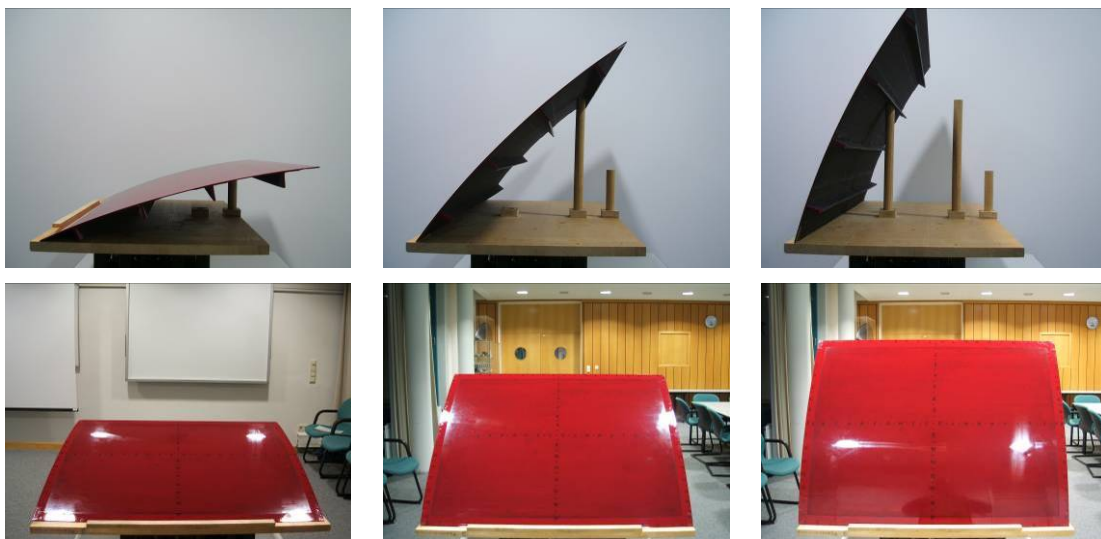
*Figure 50: Inspection angles 15° (left), 45° (middle), 65° (right hand side)*

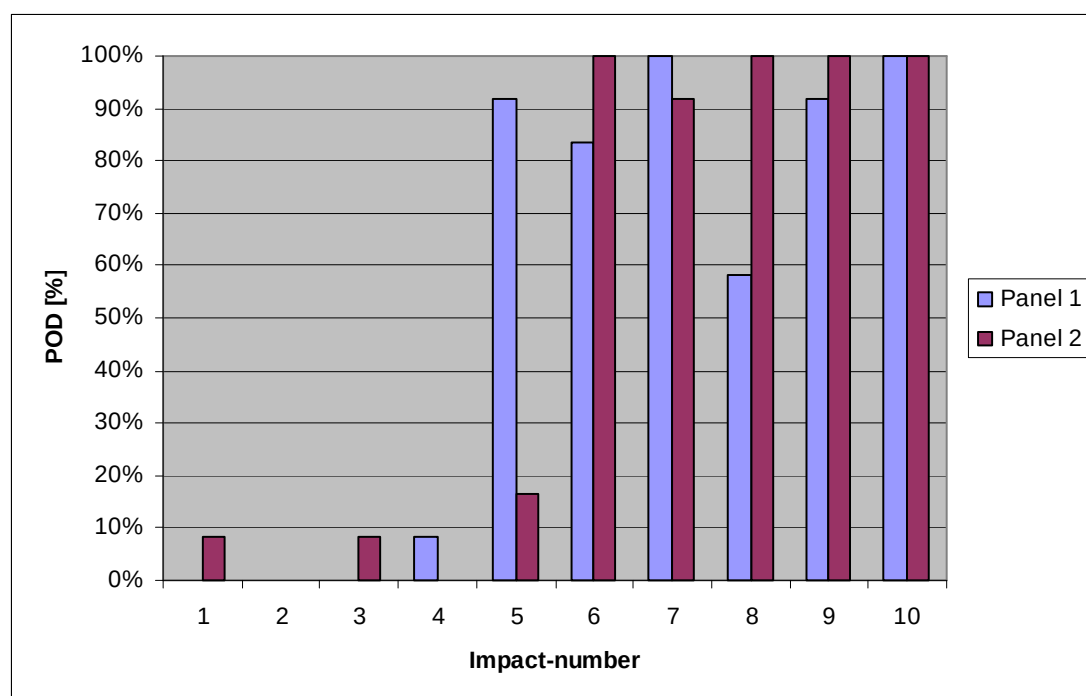
Figure 51: POD for both panels under equal inspection conditions.

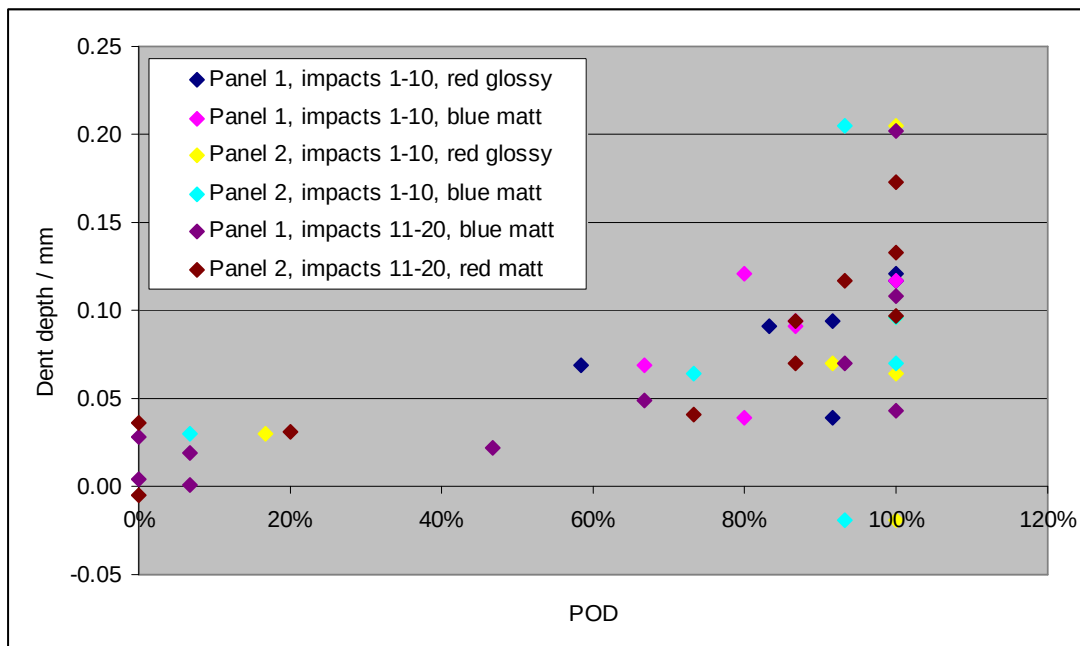
Figure 52: Influence of dent depth on detectability of damage.

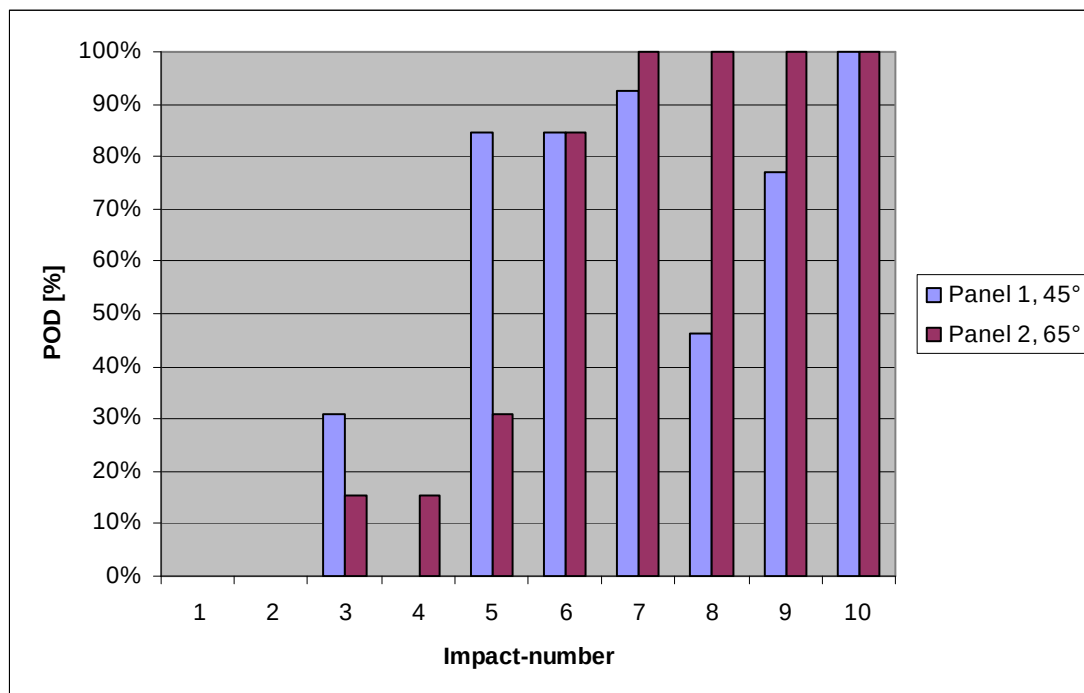
Figure 53: POD for panel 1 at an inspection angle of 45° and panel 2 at an inspection angle of 65°

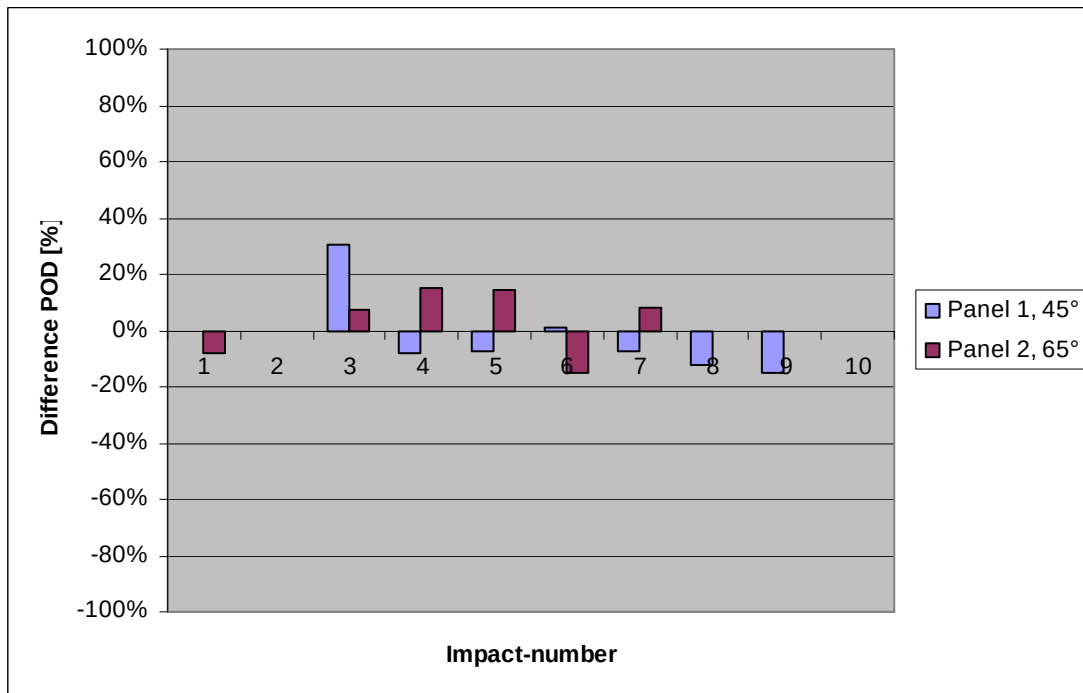
Figure 54: Influence of the inspection angle - difference in POD with respect to the reference inspection

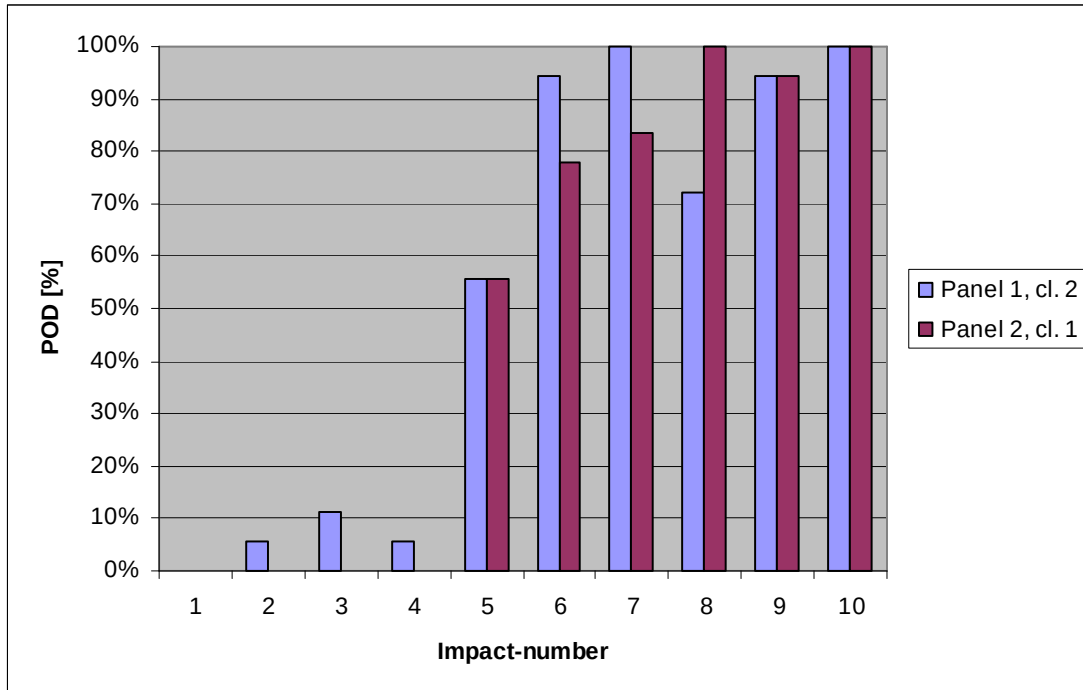
*Figure 55: POD for panel 1 at a cleanliness level of 2 and panel 2 at a cleanliness level of 1.*

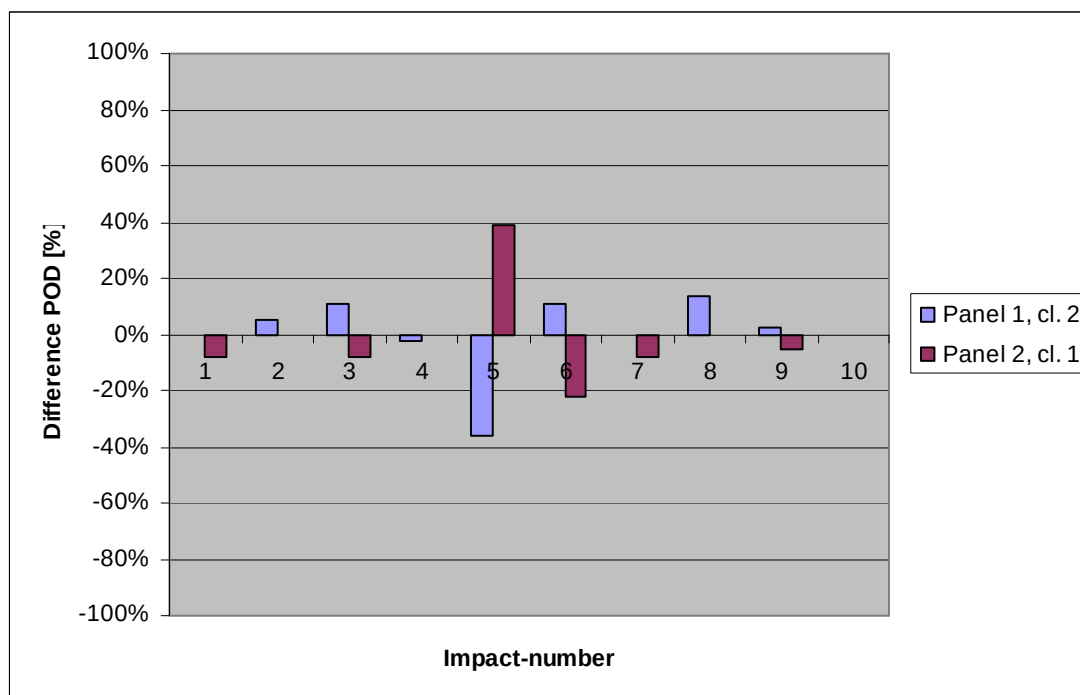
Figure 56: Influence of cleanliness - difference in POD with respect to the reference inspection.

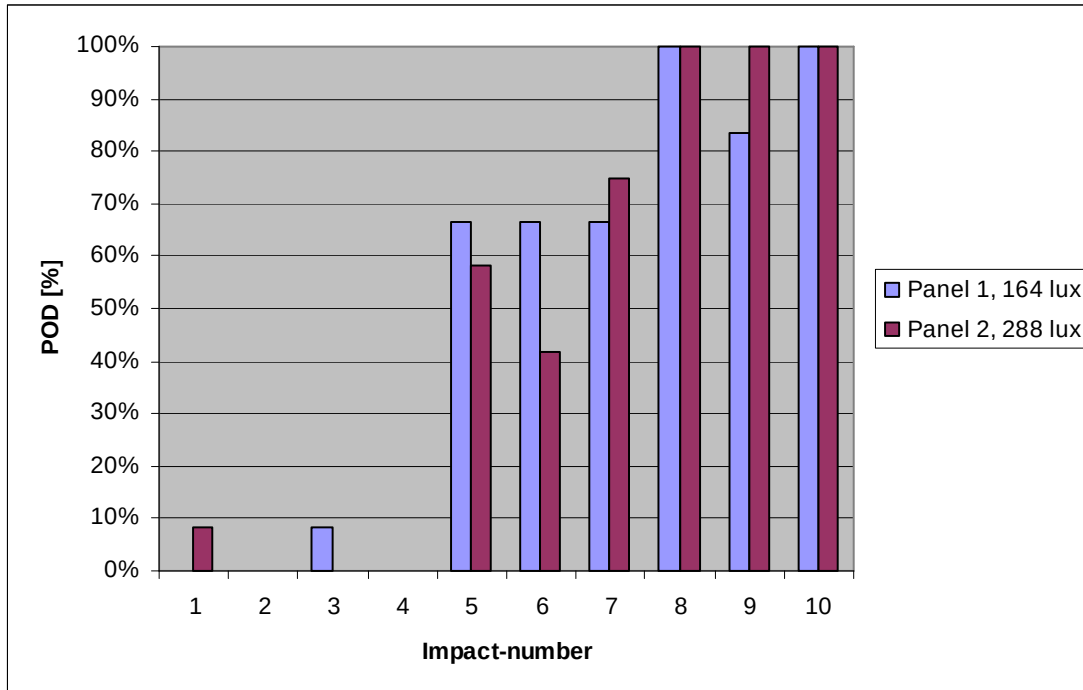
Figure 57: POD for panel 1 at an illumination of 164 lux and panel 2 at an illumination of 288 lux.

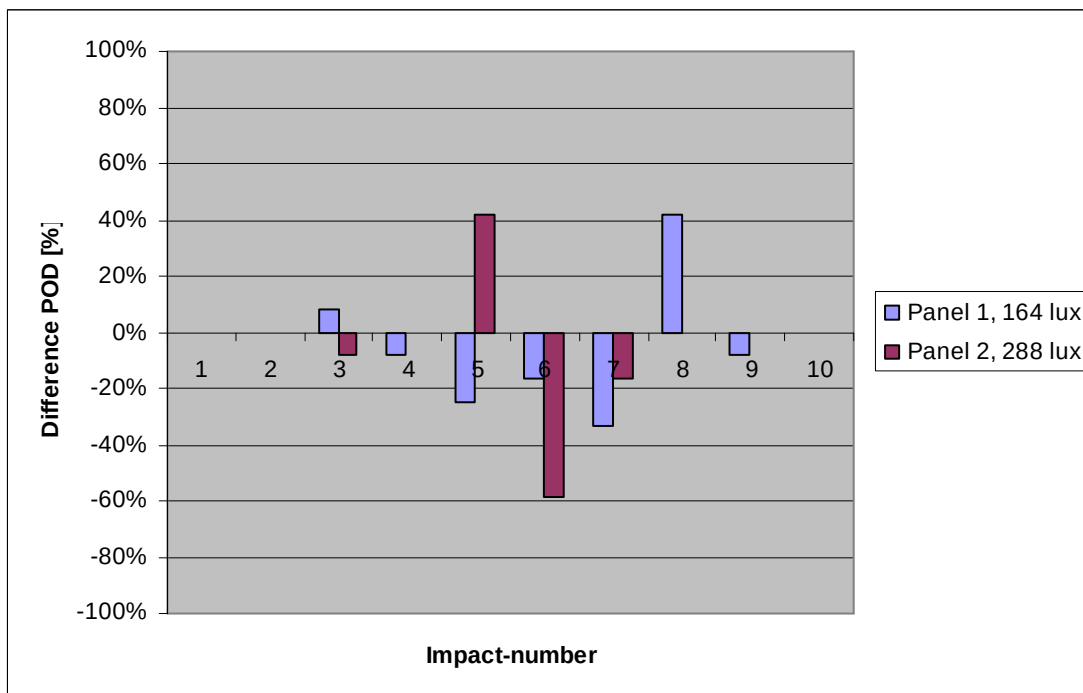
Figure 58: Influence of illumination - difference in POD with respect to the reference inspection.

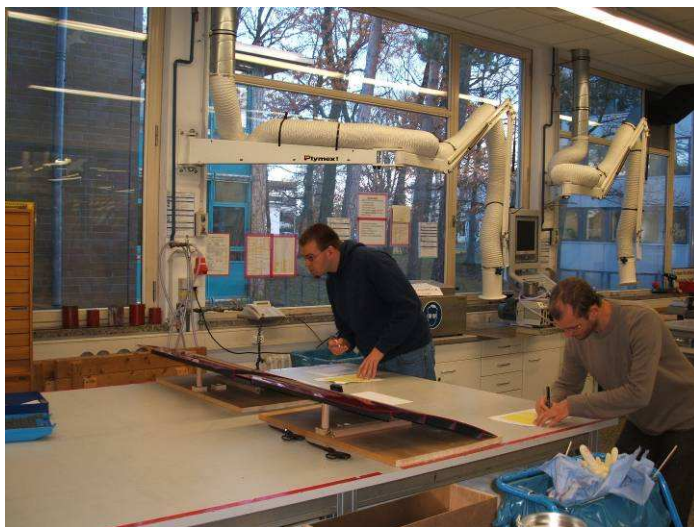
All inspectors found damages 6 to 10 on both panels, only one inspector missed the No. 5 damage on panel 2. Even the impact location No. 4 was found by quite a few inspectors. The US-scan did not even show internal damage here. But even the very good lighting conditions did not help much at locating the flat, spread out dents from the blunt impacts.

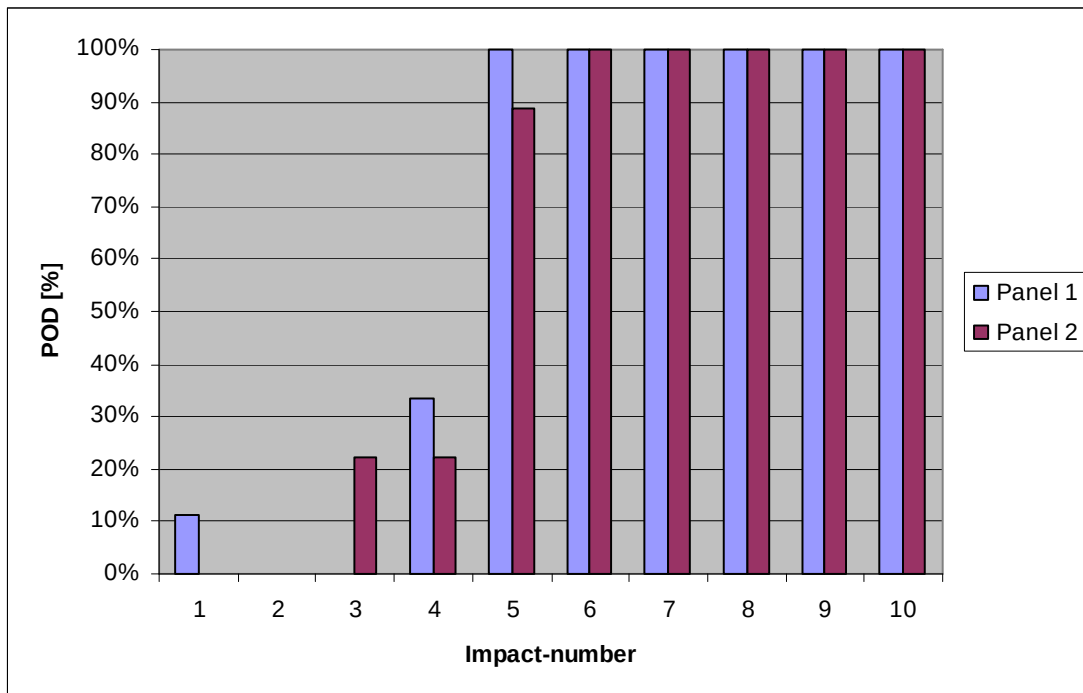
Figure 60: POD for both panels at an illumination of 1100 lux.

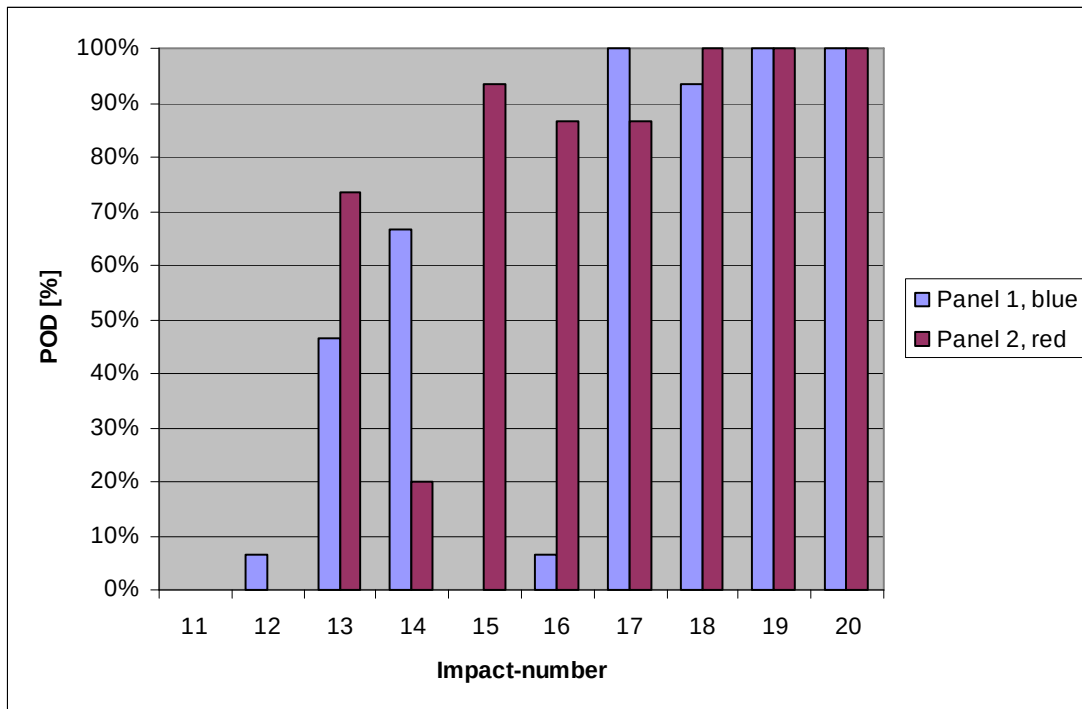
Figure 62: POD for differently coloured panels.

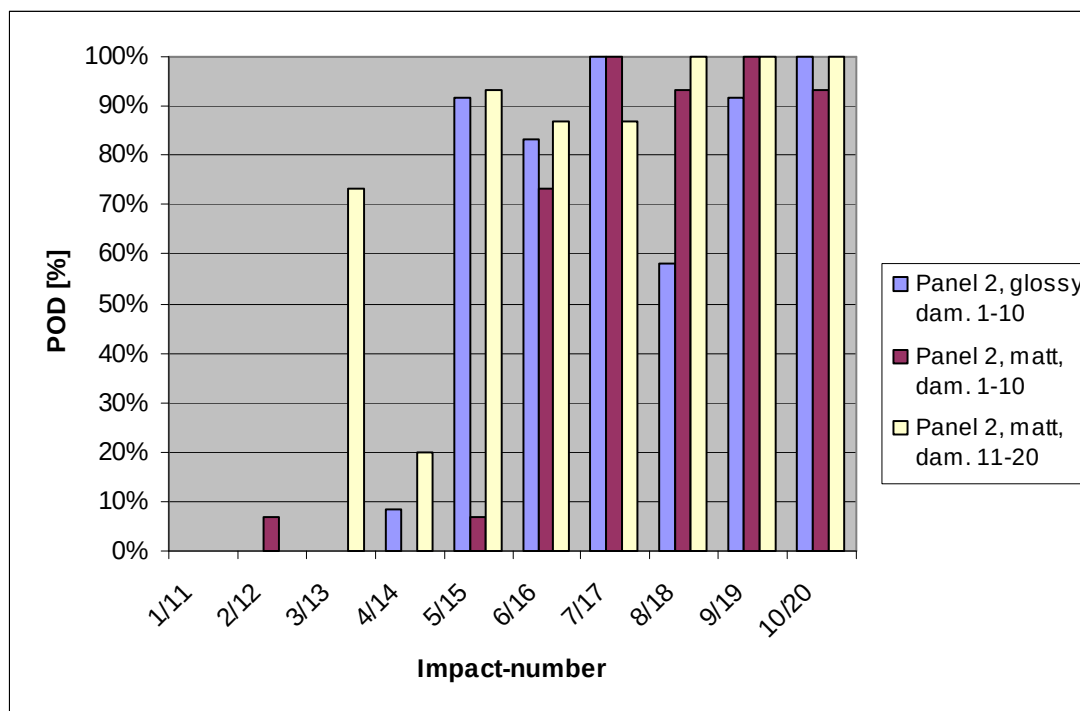
Figure 63: POD for panel 2 with different finishes.

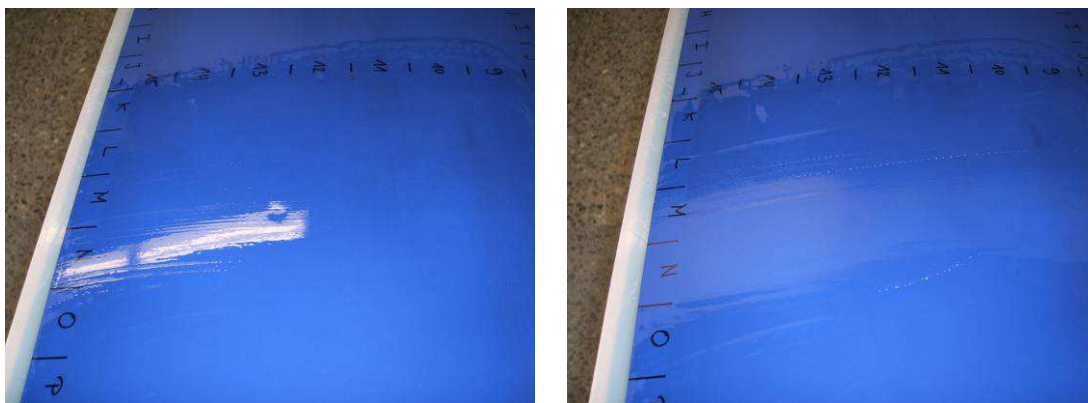
Figure 64: Surface wetting, to improve detectability of dents on matt surface.

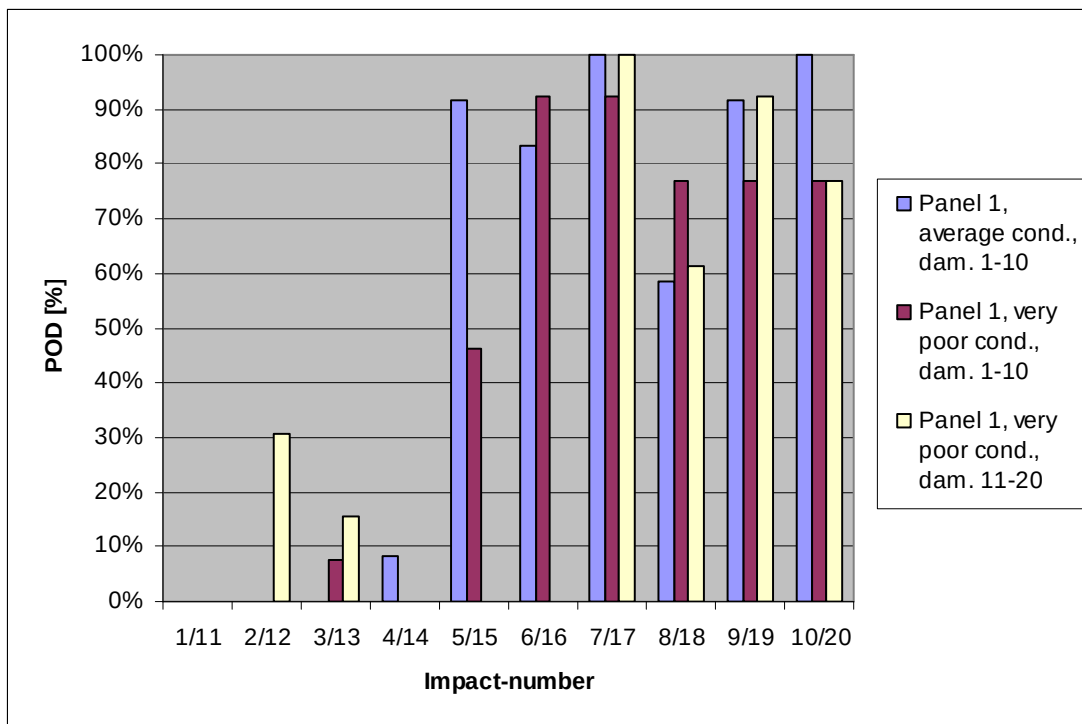
Figure 65: POD for panel 1, comparison of overall average and very poor inspection conditions.

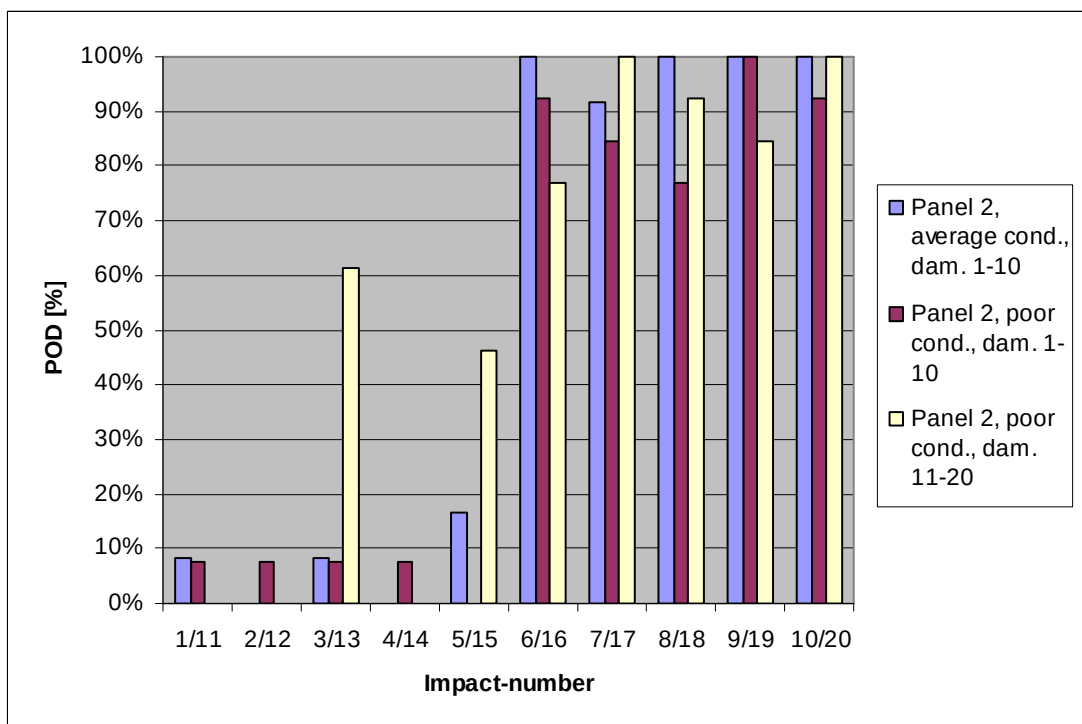
Figure 66: POD for panel 2, comparison of overall average and poor inspection conditions.

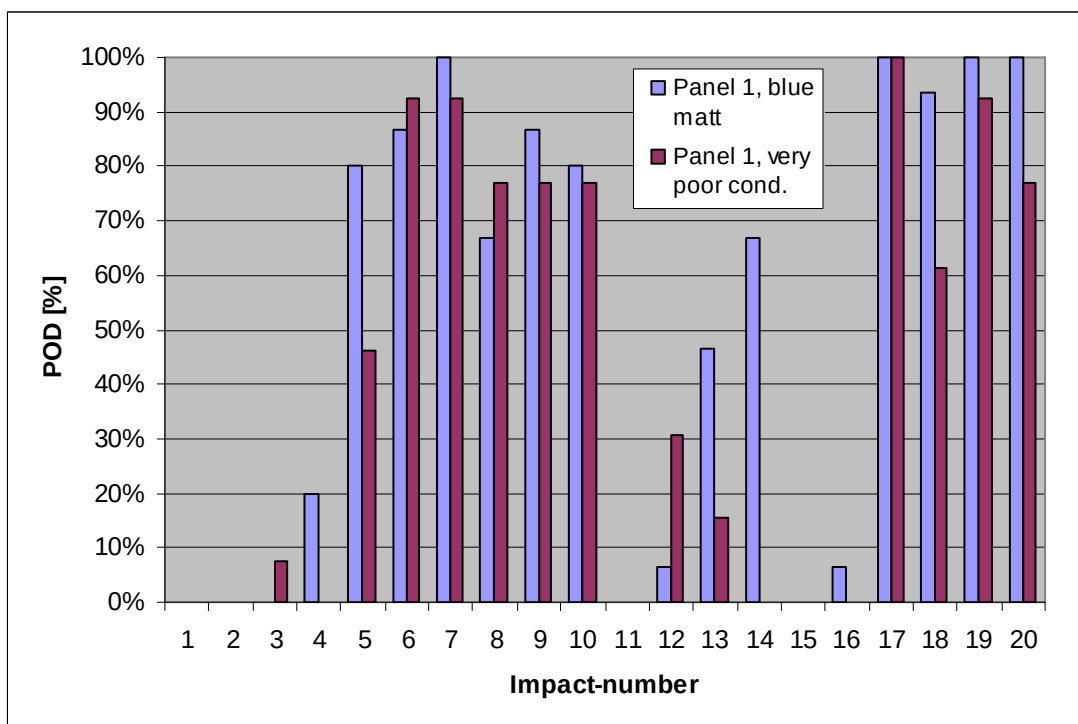
Figure 67: POD for the matt blue panel 1, comparison of otherwise average and very poor conditions.

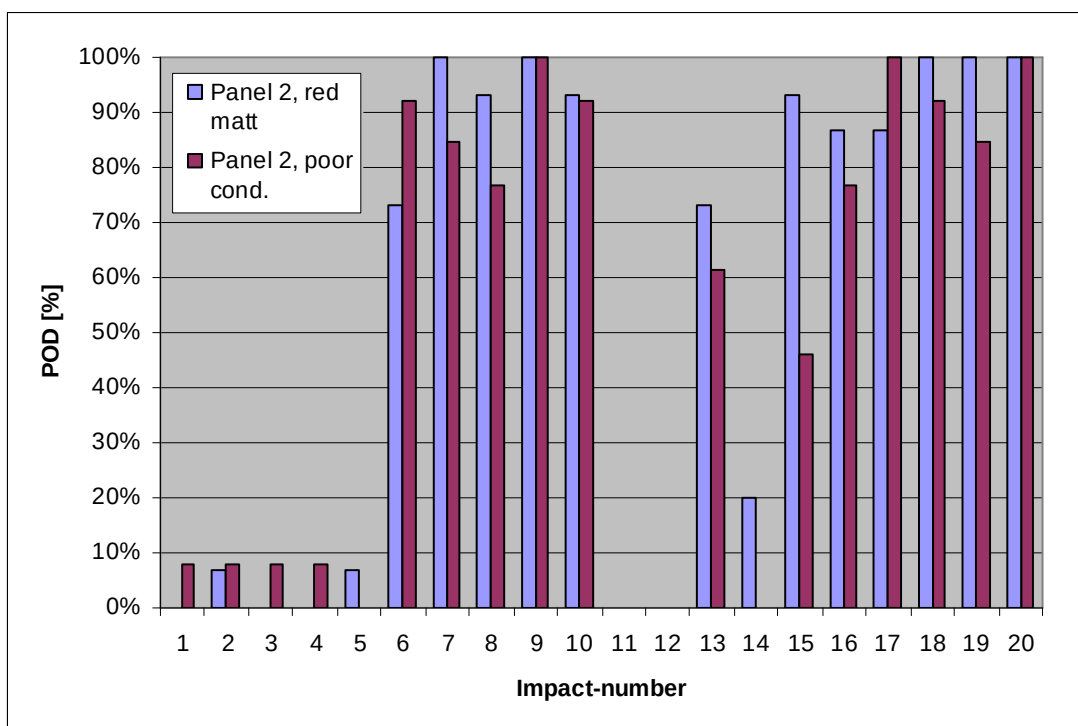
Figure 68: POD for the matt red panel 1, comparison of otherwise average and poor conditions.

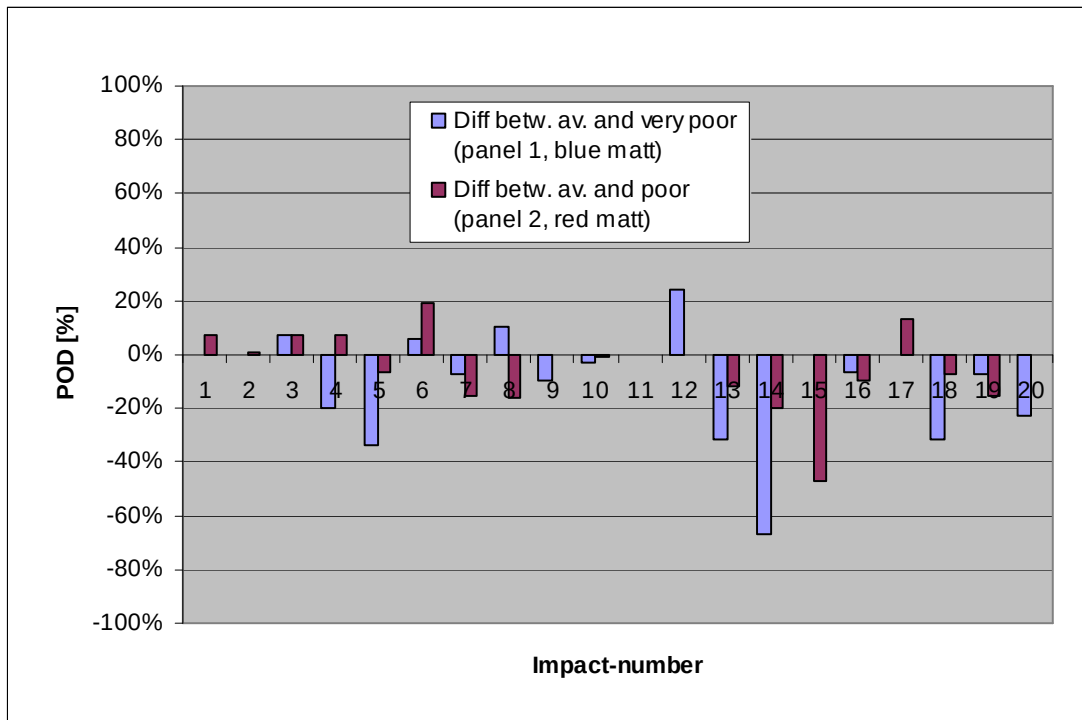
Figure 69: Influence of overall poor and very poor inspection conditions - difference in POD with respect to the inspection No. 8.

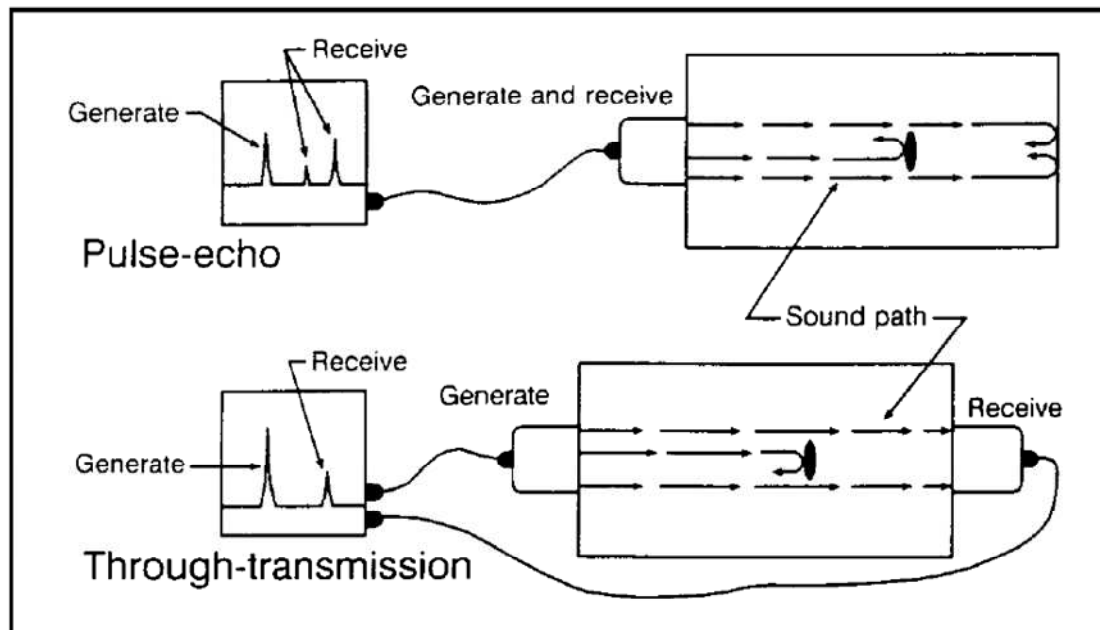
Figure 76 Pulse-echo and through-transmission ultrasonic inspection techniques (source: AC 43.13-1b).

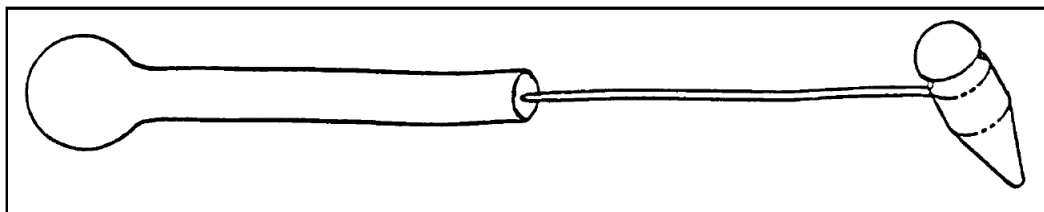
Figure 77: Sample of special tap hammer (source: AC 43.13-1b).
