Research Project EASA.2009/3

LIBCOS - Load upon Impact Behaviour of Composite Structure

EASA.2009.OP.24 LIBCOS – Significance of Load upon Impact Behaviour of Composite Structure

Final report

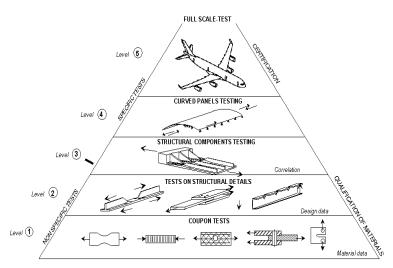
Fig. 1: Suggested pyramid of physical tests used to support aircraft design and certification [1]

The route to certification adopted by the aircraft manufacturers is based on the well known test pyramid for aircraft structures, Fig. 1, which typically foresees 5 levels of tests from materials test coupons in level 1 up to full aircraft structures in level 5. As described by Hachenberg [1], the certification of primary aircraft structures is governed by the airworthiness requirements FAR-25 [2], EASA CS-25 [3] for large transport aircraft. For composite materials the means of compliance recommendations ACJ 25.603 [4] (now replaced by AMC 20-29 [5]) and FAA AC 20.107A [6] of the airworthiness authorities are applied. Besides material and manufacturing qualification the main requirement is proof of strength as follows:

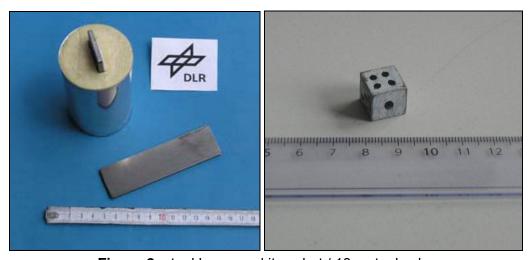
Figure 2: steel beam and its sabot / 13 g steel cube

- 100g steel beams (dimensions 30 mm x 4 mm x 108 mm) with velocities in the range 65 – 75 m/s and 13 g steel cubes (12 mm side length) with velocities in the range 60-135 m/s for notch damage,
- 100g Rubber beams (dimensions 30 mm x 24 mm x 134 mm) at approximately 100 m/s and 18-20 g glass ball (24-25 mm diameter) with velocities in the range 60-85 m/s

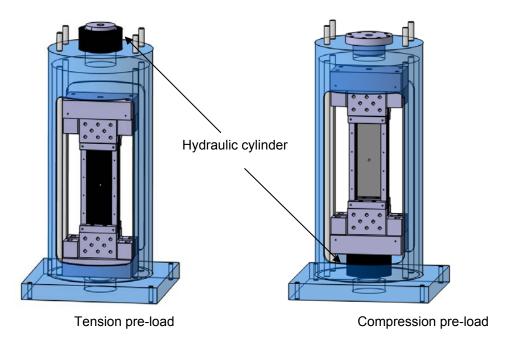
Figure 5: Design of the pre-stressing fixture

At the DLR Institute of Structures and Design, a loading frame for the pre-stressing fixture was already available. It can accept plates with 250 mm x 750 mm dimensions. This frame was extended/upgraded according to the principles shown in Fig. 5 for applying pre-stressing under compression or tension. As it was decided to use a force driven pre-stressing, a hydraulic cylinder jack is used to apply the pre-stressing loads (max. 1000 kN). Depending on its location and mode of operation, compression or tension loads may be applied.

The test fixture is mounted on 4 adjustable feet, which enable the point of impact on the test plates to be specified. The configuration of the pre-stressing fixture is shown in Fig. 6 for both tension and compression preload tests. The test plates are clamped at the ends for correct load introduction. The long sides are supported by two pairs of rails built into the loading frame with knife edge contact at the plates. The long edges were supported 15 mm inside the plate boundaries, with the consequence that 200 mm wide test plates had an effective width for impact loading of 170 mm.

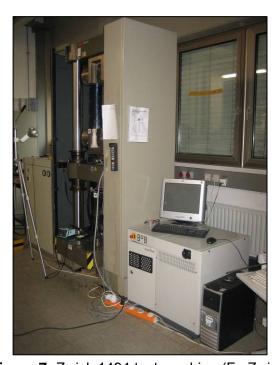
Figure 7: Zwick 1494 test machine (Fa Zwick)

load	± 500 kN
max. traverse path	850 mm
max. testing velocity	200mm/min
temperature range	up to 180° C
max. workspace (B x H)	B = 630 mm; H = 1000 mm
clamping pressure	up to 480 bar
control	manually, path and power controlled

For the design of the test specimens it is seen from Table 3 that the maximum failure load expected for undamaged carbon/epoxy plates of Lam. B is 409.0 kN, and for 2 mm aluminium it is 172.0 kN. Based on this maximum load required in the quasi-static tests to ultimate failure and using typical adhesive bond strengths, it was calculated that the 500 x 200 mm plates required tabs at least 125 mm wide for load introduction. Such tabs will also be suitable for the compression tests loaded into the postbuckling region, where loads are lower. Fig. 9 shows a typical composite plate specimen with bonded tabs. The tabs are aluminium plates 200 x 125 x 20 mm in size, each with 8 x 16 mm diameter holes bored through the thickness. They are bonded to the 750 x 200 mm composite and aluminium test plates with adhesive Epikote 02306 supplied by Hexion. They are designed to allow the same specimens to be fixed in the preload fixture (Fig. 6) for HVI testing with preload, then to be tested subsequently in the Q/S 500 kN Zwick test machine (Fig. 7) to determine ultimate

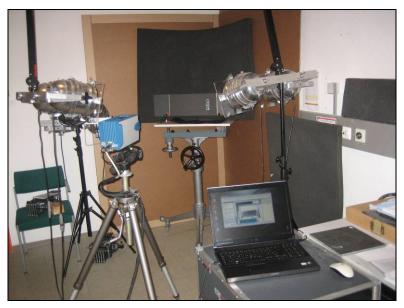
Figure 8: Lock-in thermography

For post-test investigations of impact damage a number of NDE techniques are available at the DLR Institute of Structures and Design: ultrasonic C-Scan, lock-in thermography and X-ray based computer tomography (CT). Lock-in thermography as shown in Fig. 8 may be used for a non-contact evaluation of skin damage. The advantage of this technique over ultrasonic inspection is that it requires no contact, it is fast, and large structures can be inspected [17]. The main disadvantage is that the damage is not always clearly represented and skill is required in setting up the equipment and understanding the influence of frequency on the signals. Because of the large number of specimens in LIBCOS and the need for rapid NDE evaluation between HVI test and residual strength test, thermography was used for assessment of damage.

Each plate was inspected using a CEDIP JADE III LWIR ($7.7 \sim 9.3 \mu m$) infrared camera. The 320 x240 LWIR MCT focal plane detector array responds to radiation in the 3-5 μm spectral band at a frame rate up to 200 Hz. The camera is equipped with a Stirling cooling and the thermal sensitivity is 35mK. A lockin module and a signal generator control the light source (generating the thermal waves) which is synchronised to the recording process of thermal images. In the present task four modulated heating lamps were used. After several images (<1000) are recorded over several modulation cycles a Fourier analysis is performed at each pixel resulting in a local amplitude and phase modulation.

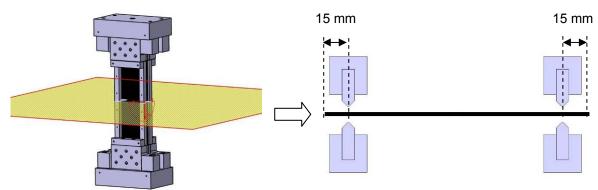
Figure 10: Principle of lateral support through lateral rails

In the pre-stress fixture described in §2.2, the plates are fully clamped at the tabs whereas their lateral sides are laterally supported by lateral 420 mm long rails as shown in Fig. 10. For each plate, the lateral rails are translated so that they contact and support the test plate. The pre-loading is introduced by a hydraulic jack and is differently controlled depending on compression or tension pre-load. If the pre-loading is under tension, the level of pre-loading is controlled by four strain gauges (Figure 11). If the pre-loading is under compression in the post-buckling region the strain gauges may not be used due to the local bending in the plates. In this case the level of pre-loading is controlled by the applied compression force determined from the pressure level in the hydraulic jack. First the Q/S test on an undamaged plate was used to measure the initial buckling load Pb for the plates. As discussed in § 4.2 it was decided to apply preloads of 1.4 Pb for composite plates and 1.5 Pb for aluminium plates. After calibrating the hydraulic jack pressures in the cylinder against the resulting loads, it was then possible to determine the applied pressure for the required compression loads.

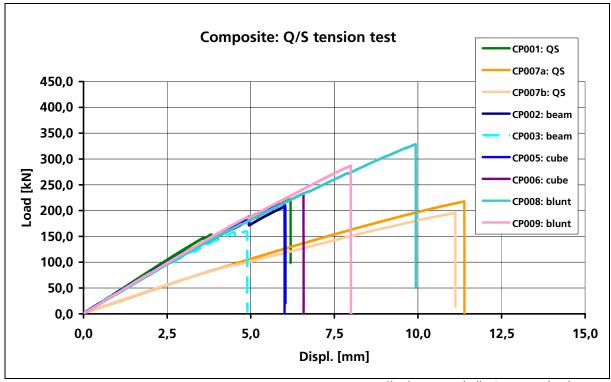
*broken curve indicates no preload

Figure 13: Residual strength test data for 2.1 mm composite plates in tension

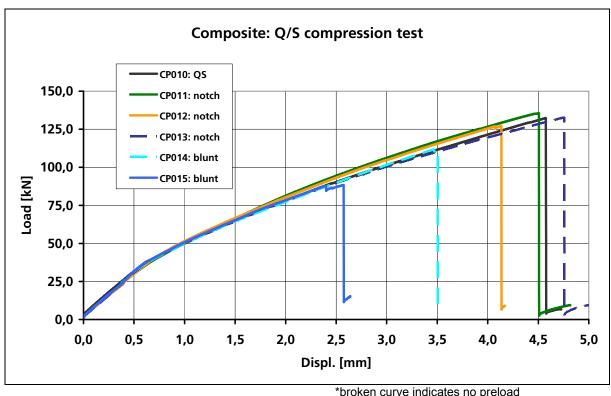
broken curve indicates no preioad

Figure 14: Residual strength test data for 3.1 mm composite plates in compression

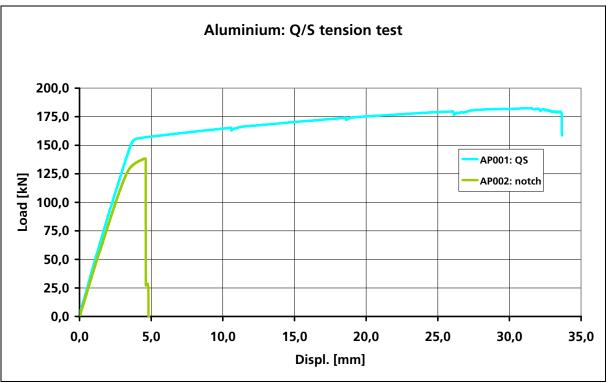
Figure 15: Residual strength test data for 2.0 mm aluminium plates in tension

extension and load 138.4 mm and giving a residual strength factor of 0.76. Fig. 15 shows the marked notch sensitivity of aluminium plates compared to undamaged plates. This is a higher RSF than those measured in the 2.1 mm composite plates, however the failure loads were still higher in the notched composite plates, due to their better tensile strength properties.

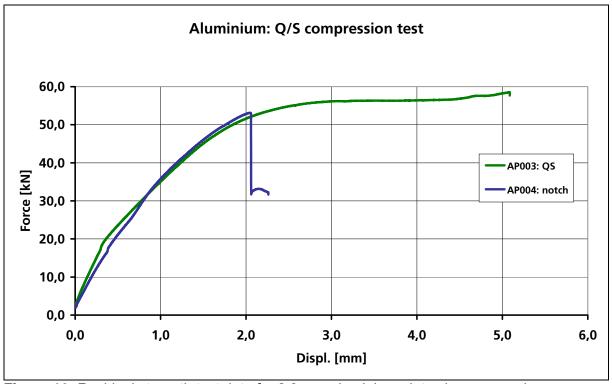
Figure 16: Residual strength test data for 2.0 mm aluminium plates in compression

In the compression programme AP003 was tested in Q/S compression to determine buckling mode, again 3 cell buckles, and buckling load of about 20 kN, see Fig. 16. On further loading the buckles increased in size with extensive plastic deformation, but the panel did not fracture and tests were stopped at 5 mm displacement, and maximum loads of 58.6 kN. Plate AP004 was impacted by the 12 mm steel cube with a preload 1.5 Pb giving extensive notch damage. Compression tests into the postbuckling region did not lead to fracture but buckling and plastic flow. At a load of 53 kN the plate buckled prematurely in the 40 mm space between the tab and end of the lateral support rails. The test was stopped at 2.1 mm displacement with maximum load 53 kN. This corresponds to an RSF value 0.93 indicating that plate buckling failure loads are not strongly influenced by notch impact damage. However the high notch sensitivity of aluminium is seen by the much lower extensibility due to the notch. As a result of the early failure in a small unsupported part of the plate edges, it was decided that the edge support rails should be extended for subsequent tests. This minor change to the support fixture was made and the extended supports used for both compression preloads and residual strength tests.

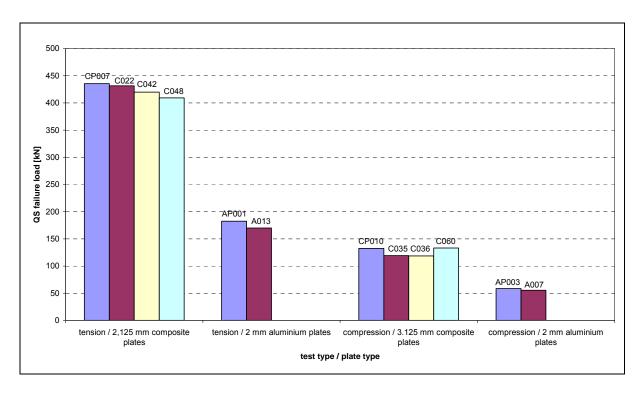
Figure 17: Baseline plate strengths measured on undamaged plates

In each of the four main plate test programmes Q/S tests were carried out on the standard 500 mm x 200 mm tabbed plate specimens to determine plate failure loads in undamaged plates. A limited number of repeat tests were performed to give some indication of inherent scatter in properties, due to the materials or plate bonding and clamping conditions. Details on the tests are given in the main results Tables A4 – A7. Fig. 17 gives an overview of the measured failure loads. It shows that for the chosen specimen materials and geometries in LIBCOS the composite plates have tension and compression failure loads generally about twice as high as those measured in the aluminium plates. It confirms also that plate compression strengths due to buckling failures are low, typically about 25% of the tensile strengths. These large differences in baseline properties should be kept in mind when working with the RSF values, which are all normalised to unity for each test series.

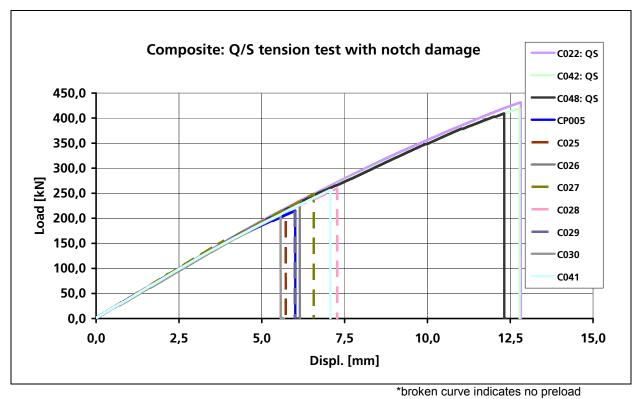
Figure 18: Tensile test curves for 2.1 mm composite plates with notch damage

The measured tensile load-displacement curves up to failure for the plates with notch damage are shown in Fig. 18: The baseline curves (marked QS in this and subsequent figures) are included for comparison. Notch damage tests had impact velocities in the range 84.5 – 103.1 m/s, with kinetic energies 47.9 – 71.2 J. All plates with notch impact damage had visible damage where the cube passed through the impacted face, with extensive damage and delamination at the back face. In the residual strength tests the impacted plates with notch damage exhibited similar initial response to the baseline plates, with almost linear behaviour up to an 'explosive' brittle failure as seen in Fig. 18. Final failure initiated from the central notch and moved to the plate edges near the centre of the plate, see photos of damaged plates in Annex B. The notch damage is severe and led to failure loads equal to about half the baseline strengths, with RSF factors in the range 0.48 – 0.61.

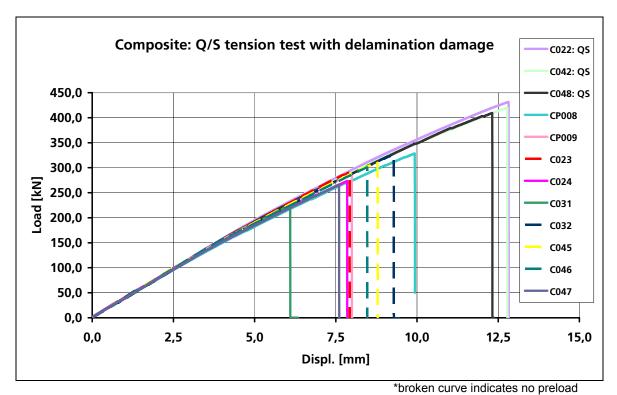
Figure 19: Tensile test curves for 2.1 mm composite plates with blunt impact damage

The measured tensile load-displacement curves up to failure for the plates with blunt impact damage are shown in Fig. 19, together with the baseline curves. The blunt impact tests with the 25 mm glass balls had impact velocities in the range 63.8-69.7 m/s, with kinetic energies 36.6-51.0 J. In all cases the plates had a small round contact mark on the impact face, with light delamination of the outer 45° ply visible on the back face. However, the thermography tests indicated extensive delamination damage near the back face. In the residual strength tests with delamination damage the test curves deviated a little from the baseline curves as the damage propagated, and again failed with an 'explosive' brittle facture. Final failure surface showed extensive fibre and ply pull-out over the complete plate width, see photos of damaged plates in Annex B. The delamination damage caused significant reduction in tensile failure loads, which was unexpected, with RSF factors in the range 0.63-0.76. One test C031 at 0.15% prestrain had a low RSF value of 0.52, in the range of the notch damage tests.

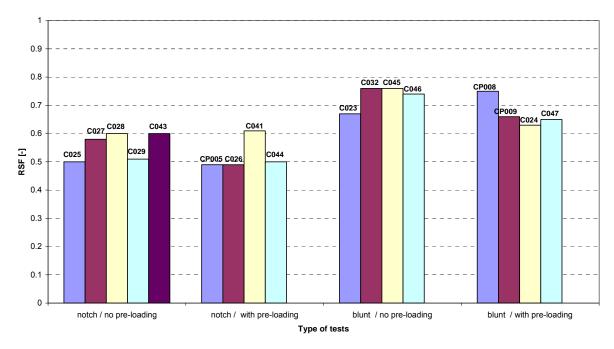
Figure 20: Residual strength factors in tension for 2.1 mm composite plates with zero and 0.25% preload, for notch and blunt impact damage

Fig. 20 provides an overview of the RSF values from tensile tests on the 2.1 mm composite plates, with notch and blunt impact damage. It shows clearly the magnitude of the tensile strength reductions due to notch and blunt impact damage. It shows that for blunt impact there is a clear tendency for a small reduction in RSF with preload with mean RSF values reduced by about 10% from 0.73 without preload to 0.67 with 0.25% strain preload. For notch damage the influence of preload is not so strong, mean values without preload are 0.56 and with 0.25% strain preload, they are 0.52, which is about 7% lower. However these effects could be within the scatter band of the results. It should be remembered for the notch damage tests that the projectile is a steel cube. Study of the HS film of the tests shows that first contact at impact may be flat contact from the cube face, line contact from an edge, or point contact from a corner. Experience has shown that point and edge contacts are more likely to cause directly notch damage and penetration, whilst face contact may lead to rebound. It follows that more scatter in behaviour is expected for impact damage and hence residual strength with steel cubes, compared with blunt spherical impactors.

The most significant reduction in RSF from the complete test programme was from notch impact tests on composite plates under tensile loads, as seen in the bar chart Fig. 20. This showed a small additional reduction in RSF when 0.25% prestrains were applied, which could also be interpreted as scatter due to the small number of plates tested. Fig. 28a shows the RSF for the notch tests plotted against the impact energy. It shows that provided the impact energy is high enough for penetration in these notch tests, there is no change in RSF as the energy is increased. There is a tendency for a slightly lower RSF with 0.25% tensile preloads, which does not appear to be influenced by impact energy. Fig. 28b considers the influence of impact damage, by plotting RSF against measured damage area in mm². Fig. 28b shows that damage area is in the range 5000 – 10 500 mm², for this test programme. It appears that the damage area may be significantly larger for notch impact with tensile preload. However, this seems to have no influence on the measured RSF values. It is concluded that for severe notch damage, the size of the notch (which due to the 12 mm steel cube is fairly constant) determines the strength reductions, and additional delamination damage is of secondary importance.

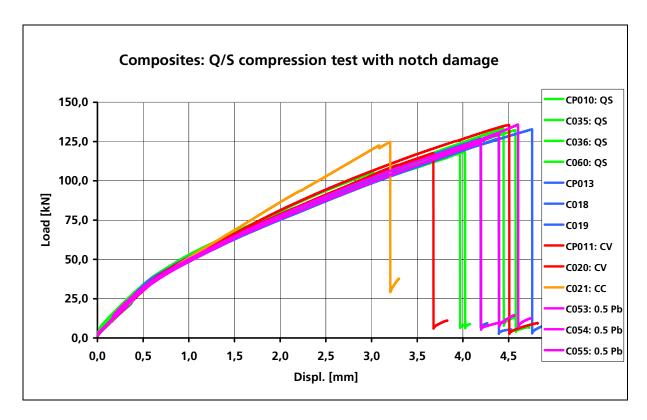
Figure 21: Compression test curves for 3.1 mm composite plates with notch damage Curve colours: green: baseline (no impact), blue: preload 0, lila: preload 0.5 Pb, red: preload 1.4 Pb (convex), orange: preload 1.4 Pb (concave)

Fig. 21 shows the Q/S compression load-displacement curves for the plates with notch damage, together with the baseline compression test curves. It is seen that all plates, including those with extensive notch damage, had the same initial stiffness properties, and all buckled at about the same point (~0.6 mm displacement, ~ 38 kN). After initial buckling the buckle amplitude increased significantly, as seen by the nonlinearity in the test curves, however, even with notch damage the continued buckling and final collapse load were not significantly reduced by notch damage. Note that in these impact tests with preload the impact point was on the convex face of the buckle in two plates CP011, C020 and concave for C021, which then had a different load curve to failure. It is interesting to note that the curves without preload, ie impacted on a flat plate, and those with 0.5 Pb preload were not significantly different to those impacted in the post-buckled state with preload 1.4Pb. In fact two of the 0.5Pb curves almost coincided with two of the unloaded plates and overlay them in Fig. 21. The RSF values of all plates were in the range 0.89 – 1.02 showing that the notch damage which caused significant visible damage to the plates, see photos and thermography data in Annex B, does not influence the buckling failure strength of the plates, which confirms the unexpected result first seen in the preliminary compression tests with notch damage. Possible explanations for this are discussed at the end of the sub-section. Note that the one notch test C021 with a concave impact, was at a lower velocity of 93.5 m/s which caused rebound plus notch damage. The RSF was 0.94, which was in the range of the unloaded and preloaded convex impact cases. It was decided that a detailed study of notch damage under concave impact was not warranted.

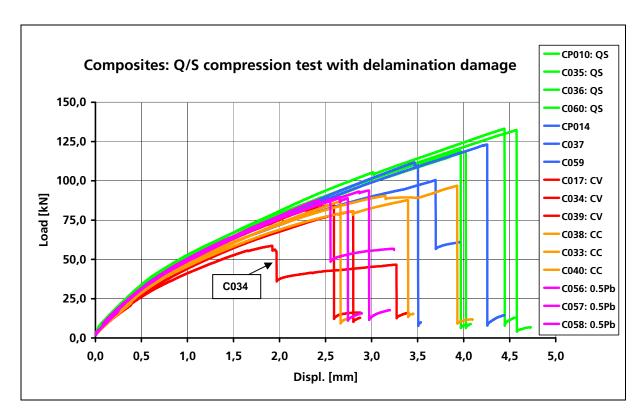
Figure 22: Compression test curves for 3.1 mm composite plates with blunt impact damage Curve colours: green: baseline (no impact), blue: preload 0, lila: preload 0.5 Pb, red: preload 1.4 Pb (convex), orange: preload 1.4 Pb (concave)

Fig. 22 shows the compression load-displacement curves for the blunt impact tests with glass balls to initiate delamination damage. Included are four baseline curves on undamaged plates (green), three tests with no preload (blue), three tests with 0.5 Pb preload (lila), three tests with 1.4 Pb preload and convex impact (red), and three tests with 1.4 Pb preload and concave impact (orange).

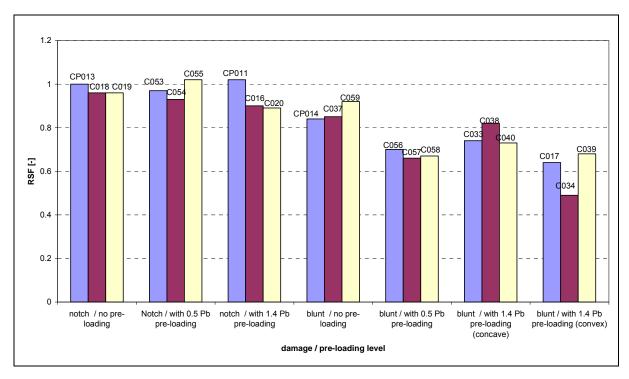
Figure 23: Residual strength factors in compression for 3.1 mm composite plates with zero, 0.5 Pb and 1.4 Pb preload, for notch and blunt impact damage

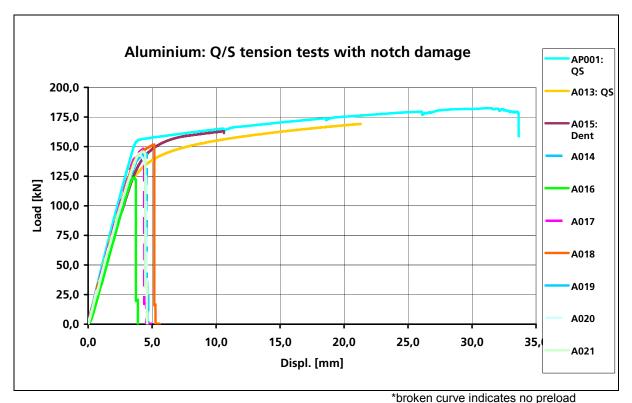
Figure 25: Tensile test curves for 2.0 mm aluminium plates with notch damage

Table A6 summarises the impact and residual strength tests with 2.0 mm thick aluminium plates in tension with measured load-deflection curves shown in Fig. 25. The tensile test procedures were the same as in the composite-tension programme, without preload, and with longitudinal prestrains of 0.25%. All tests were with 12 mm steel cube projectiles with velocities in the range 92.9 – 171.5 m/s, kinetic energies 57.9 – 148.4 J. Most tests were at velocities high enough to cause notch impact damage. Some tests were carried out at lower velocities to cause an indentation with rebound. However, it was not found possible with the sharp edged steel cube to reliably obtain a plastic indentation without impactor penetration or local cracks in the plate. This would be possible with a steel ball projectile, but it was decided that aluminium plate indentation was not so important to justify a test programme with other projectiles.

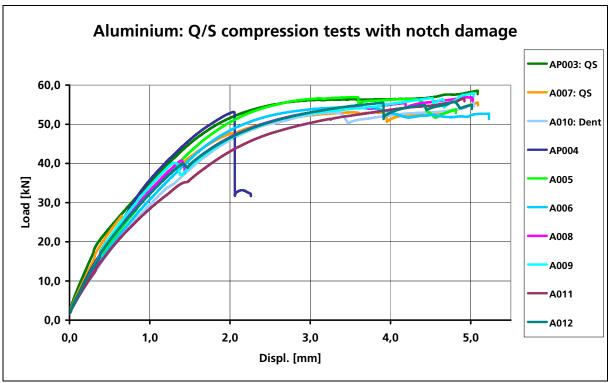
Figure 26: Compression test curves for 2.0 mm aluminium plates with notch damage

As Fig. 26 shows that all damaged plates (except for AP004) buckled below 20 kN load and on loading the 3-cell buckles increased in amplitude and above about 3 mm displacement a steady plastic flow developed at a constant loads in the range 50-55 kN. Buckling collapse or fracture was not reached, even with notch damage, so that all tests were stopped at about 5 mm displacement. Plate AP004 buckled locally near the tabs as explained in the prescreening test discussion above. The test curves followed the trend of the baseline curves without damage, indicating that despite the plates having holes or cracks up to 25 mm in size at the centre, this has little influence on the buckling failure mode, or collapse loads. The RSF values were in the range 0.95-1.01, indicating how unimportant notch damage, with or without preloads is for thin aluminium plates subjected to compression loads with buckling failures.

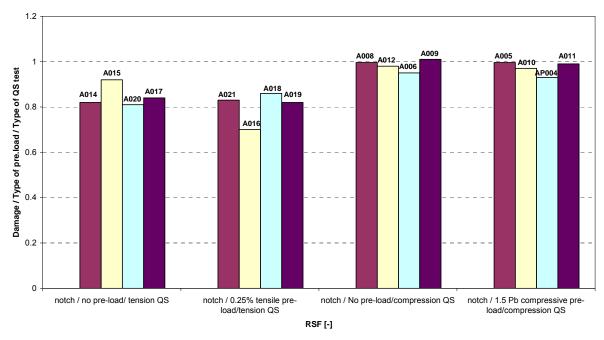
Figure 27: Residual strength factors in tension and compression for 2.0 mm aluminium plates with and without preload, for notch impact damage

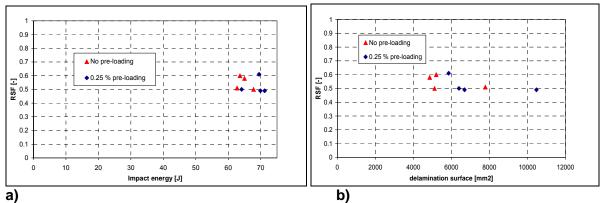
Figure 28: Composite-tension with notch damage. Influence on RSF of: a) impact energy and b) damage area

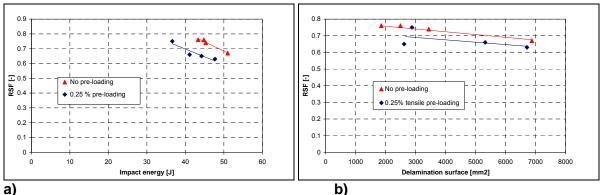
Figure 29: Composite-tension with blunt impact. Influence on RSF of: impact energy and b) damage area

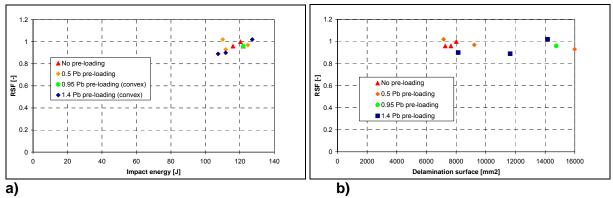
Figure 30: Composite-compression with notch damage. Influence on RSF of: a) impact energy and b) damage area

In the case of compression preloads in the pre-and post-buckled region the RSF values are little influenced by notch damage and it even appears from Fig. 30a that increasing impact energy leads to higher RSF values closer to unity. The RSF values for the pre-buckled plates $0.5~{\rm Pb}$ are very close to and sandwiched by the zero preload and buckled preload $1.4~{\rm Pb}$ data. Fig. 30b indicates large damage areas from $7000-15~000~{\rm mm^2}$. Generally the preloaded plates have considerably greater damage area than the unloaded plates, but this damage in the plate does not have a strong influence on residual strengths. This may be explained if the notch and delamination damage is in the plate central impact zone, but due to the complex buckling stress field, higher stresses leading to failure are away from the centre.

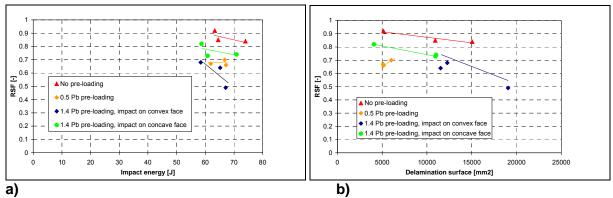
Figure 31: Composite-compression with blunt impact. Influence on RSF of: a) impact energy and b) damage area

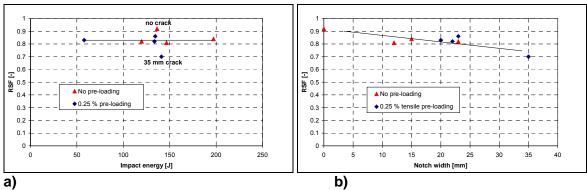
Figure 32: Aluminium-tension with notch damage. Influence on RSF of: a) impact energy and b) notch size

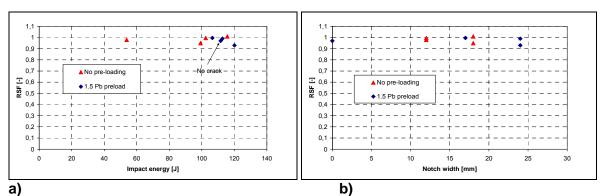
a) b)
Figure 33: Aluminium-compression with notch damage. Influence on RSF of:
a) impact energy and b) notch size

A similar analysis is carried out here for the influence of impact energy and notch size on aluminium plates under compression buckling loads. Fig. 33a shows first that notch damage has only a small influence on RSF in compression, with values 0.95 – 1.01. Further, the residual strengths are not influenced significantly by impact energy. Again Fig. 33b shows a tendency for the prebuckled plates to have a higher notch size, which is accompanied by a small reduction in RSF. However, it is again apparent that significant notch damage in the plate centre plays a minor role in the plate collapse in buckling, since the buckles were observed to increase in amplitude with plastic deformation at higher loads despite the notch damage in the central buckle.

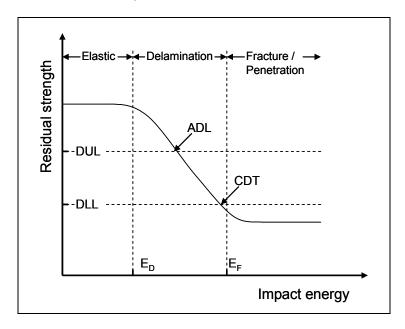
Figure 34: Schematic of residual strength in plates as function of impact energy with zero preload

design ultimate load DUL are known for the panel (DUL = 1.5 DLL in FAR 25 [2]) under the relevant load condition, then the residual strength curve Fig. 34 may be used to define an allowable damage limit ADL, when residual strength falls to DUL, and a critical damage threshold CDT, when residual strength falls to DLL.

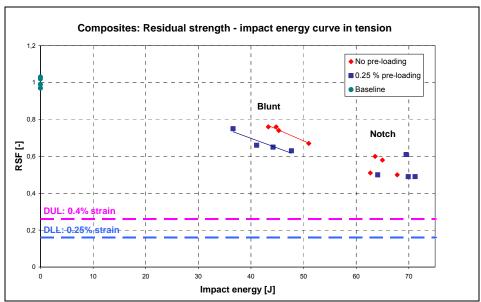
Figure 35: Residual tensile strength – impact energy curve for 2.1 mm composites (Preload: P/P_F = 0.16, $\varepsilon/\varepsilon_F$ = 0.17, Critical energy estimates E_D ~ 20 J, E_F ~ 55 J)

To provide an assessment of the damage tolerance of the 2.1 mm composites plates under tensile loads, all the residual strength data from both blunt and notch impacts with and without tensile preloads is plotted on a single graph in the format of Fig. 34. The result is Fig. 35, on which representative values for DLL and DUL are marked. As discussed in $\S4.1$ typical values for these composite fuselage bay panels are DLL = 0.25% strain, DUL = 0.4% strain. Based on the DLR impact tests it is estimated that the critical impact energy at

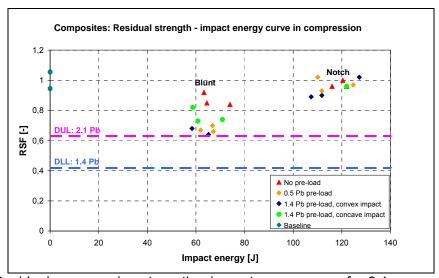
Figure 36: Residual compression strength – impact energy curve for 3.1 mm composites (Preload: P/P_F = 0.42, Critical energy estimates $E_D \sim 30$ J, $E_F \sim 90$ J)

To provide an assessment of the damage tolerance of the 3.1 mm composites plates under compression loads, the residual strength data from both blunt and notch impacts with and without compression preloads is plotted on a single graph in Fig. 36. The data point from specimen C034 is excluded here because of a problem with the rails leading to a premature failure (see Fig. 22). For compression preloads in the postbuckling region, a distinction is made between impact on the convex or concave face of the large central buckle. Representative values for DLL and DUL are marked on the figure. These are of course dependent on the structure under consideration, load conditions and selected design criteria. The values chosen here follow the discussion on compression preloads in §4.1 relevant to a fuselage bay panel, which may buckle at DLL, due to the panel size and low thickness. In terms of a measured buckling load Pb, DLL was nominally chosen here to be 1.4 Pb for the 3.1 mm thick composite panels, hence DUL = 2.1 Pb. Based on the DLR impact tests it is estimated that the critical impact energy for fracture and penetration of these 3.1 mm composite panels from these small projectiles is E_F ~ 90 J, and from literature data and other DLR tests a value $E_D \sim 30$ J might be expected. In these tests the maximum preload was 1.4 Pb = 53.2 kN and, since the mean baseline residual compression strength at buckling failure was 125.9 kN, it follows that the preload factor P/P_F = 0.42. This is much higher than the value 0.16 applied in the tensile preload tests.

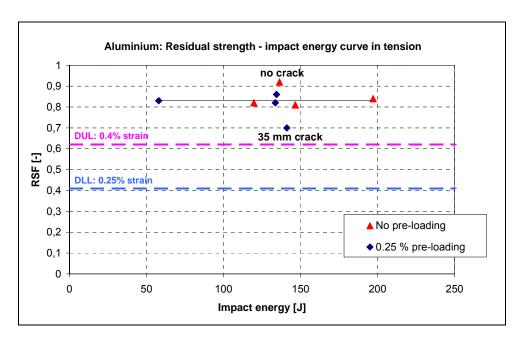
Figure 37: Residual tensile strength – impact energy curve for 2 mm aluminium (Preload: $P/P_F = 0.41$, Critical energy estimates $E_F \sim 55$ J)

The damage tolerance of the 2 mm aluminium plates under tensile loads is summarised in Fig. 37, where the residual strength data from notch impacts with and without tensile preloads is plotted on a single graph in the format of Fig. 34. Representative values for DLL and DUL are marked for thin aluminium fuselage bay panels, with the assumption of DLL = 0.25% strain, DUL = 0.4% strain. Based on the DLR impact tests it is estimated that the critical impact energy at fracture for the panels from these small projectiles is $E_F \sim 55$ J. The DLR baseline tests give a maximum preload factor of P/P_F = 0.42, much higher than in the composite tension tests. The figure shows that for aluminium the RSF values are in the range 0.7 - 0.9, which are much higher than those from notch impact tests on composite panels. There is no clear tendency for reduced RSF values at 0.25% tensile prestrain, nor does the impact energy have a strong influence provided it is high enough to cause complete penetration by the impactor. This follows because the residual strengths of the notch damaged aluminium plate depend on the notch size in relation to the plate width. All the residual strength values are above DUL, with some strength in reserve, showing there is an adequate safety margin in tension for the aluminium panels under small object FOD impacts with maximum preloads equal to DLL.

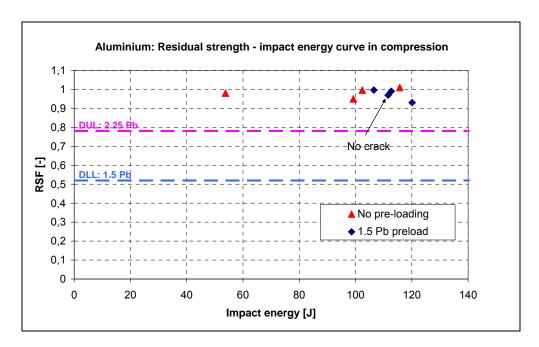
Figure 38: Residual compression strength – impact energy curve for 2.0 mm aluminium (Preload: $P/P_F = 0.52$, Critical energy estimates $E_F \sim 55$ J)

To provide an assessment of the damage tolerance of the 2 mm aluminium plates under compression loads, the residual strength data from notch and indentation impacts with and without compression preloads is plotted in Fig. 38. Representative values for DLL and DUL are marked on the figure. In terms of a measured buckling load Pb. DLL was nominally chosen here to be 1.5 Pb for the 2 mm thick aluminium panels, hence DUL = 2.25 Pb. Based on the DLR impact tests it is estimated that the critical impact energy for fracture and penetration of these 2 mm aluminium panels from these small projectiles is $E_F \sim 55$ J. In these tests the maximum preload was 1.5 Pb = 30 kN and, since the mean baseline residual compression strength at buckling failure was 57.1 kN, it follows that the preload factor P/P_F = 0.52, which is a high factor. Measured RSF values are in the range 0.9 - 1.0, showing no significant reductions in compression strengths due to notch damage and the buckled preload. The panels had significant reserve strength above DUL for these small object FOD impacts. Higher impact energies with these projectiles would not be expected to reduce residual strengths any further. The explanation for the high residual strengths is that buckling failure was again in the 3-cell mode with large plastic deformations near the plate supports and at the interface between the buckled cells, which was not strongly influenced by the central holes in the panel produced by the cube impacts.
