Report EASA.2013.2

De-icing fluid wind tunnel testing

***EASA De-Icing Fluid Tests (DIFT)
on a Horizontal Stabilizer Section
at the NRC PIWT
Final Report***

LTR-AL-2014-0122

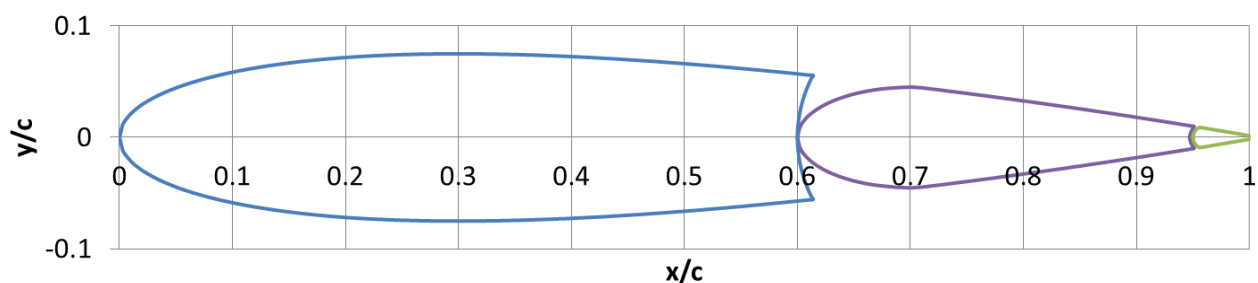
Figure 1 Horizontal Stabilizer Model NACA 0015 Profile

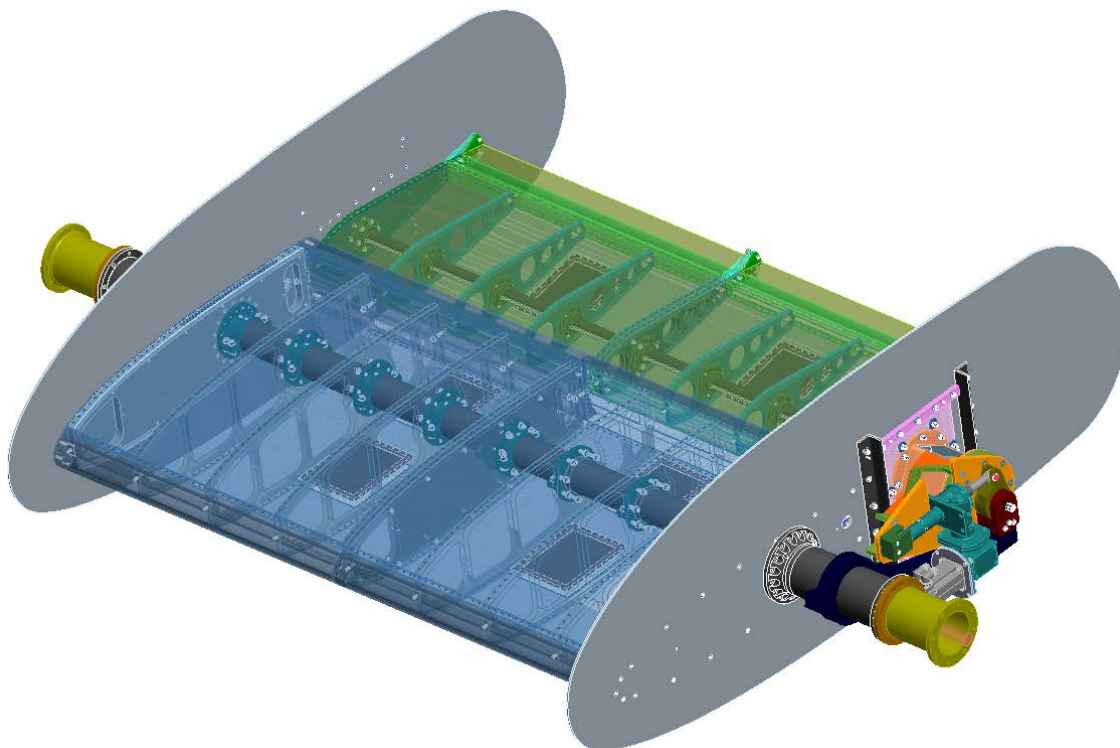
The model was designed by the NRC project engineer and NRC Design and Fabrication Services (DFS) staff. Located in Building M-4 at the NRC Montreal Road Campus in Ottawa, DFS provides design, engineering, fabrication and advisory services that support research and innovation across the NRC. Based on the information provided by the NRC project engineer, DFS staff created the detailed design of the model in ProE and performed a stress analysis to ensure it could support the estimated aerodynamic loads, including a safety factor. A screenshot of the complete ProE model with endplates is shown in Figure 2.

Figure 2 Horizontal Stabilizer Model in ProE

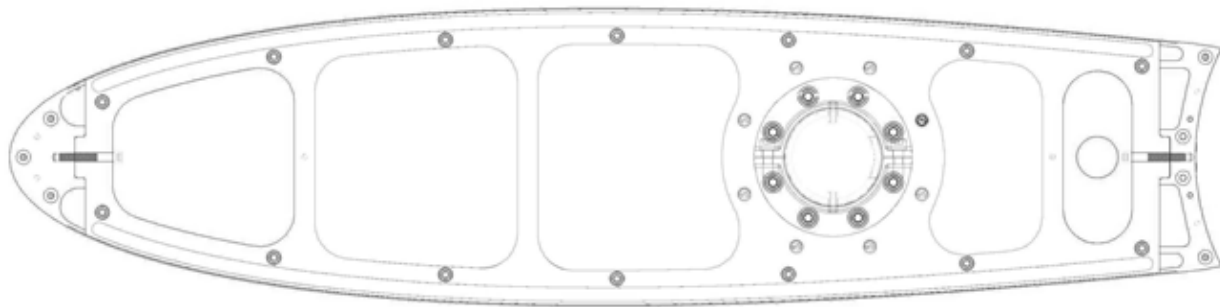
The main element consists of a solid leading edge, aluminum ribs, and 2024 aluminum skin. The cut-outs in the ribs are used to minimize the overall weight. The skin is made from a single piece of aluminum on the upper and lower surfaces spanning the width of the model and is attached to the ribs using blind, flush-head 8740 alloy steel stem CherryMax aerospace rivets. The main element is designed to be mounted on the existing external wall-balances at the PIWT in order to measure the aerodynamic loads as well as rotate the model. A circular aluminum shaft runs along the span of the model, connecting the two balances. The main element pitch angle is $\alpha = 0^\circ$ unless otherwise indicated in the test plan.

Figure 3 Main Element Cross-Section

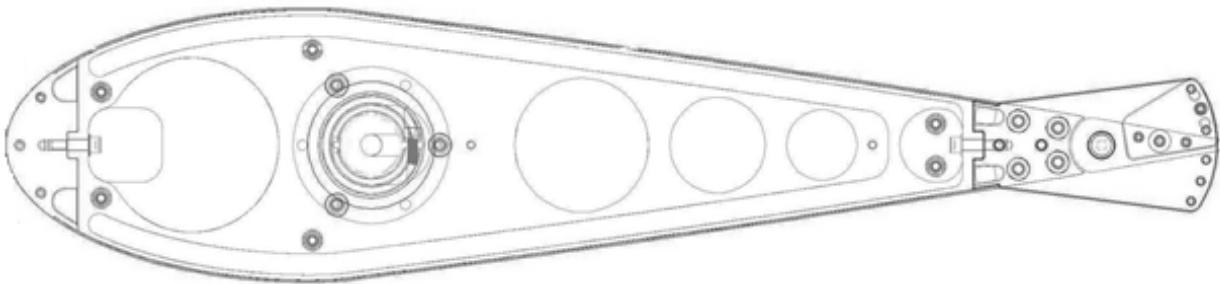
Similar to the main element in overall design, the elevator has a solid leading edge, aluminum ribs and aluminum skin attached using blind, flush-head rivets. The circular cut-outs in the elevator ribs are designed to minimize the weight of the model. The elevator is mounted on a traverse system that allows it to move laterally along the model chord relative to the main element in order to adjust the hinge gap between the two elements from 0.5 mm to 10 mm. The elevator can rotate $\pm 25^\circ$ independently of the model through the use of a separate servo motor and screw jack system on the port side of the model. The elevator deflection is measured relative to the chord line of the main element, with a positive deflection in the downwards direction. The starboard side is supported and allowed to rotate freely on a bearing. The lateral traverse and elevator rotation systems are described in more detail in Section 4.4.

Figure 4 Elevator Cross-Section

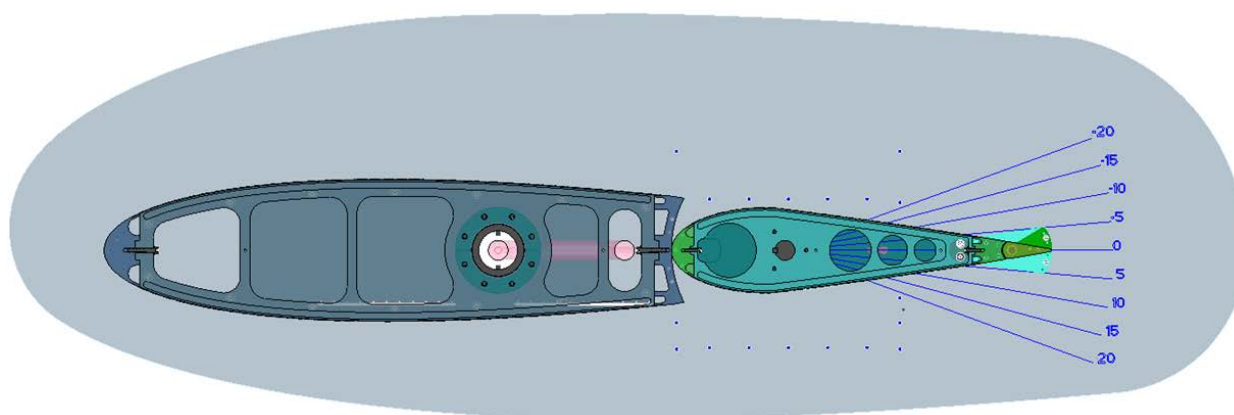
The endplates are designed to keep the airflow over the model as two-dimensional as possible and keep the fluid contained on the model surface. Originally designed to follow the NACA 0015 profile of the model, the endplate upper and lower surfaces were extended in order to maximize their performance. The vertical size of the endplates is restricted, as the gantry system that allows access to the front of the model must be able to slide on rails under the model and observers in the building need visual access to the top surface of the model during runs. The endplates with the cross-section of the horizontal stabilizer model are shown in Figure 5.

Figure 5 End Plate Design

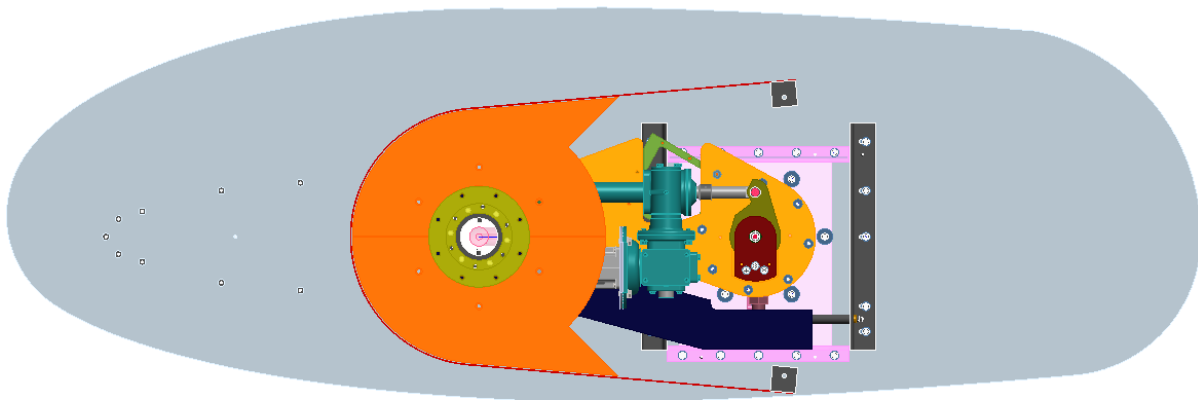
Figure 6 Fairing Location Relative to Model

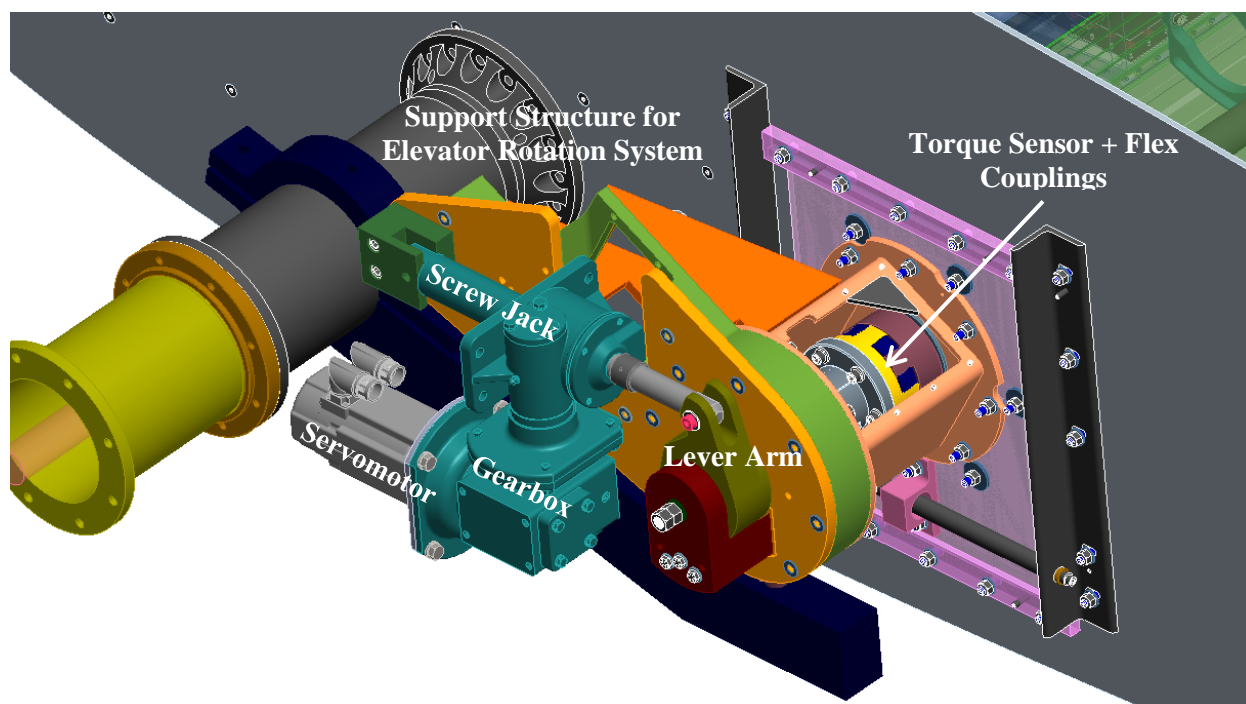
The elevator hinge moment is one of the key measurements for this research program, and is measured using a Futek reaction torque sensor mounted between two flex couplings between the elevator main shaft and the rotation system lever arm. With a maximum capacity of 1129.85 Nm (833.33 ft-lb), the torque sensor non-repeatability, non-linearity, and hysteresis are all 2.26 Nm (1.67 ft-lb).

Figure 7 Elevator Rotation System

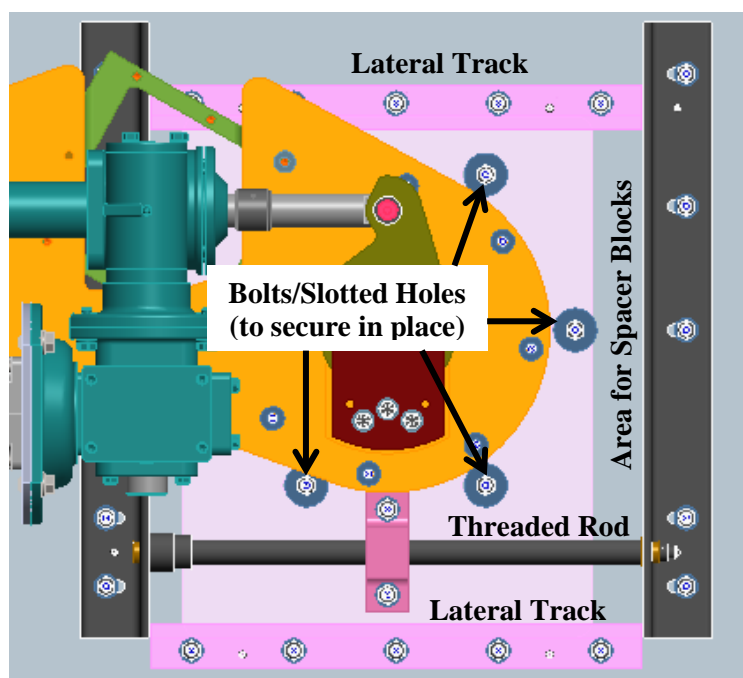
The hinge gap is the gap between the trailing edge of the main element of the horizontal stabilizer and the leading edge of the elevator. The hinge gap was identified in Section 3.4 where the elevator clearance is mentioned as a potential contributor to the incidents under investigation. The elevator traverse system is designed to allow for lateral movement to adjust this hinge gap in between runs while supporting the weight of the elevator, trim tab, and elevator rotation system. The traverse mechanisms are mounted on each side of the model to the outside of the endplates and use a threaded rod to manually translate the elevator assembly. The position of the elevator relative to the zero-gap position is set using spacer blocks; six bolts mounted in slotted holes are tightened to secure the assembly in place when the desired lateral position is reached. The port side of the main elevator shaft connects to the torque sensor and elevator rotation system. The starboard side of the shaft is supported by a roller bearing and rotates freely. Two people are required to operate the elevator traverse system, one on each side of the model working synchronously.

Figure 8 Elevator Lateral Traverse Assembly

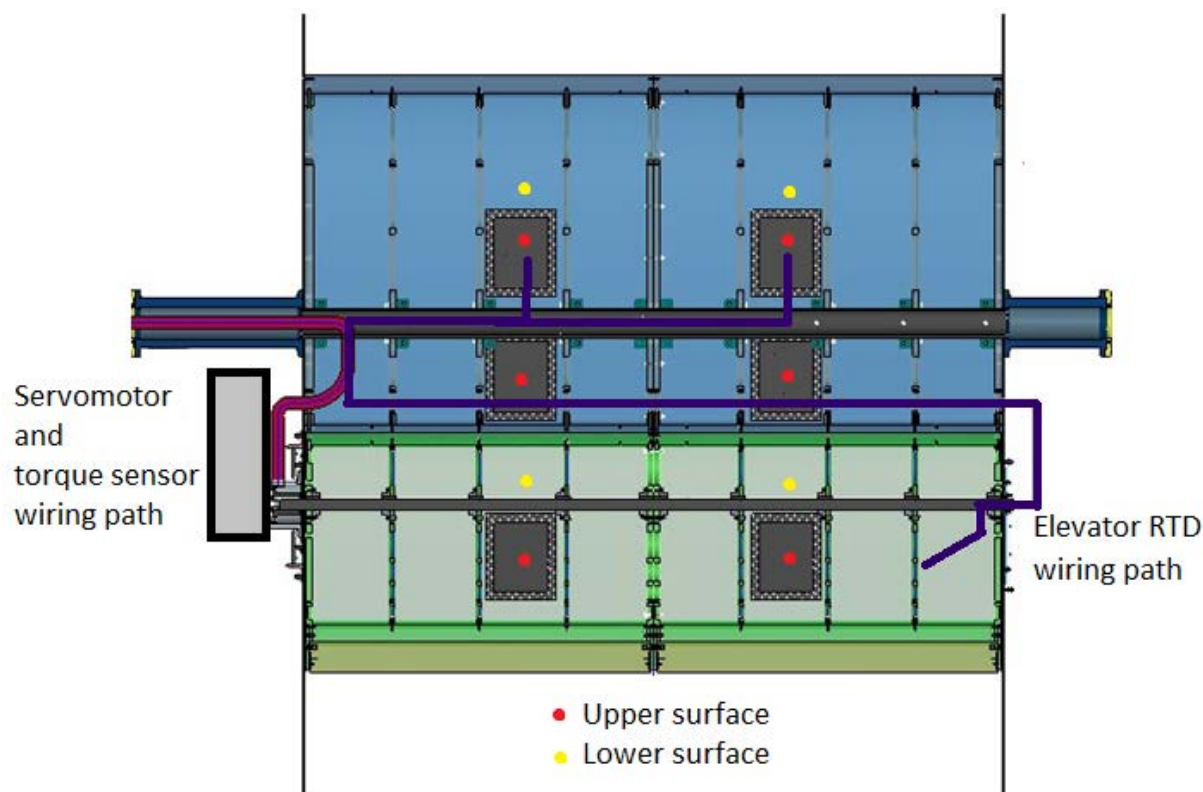
The wiring from the thermocouples in the main element is routed directly into the center spar and out the port side of the test section. The wiring from the thermocouples in the elevator is routed out the starboard side of the elevator and along the endplate to re-enter the main element through a hole in the endplate. The wiring then enters the main spar and exits through the port side of the model with the rest of the thermocouple wiring.

Figure 9 RTD Positions and Wiring Routes

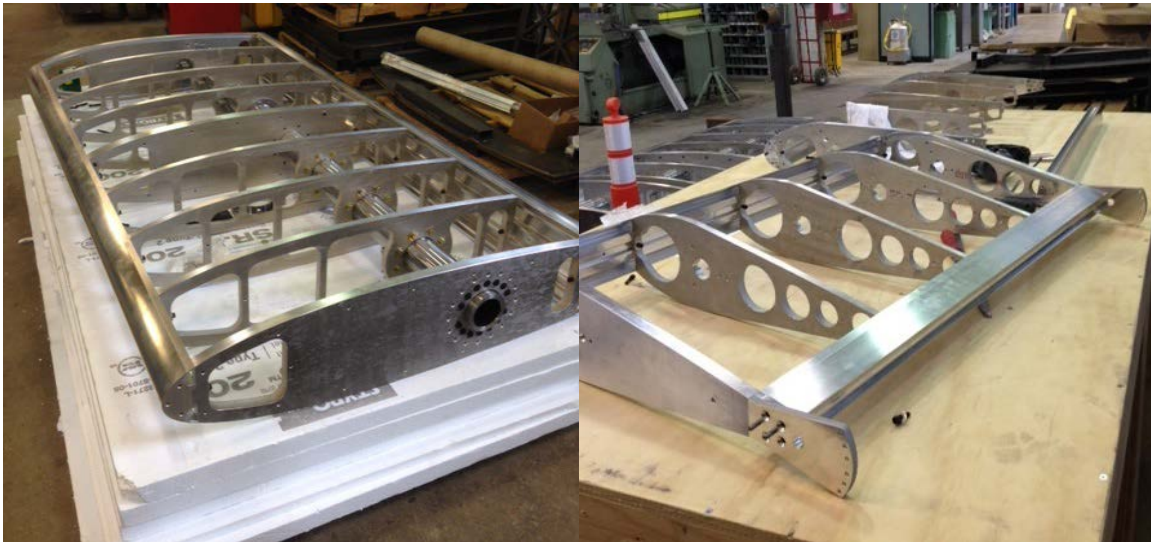
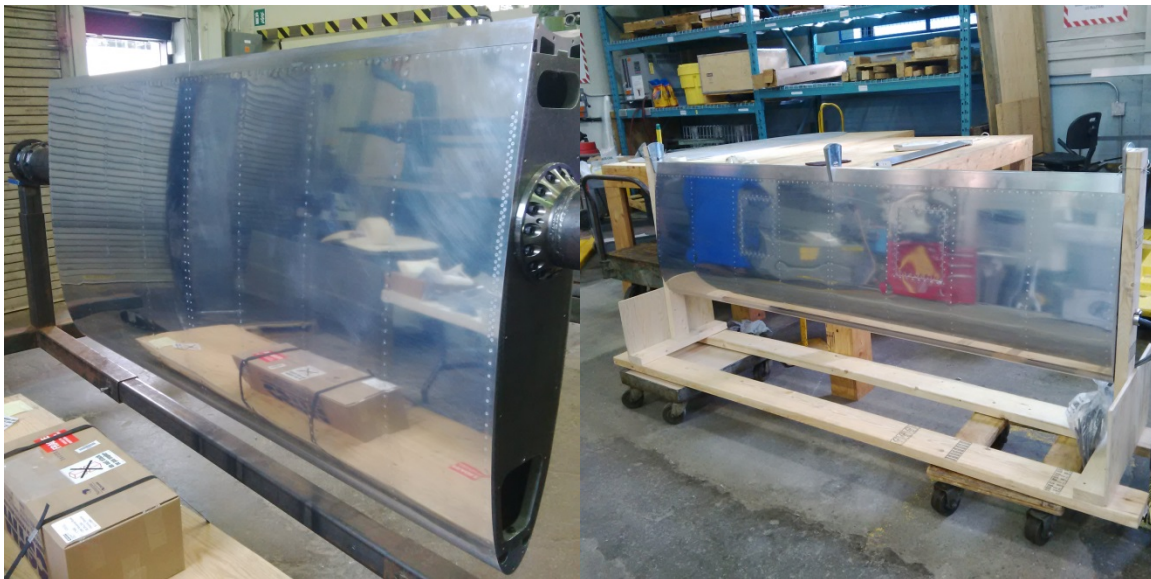
The horizontal stabilizer model was manufactured in-house at the NRC-DFS fabrication shop. Photos of the model construction and assembly are shown below.

a) Main element rib assembly

b) Elevator rib assembly

c) Main element skinned

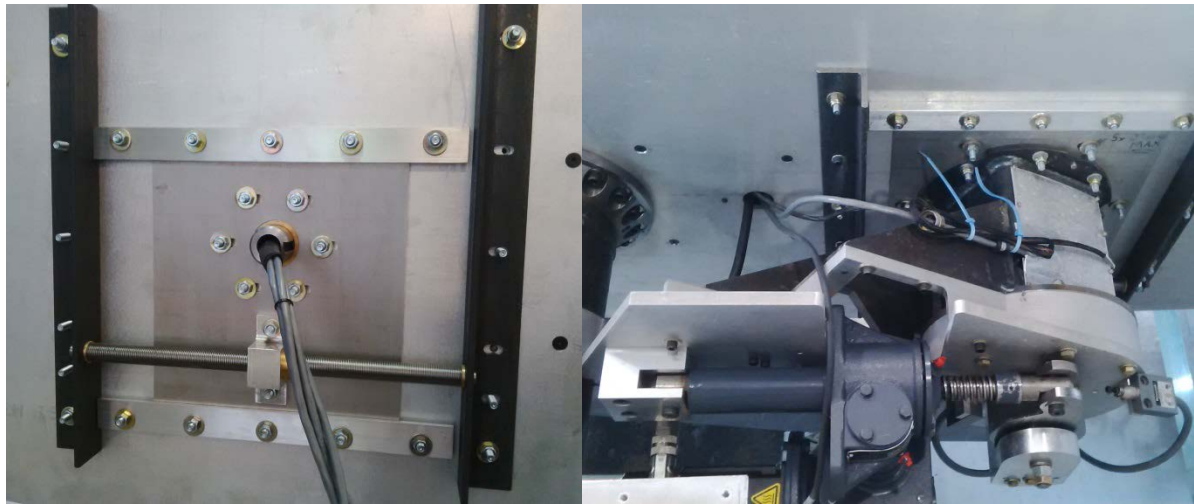
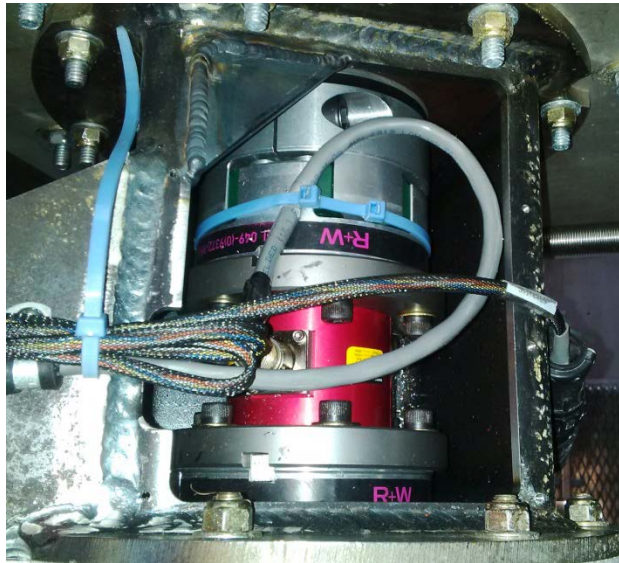
a) Starboard elevator traverse system

b) Port elevator traverse and rotation system

c) Torque sensor and flex couplings

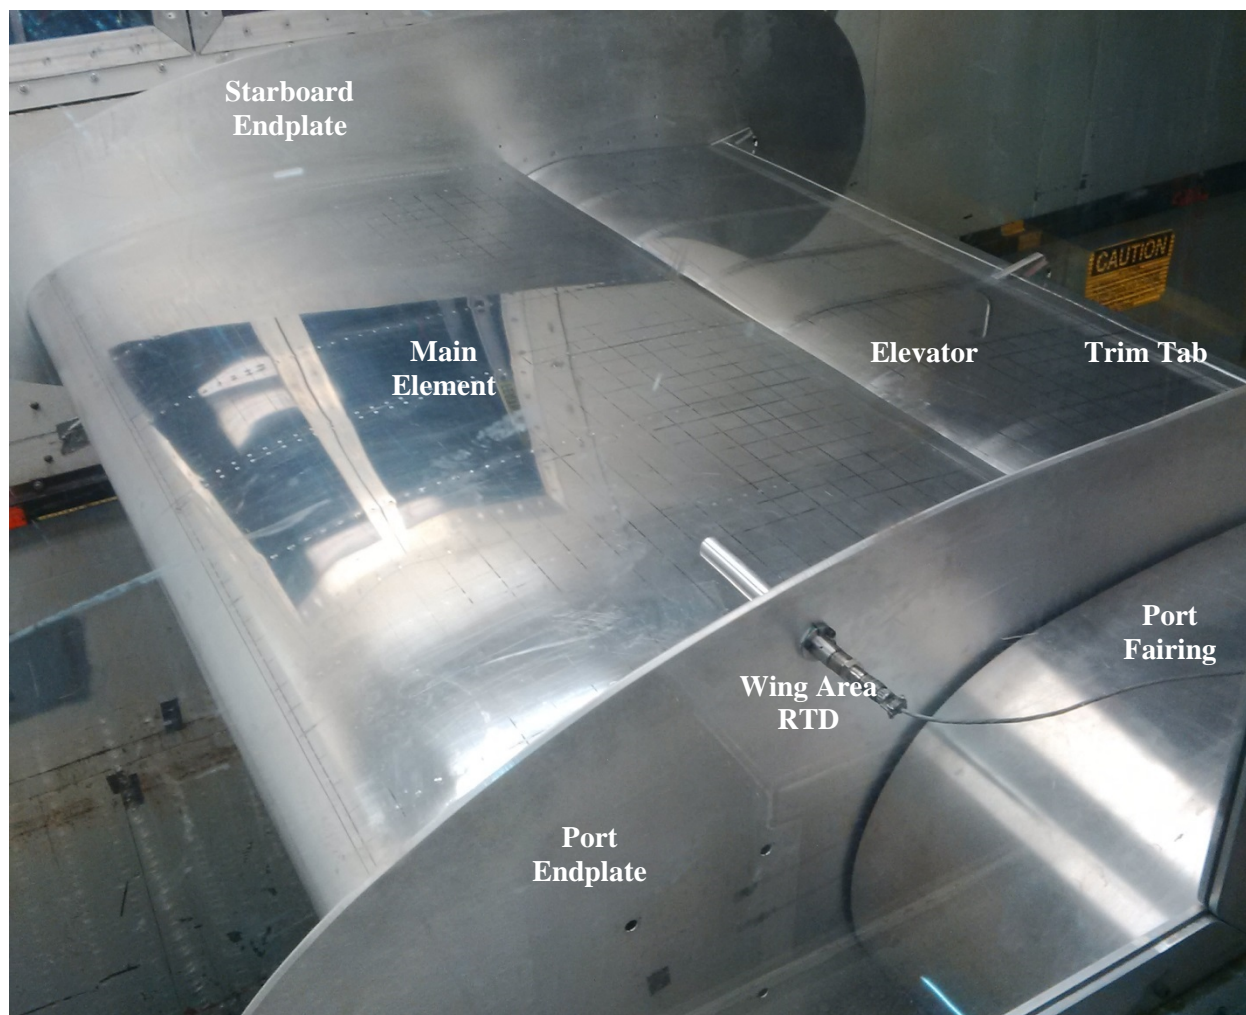
APS personnel marked a grid on the model upper and lower surfaces prior to the start of the test. Each grid cell measured 5.1 cm \times 5.1 cm (2 in. \times 2 in.). The grid spanned a width of 1.8 m (6 ft), starting approximately 10.1 cm (4 in.) aft of the leading edge of the main element and ending at the trailing edge of the model (including the trim tab). This grid was used to facilitate observations of the fluid shearing off the model surface during the tests. A photo of the complete model installed in the test section is shown in Figure 12, with the key model components labelled.

Figure 12 Model Installed in Test Section

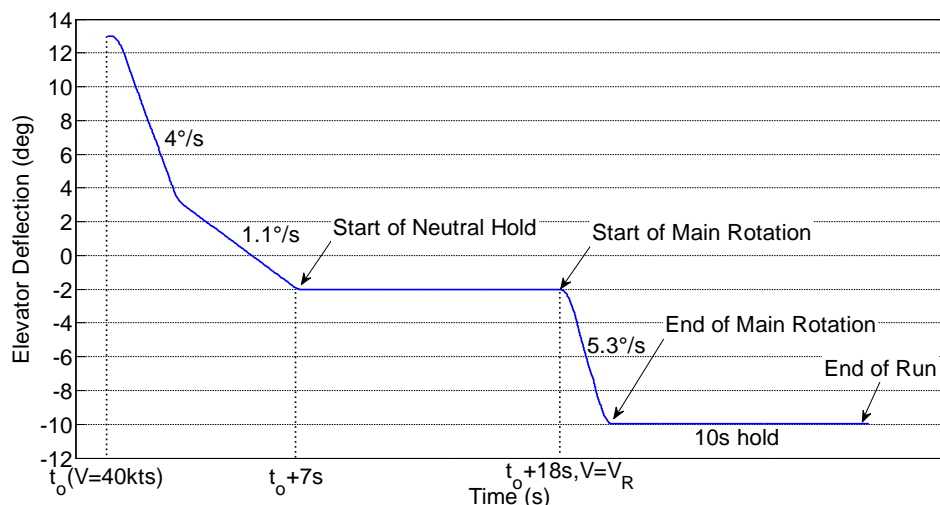
Scenario 1: Heavy aircraft at maximum take-off weight with a center of gravity forward of its maximum permitted position. In this case the horizontal stabilizer needs to generate a high value of negative lift in order to rotate the aircraft.

Figure 13 Scenario 1 (Heavy Aircraft) Rotation Profile

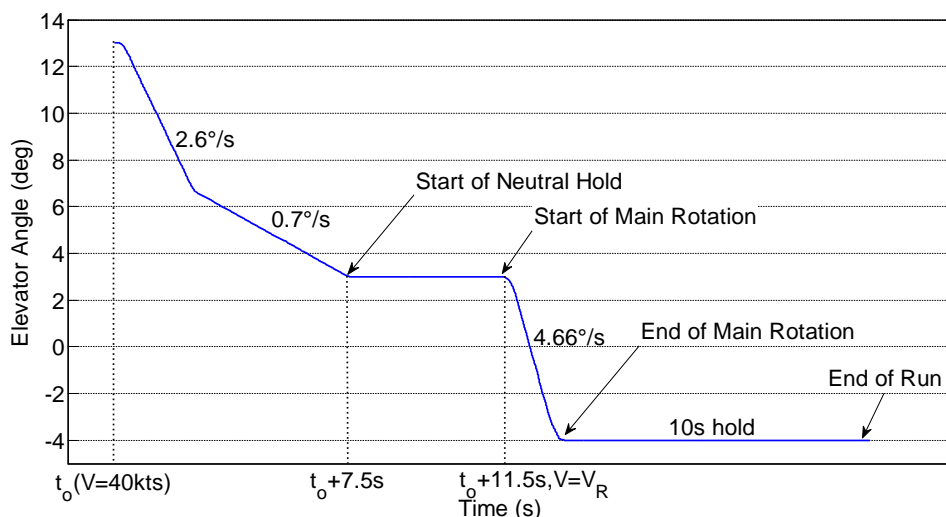
Scenario 2: Light aircraft with a center of gravity towards the back, within permitted limits. In this case the aircraft accelerates quickly and there is minimal time for the anti-icing fluids to shear off the horizontal stabilizer, so excessive fluid could exist on the critical surfaces at the time of rotation. The lift required on the horizontal stabilizer to rotate the aircraft is minimal due to the center of gravity position.

Figure 14 Scenario 2 (Light Aircraft) Rotation Profile

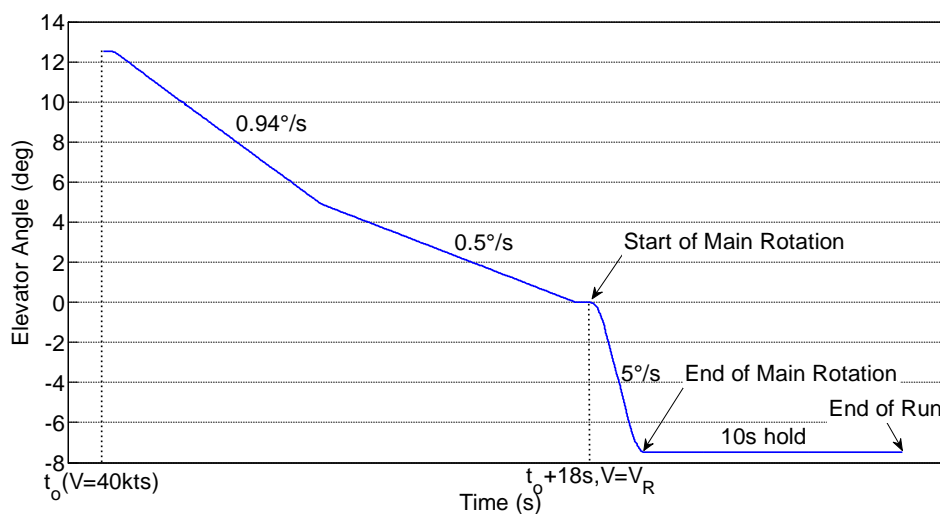
Scenario 3: Typical aircraft weight and center of gravity position. This profile attempts to replicate a normal take-off in winter conditions without intending to abuse any variable.

Figure 15 Scenario 3 (Moderate) Rotation Profile

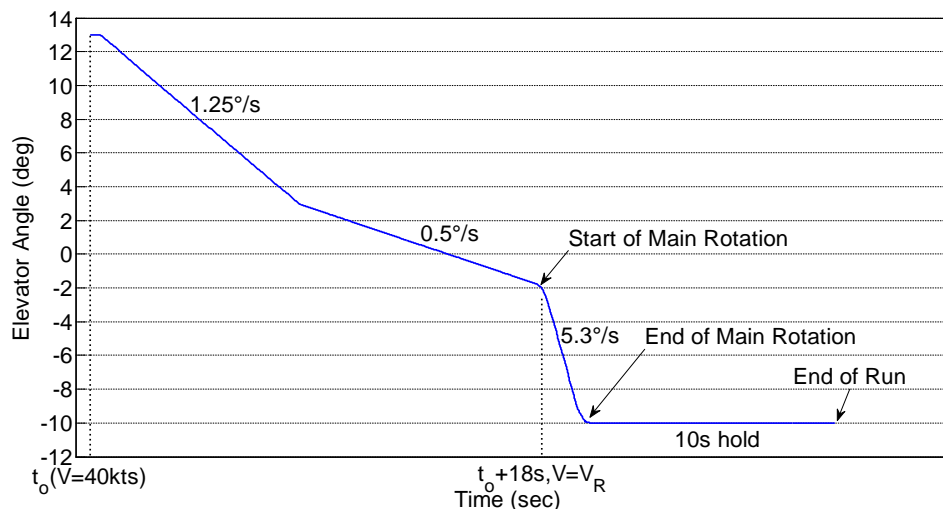
Scenario 4: Modified heavy aircraft profile from Scenario 1, at maximum take-off weight with a center of gravity forward of its maximum permitted position. In this case the elevator deflection rates are slower, so there is no hold period before the main rotation.

Figure 16 Scenario 4 (Modified Heavy) Rotation Profile

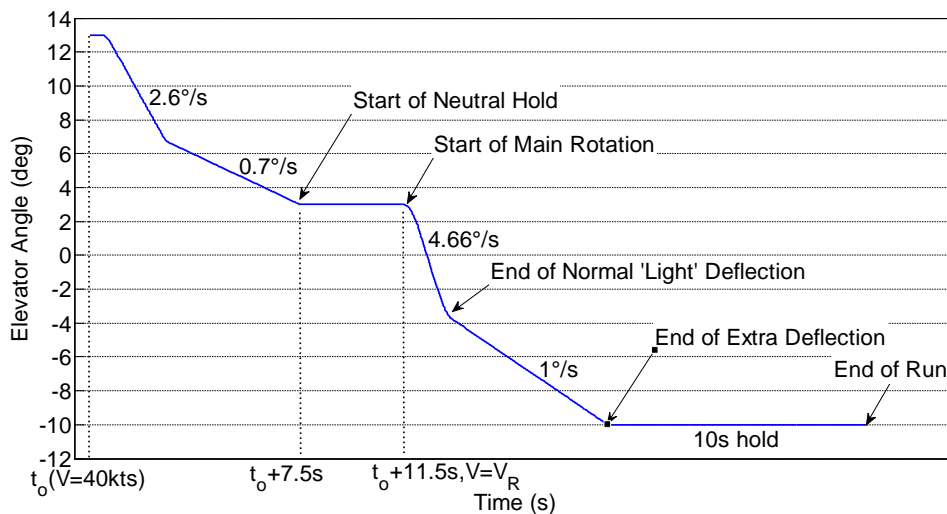
Scenario 5: Modified light aircraft profile from Scenario 2, with a center of gravity towards the back, within permitted limits. In this case, the pilot continues to pull back on the controls after the end of the main rotation, simulating a scenario where the pilot has completed normal rotation procedures but still has not lifted off the runway and continues to deflect the elevator until $\delta_E = -10^\circ$.

Figure 17 Scenario 5 (Modified Light) Rotation Profile

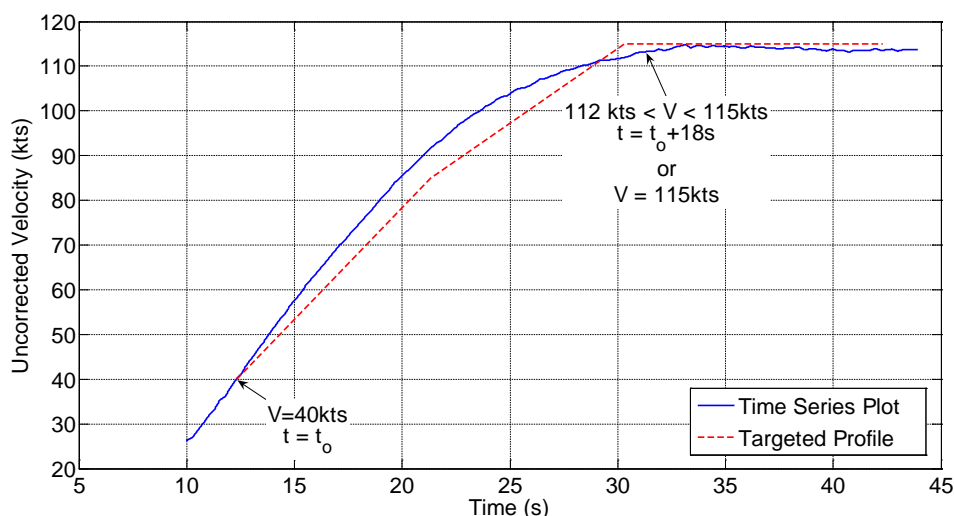
Two different tunnel acceleration profiles were tested using the above elevator deflection scenarios. The first acceleration profile targeted a rotation speed of 115 kts and was used with Scenarios 1, 3, 4 and 5. These acceleration profiles were also based on the FDR data that lead to the definition of Scenarios 1 to 3. In order to obtain the 18 s target time from 40 kts to rotation in a repeatable manner, the logic in the wind tunnel control systems triggered the main rotation of the elevator when 115 kts was reached or when the 18 s timer expired provided the speed was above 112 kts. Since this is the maximum speed of the wind tunnel, if the elevator rotation triggered solely on the velocity requirement there could be large variations in the time from 40 kts to rotation as the velocity asymptotically approaches 115 kts. A typical 115 kts acceleration profile compared to the targeted acceleration profile in the test plan is shown in Figure 18.

Figure 18 115 kts Acceleration Profile

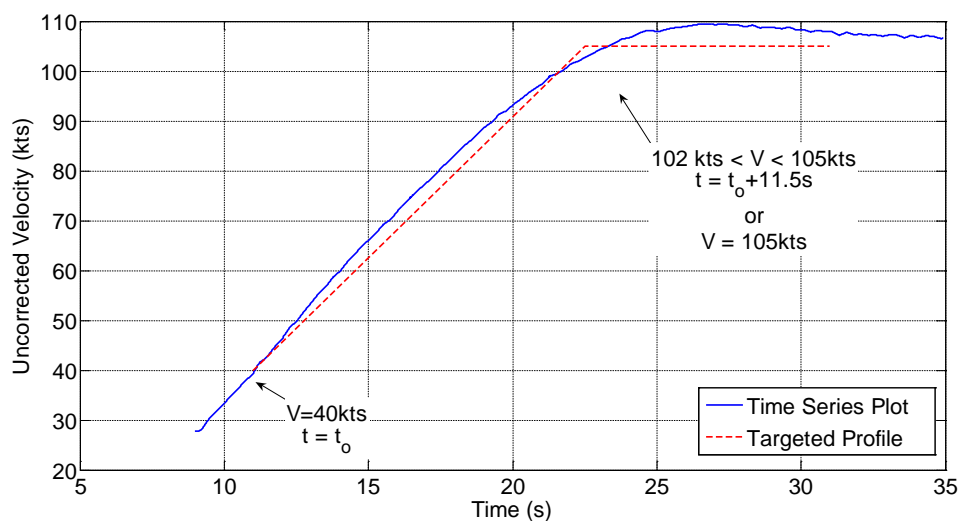
Figure 19 105 kts Acceleration Profile

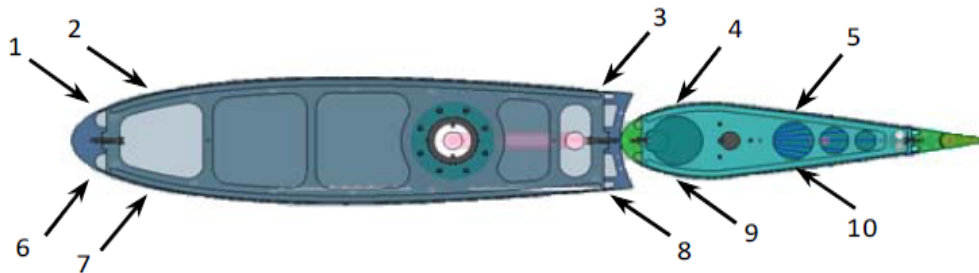
Wet film thickness gauges were used by APS staff to measure the fluid film thickness. These gauges were selected because they provide an adequate range of thickness measurements (from 0.1 mm to 10.2 mm) for all fluid types. A rectangular gauge with a finer scale was used in some cases when the fluid film was thinner; after a run for example. The locations of the fluid thickness, brix, and skin temperature measurements on the model surface are shown in Figure 21.

- Position 1 – 10 cm downstream of the leading edge stagnation point
- Position 2 – 15 cm downstream of position 1
- Position 3 – 10 cm from the trailing edge of the main element
- Position 4 – 15 cm downstream of the elevator stagnation point
- Position 5 – Mid-chord of the elevator
- Positions 6, 7, 8, 9, 10: Same positions as 1, 2, 3, 4, 5 respectively, on lower surface of model

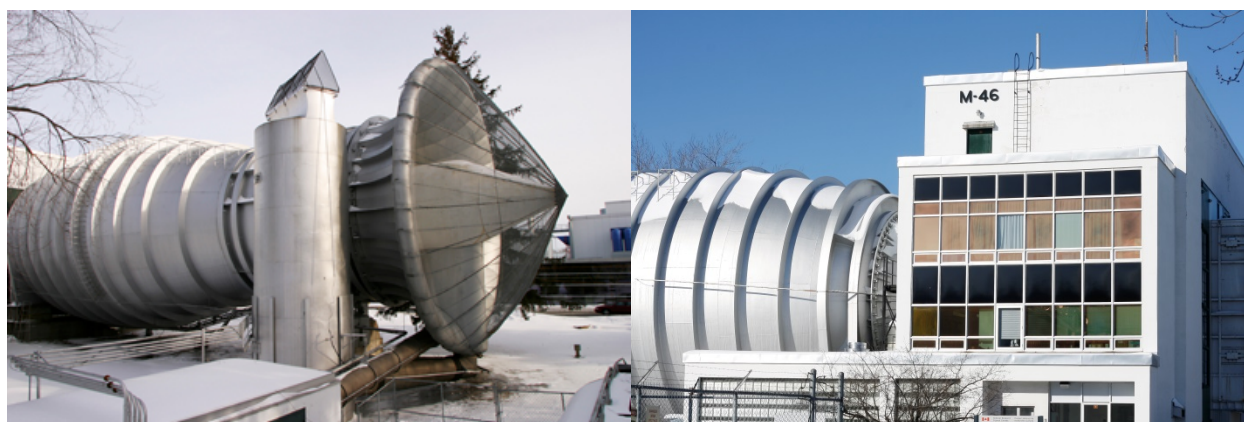
The program was completed at the NRC Propulsion and Icing Wind Tunnel (PIWT) in Ottawa, Ontario, Canada. This is an open-circuit wind tunnel facility that allows for naturally-cold test section conditions during the winter months in Ottawa. The wind tunnel fan is exposed to the atmosphere and has a high solidity ratio to reduce unsteadiness in the test section due to outdoor wind conditions. A screen across the front of the wind tunnel inlet blocks debris and birds. For this research program the PIWT test section is configured with the upper and lower inserts deployed and the fan driven by a gas-turbine engine. The 0.5 m high inserts reduce the test section height from 6 m to 5 m to allow for a maximum speed of 115 kts. Flow angularity over most of the working section is within 1° of the longitudinal axis. The NRC Aerodynamics Laboratory and its wind tunnels are ISO 9001:2008 certified.

Figure 22 Exterior View of PIWT

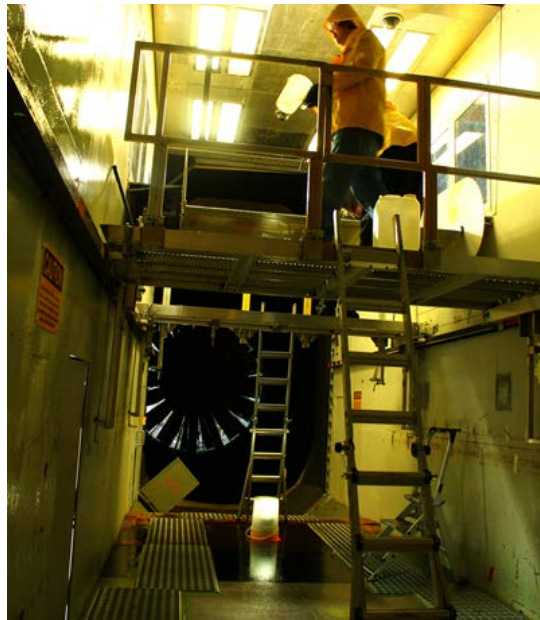
Figure 23 Gantry System

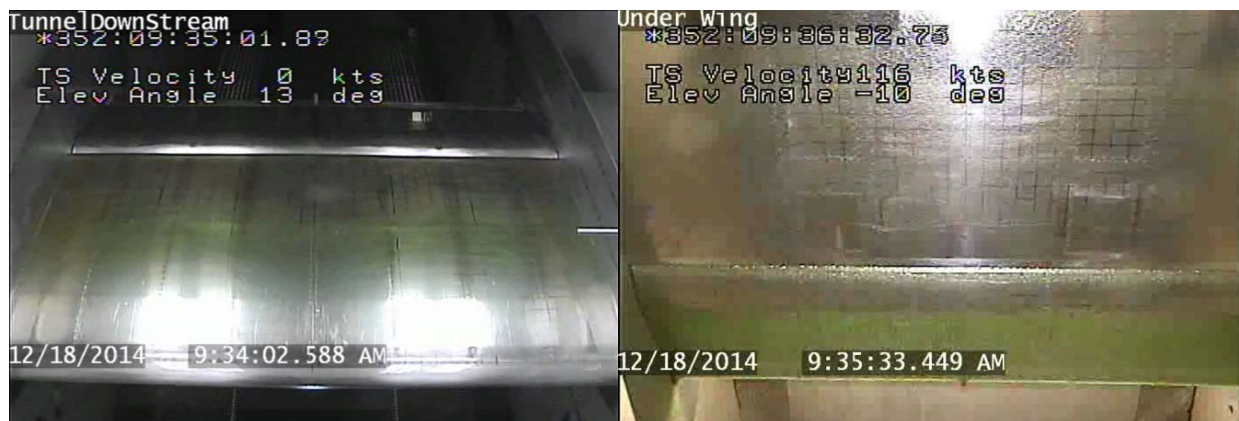
The roof insert of the test section has two 360° rotation video cameras that are used to record the fluid flow-off the upper surface of the model for each run. A floor-mounted video camera with pan, tilt and zoom capability and a built-in light records the fluid flow-off the lower surface of the model. Examples of the views from one of the roof cameras and the floor camera are shown in Figure 25.

Figure 25 Example of NRC Roof and Floor Camera Views

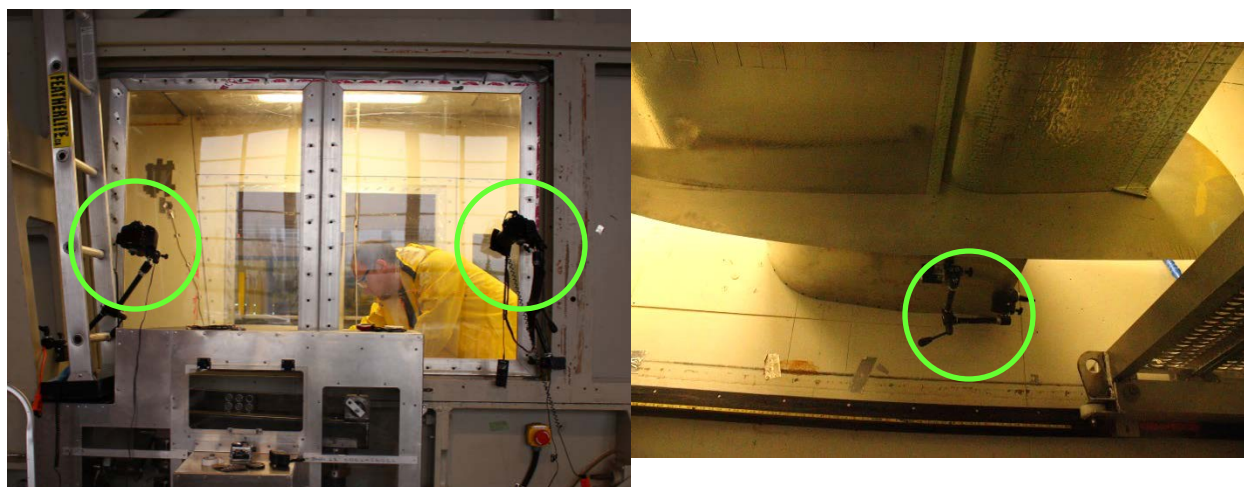
APS used the observation windows on the sides of the test section to install Canon DSLR cameras and Profoto Compact 600 flashes capable of second-by-second photography with an intervalometer. In addition, two cameras were used for wide-angle filming of the fluid flow-off during the test runs. The first was a Canon EOS XTi DSLR camera operated in video mode which was positioned in the first observation window. The second was a GoPro video camera which had a similar vantage point but was installed inside the test section looking at the bottom of the model. The positions of the flashes and cameras are shown in Figure 26. Due to the large amount of photos collected, a small sample is included in this report and the remaining photos were provided to the client on a hard drive at the end of the research program. (Ruggi, 2015)

Figure 26 Positions of APS Cameras

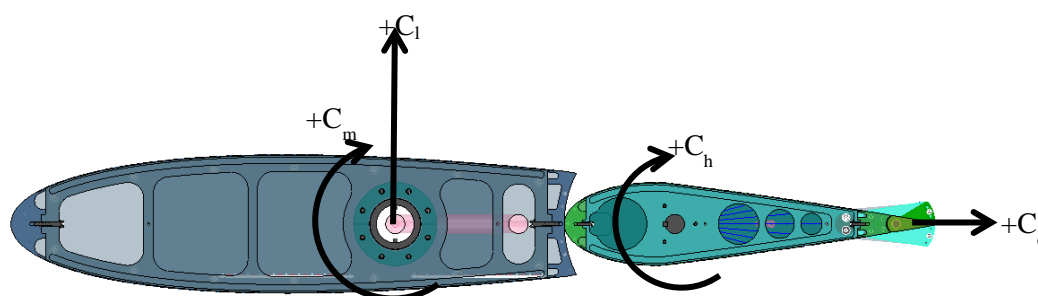
The aerodynamic forces and moments are defined using the conventions shown in Figure 28.

Figure 28 Aerodynamic Sign Conventions

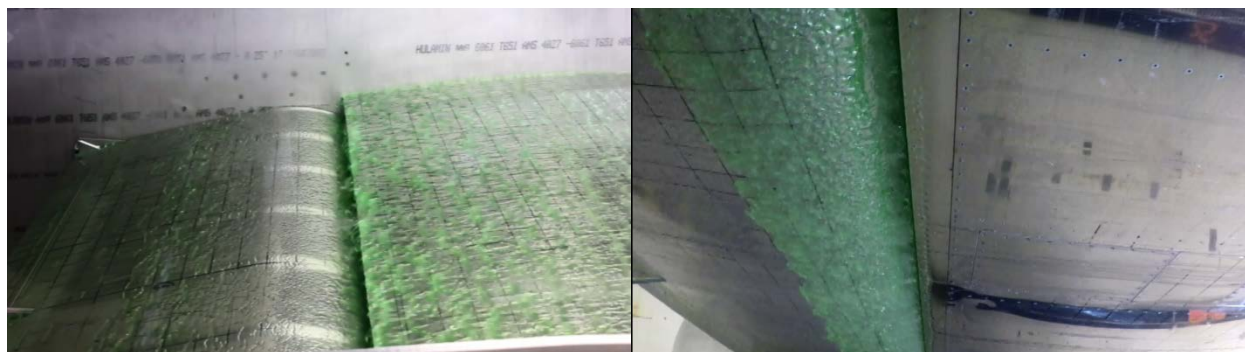
and starts to move against gravity towards the upper surface of the model due to the pressure difference between the upper and lower surfaces. Once the elevator reaches the neutral position that pressure difference is minimized, or changes direction so that the low pressure side is on the lower surface of the model, and the fluid that was contained in the gap is flushed through to the slower surface of the elevator, as shown in Figure 30. This contaminates the lower surface of the elevator prior to the start of the main rotation sequence.

Figure 30 APS Photos Prior to Start of Neutral Hold

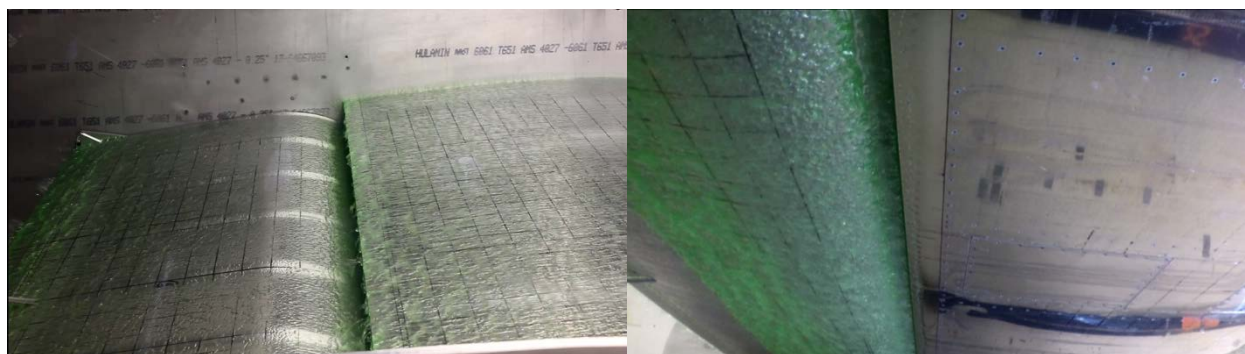
The state of the model and fluid at the start of the neutral hold (Point 1) is shown in Figure 31, when $\delta_E = -2^\circ$. At this point the upper surface of the main element contains a significant amount of fluid that has not sheared off and the lower surface of the main element has no fluid contamination. There is a significant amount of fluid on both the upper and lower surfaces of the elevator, with all of the fluid on the lower surface of the elevator pulled from the upper surface through the hinge gap.

(a) Upper surface

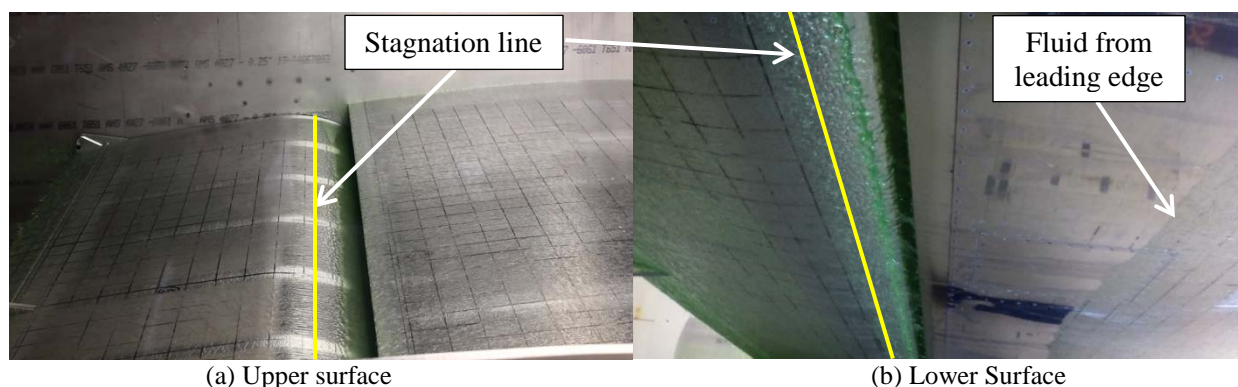
Figure 32 APS Photos at Start of Main Rotation (Point 2)

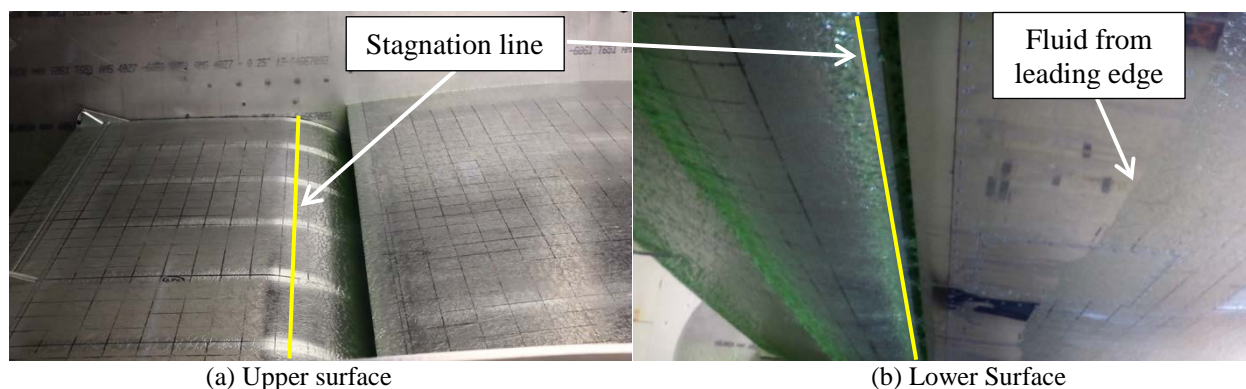
The state of the model and fluid at the end of the main rotation (Point 3) is shown in Figure 33, when $\delta_E = -10^\circ$. The change in elevator deflection angle means an increase in the pressure differential between the upper and lower surface and a change in the stagnation point on the elevator, as shown by the yellow lines in the figure below. The fluid that was trapped in the gap during the hold period is flushed through to the lower surface of the elevator. The thin wave of fluid on the lower surface of the main element continues its downstream progression. The upper surfaces of the main element and the elevator have minimal fluid remaining on them at this point.

Figure 33 APS Photos at End of Main Rotation (Point 3)

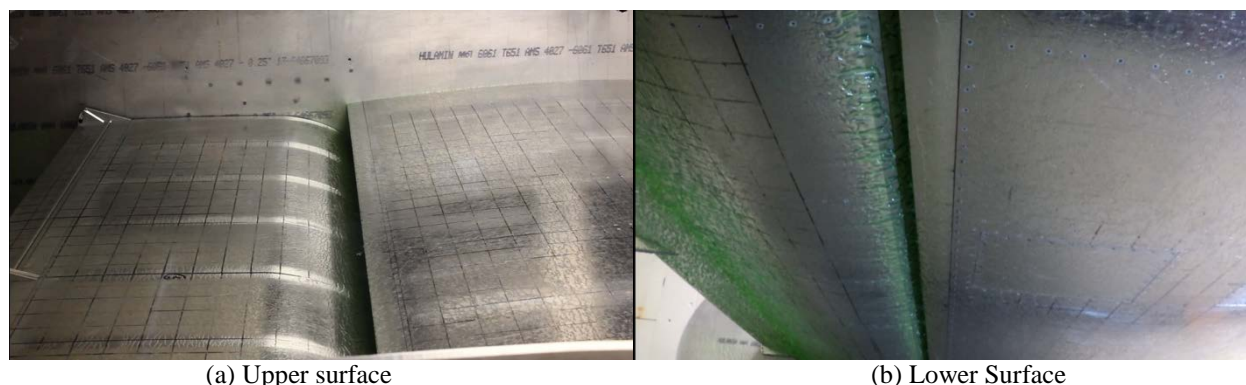
Figure 34 APS Photos at End of Run (Point 4)

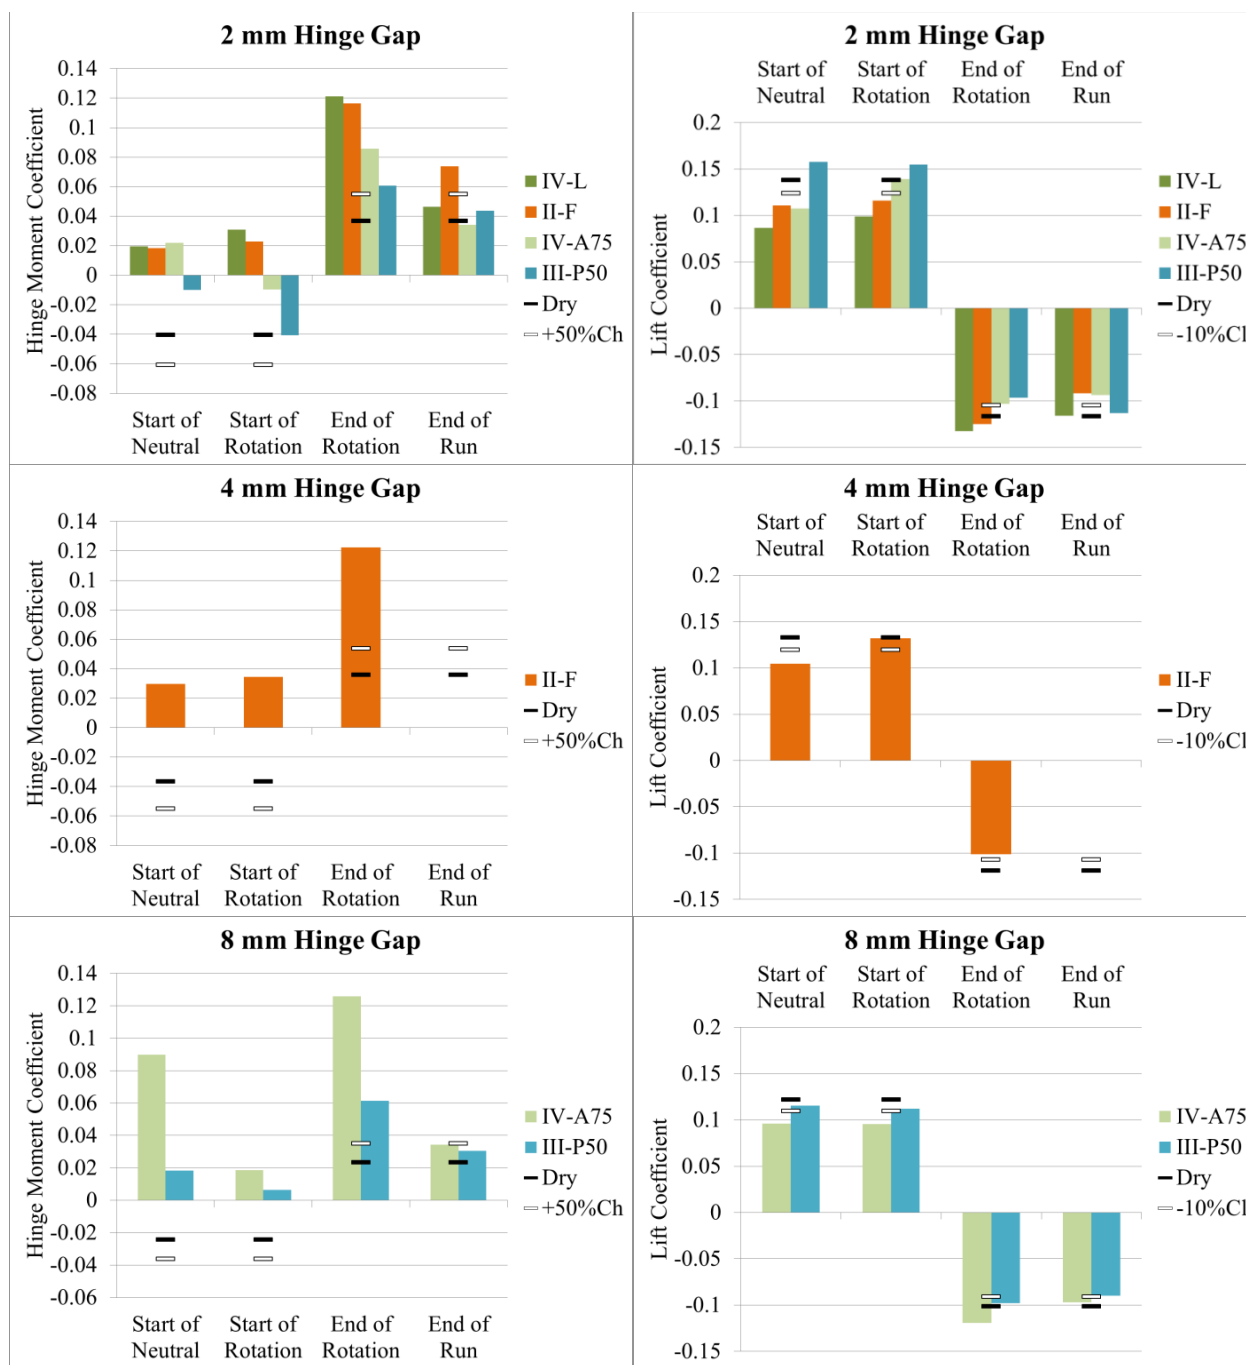
Figure 37 Effects of Fluids and Hinge Gap on Scenario 2 Performance
