Report EASA.2013.2

De-icing fluid wind tunnel testing

***EASA De-Icing Fluid Tests (DIFT)
on a Horizontal Stabilizer Section
at the NRC PIWT
Final Report***

LTR-AL-2014-0122

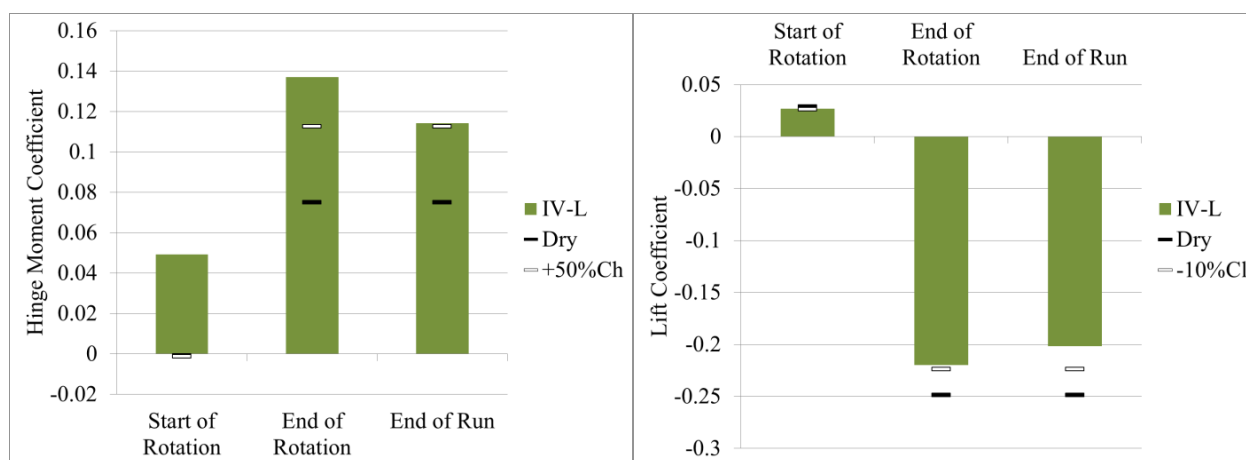
At the end of the rotation, the hinge moment and lift coefficients both exceed the established limits, but not by the large magnitude seen in Scenarios 1 and 2. By the end of the run the hinge moment is close to the +50% C_h limit, but the overall lift is still lower than the -10% C_l limit.

Figure 38 Effects of Fluid on Scenario 3 Performance

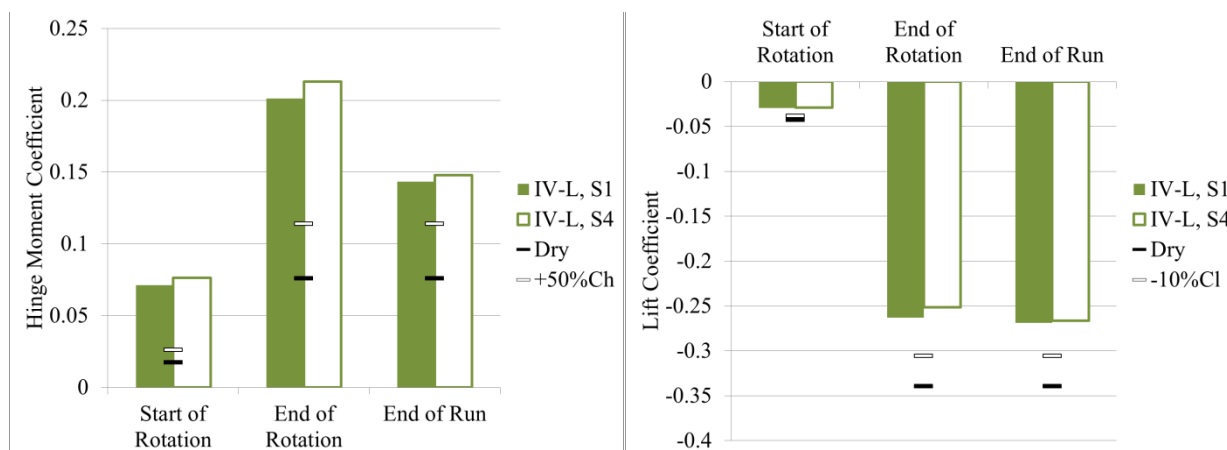
Figure 39 Effects of Fluid on Scenario 4 Performance

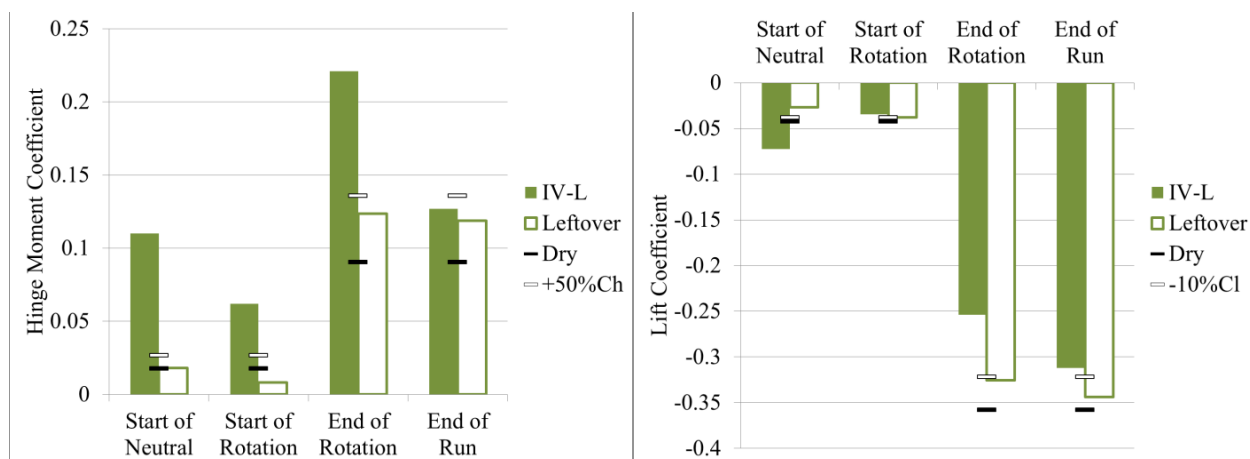
Figure 47 Effects of Leftover IV-L Fluid on Scenario 1 Performance

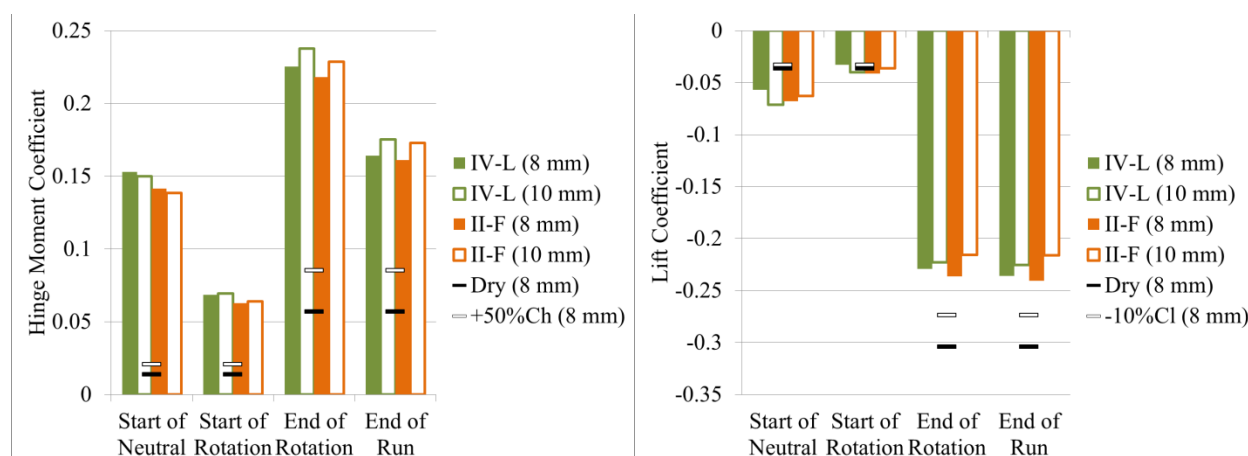
Figure 50 Effects of 10 mm Hinge Gap with Fluids on Horizontal Stabilizer Performance

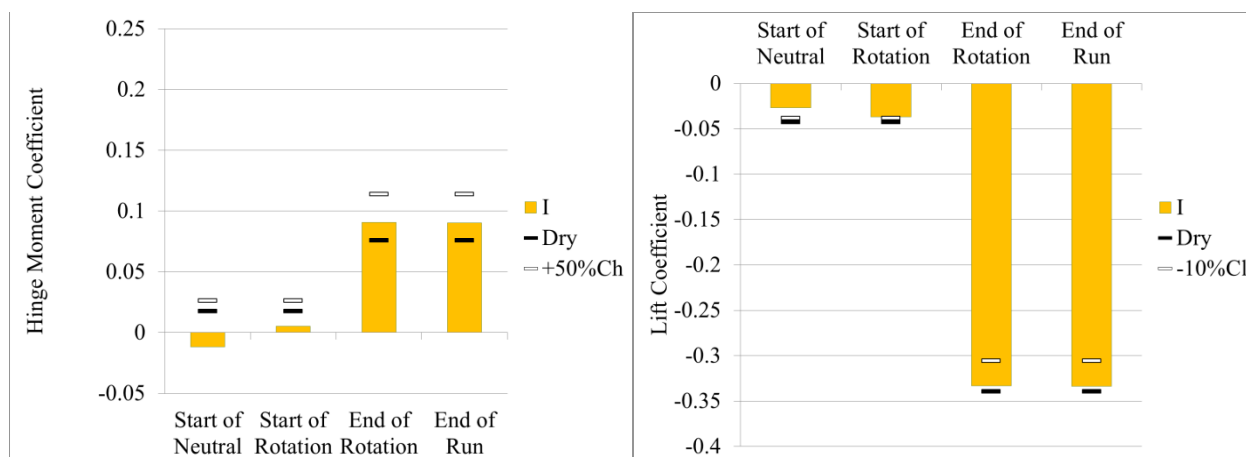
Figure 51 Effects of Type I Fluid on Horizontal Stabilizer Performance

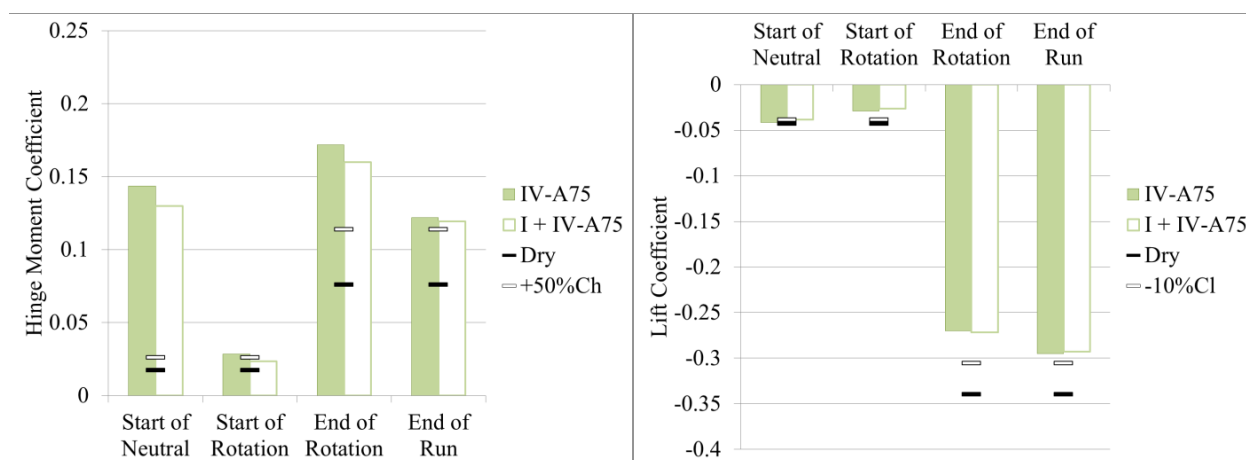
Figure 52 Effect of Two-Step De-Icing Process (I + IV-A75) on Horizontal Stabilizer Performance

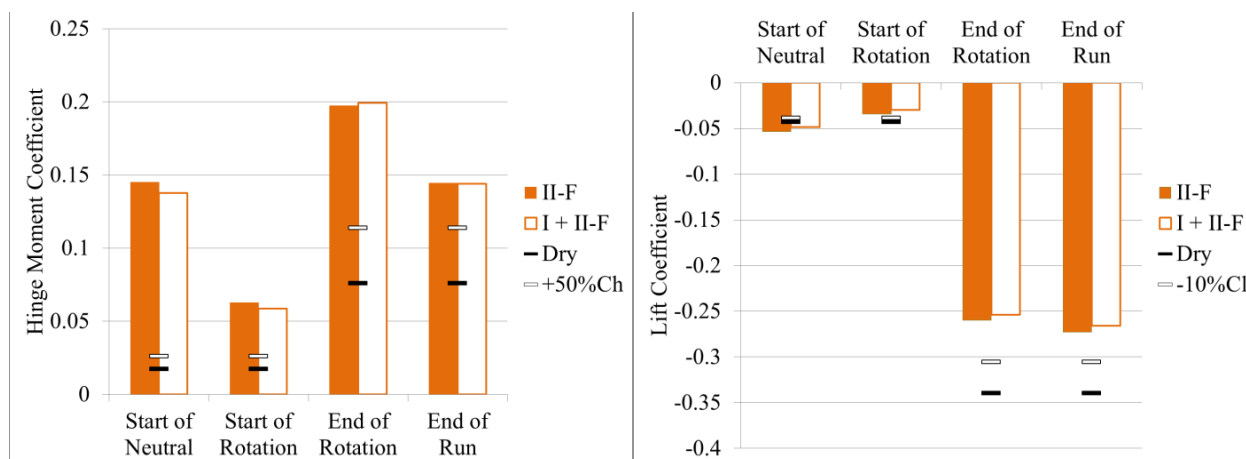
Figure 53 Effects of Two-Step De-Icing Process (I + II-F) on Horizontal Stabilizer Performance

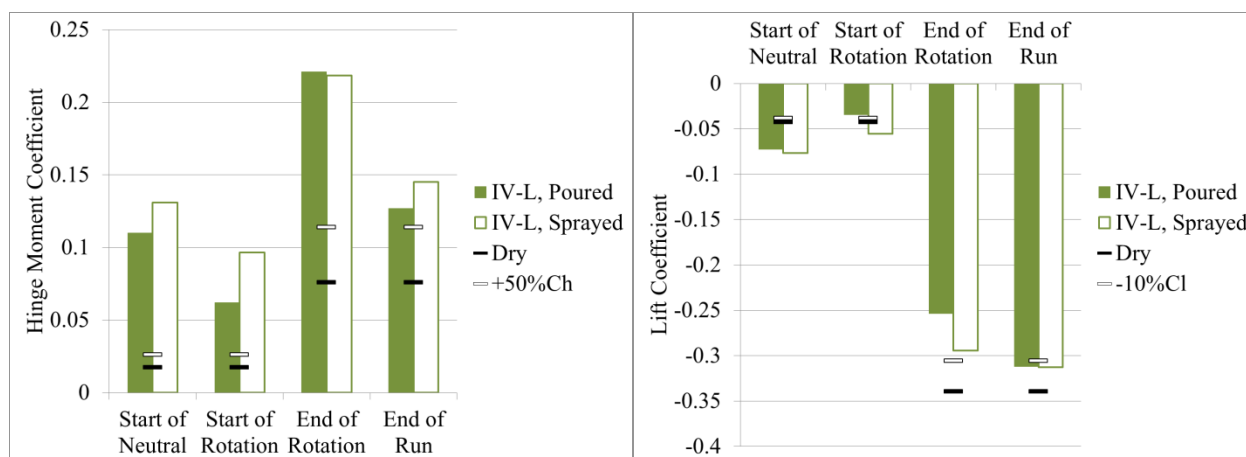
Figure 54 Effects of Spraying vs. Pouring Fluid

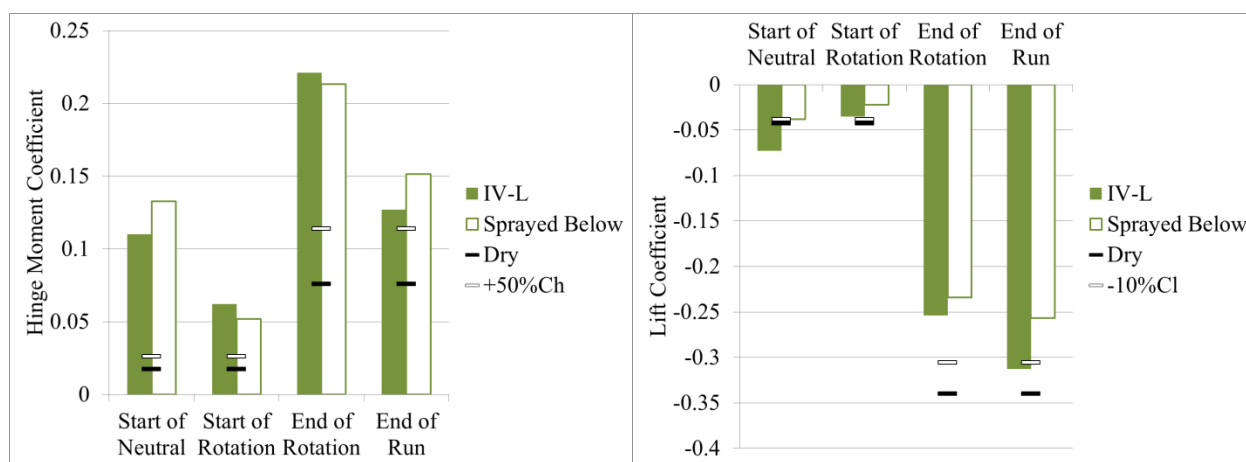
Figure 55 Effects of Additional Fluid Sprayed on Underside of Model

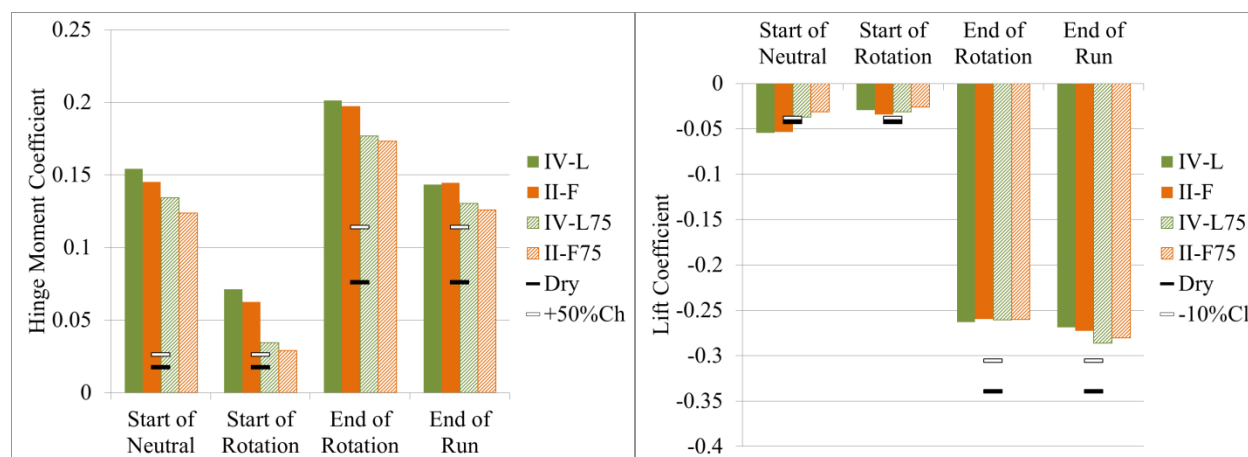
Figure 56 Effects of Fluid Dilution on Horizontal Stabilizer Performance

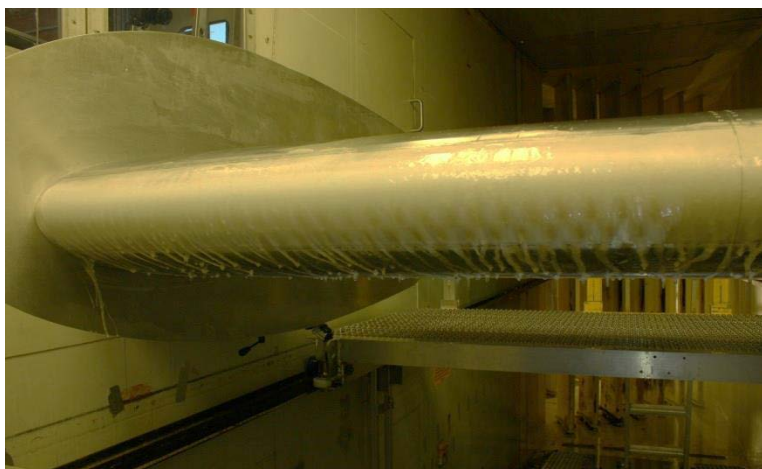
Figure 57 Ice Applied to Model Surface

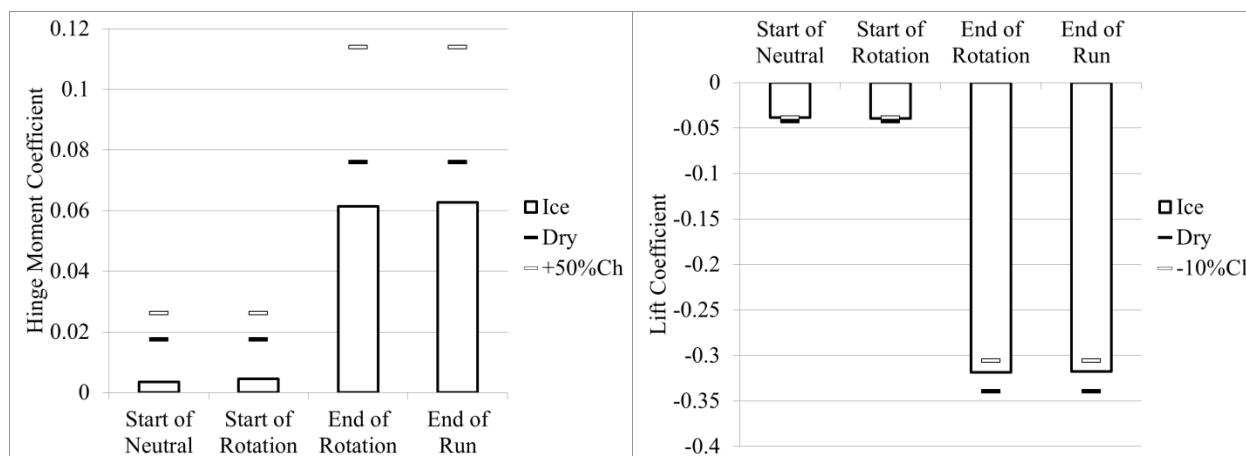
Figure 58 Effects of Ice on Horizontal Stabilizer Performance
