EASA
European Aviation Safety Agency

Final Report EASA_REP_RESEA_2013_3

CODAMEIN III

**Composite Damage Metrics and Inspection
(high energy blunt impact) – 3rd phase**

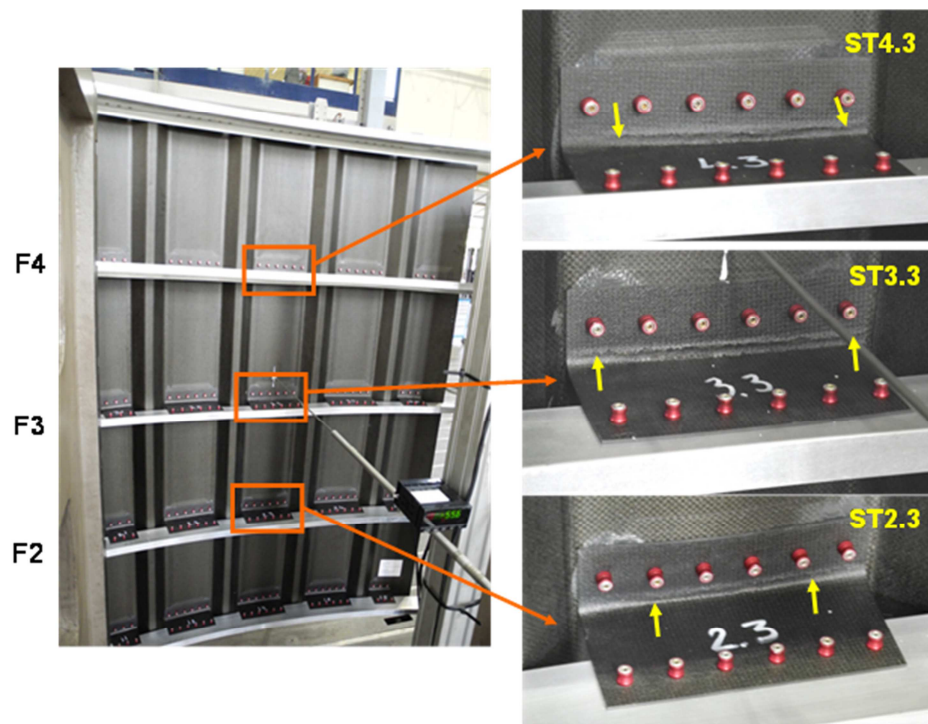
Figure 2. Shear tie damage in CODAMEIN I 2nd load cycle [Mikulik, Haase 2012]

in the skin, delamination in the shear tie radii was expected to be the first point of damage onset. The failure threshold energy for the first damage onset was 1270 J, which represents a vehicle with a mass of 2500 kg impacting the fuselage with a velocity of 1 m/s. The second load cycle was stopped when several shear ties in the panel centre showed significant radius cracking (see Figure 2), which accompanied a continuous softening of the panel. Besides the multiple shear tie damage, which was clearly visible in the loaded state and became invisible after unloading, no further damage was detected either visually or by A-scan.

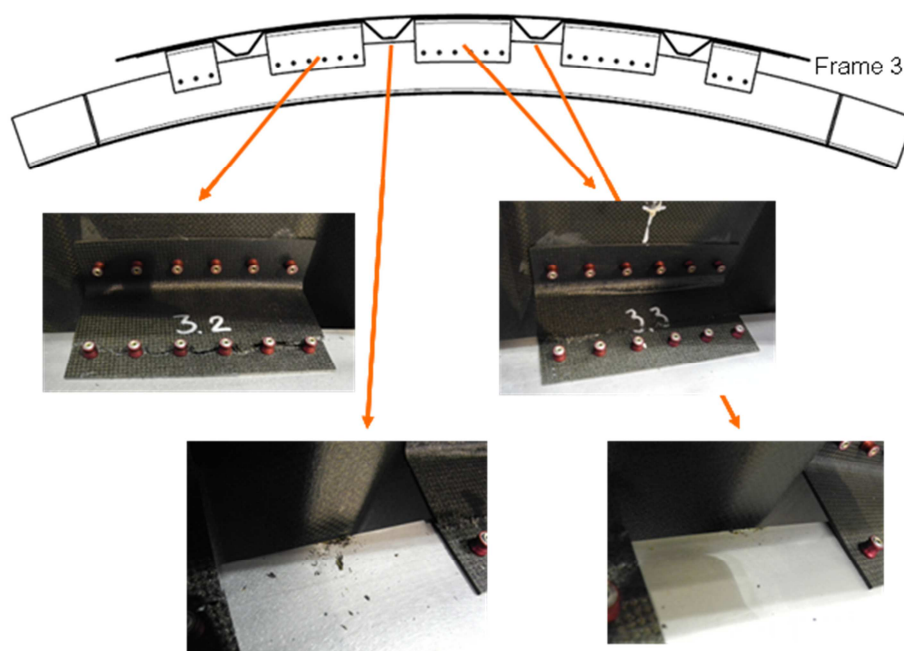
Figure 3. Shear tie failure and stringer damage in CODAMEIN I 3rd load cycle [Mikulik, Haase 2012]

In the third load cycle, several shear ties failed, the centre frames came into contact with the centre stringers and the frames showed significant rotation. The third load cycle was stopped just before the estimated point of plastic deformation of the frames in order to prevent permanent deformation of the panel. A maximum energy of 2660 J was applied in the performed load cycles. The final inspection showed damage and failure of several shear ties as well as minor surface damage to the frames and stringers due to contact between those parts. The shear tie failure and stringer damage at frame 3 is shown in Figure 3. No delamination was detected in the skin and the stringers after the test.

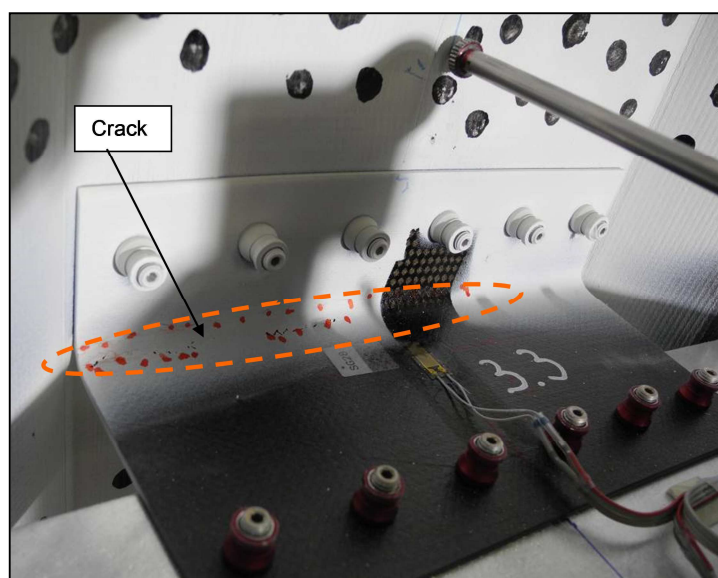
Figure 4. Damage after 1st load cycle: Crack in the centre shear tie no. 3.3 [Haase 2013]

The first load cycle was run up to a load of 39.5 kN and stopped at a damage event which caused a load drop of 1 kN. The only visible evidence of damage after the first load cycle was a crack in the radius of the centre shear tie no. 3.3 (see Figure 4) which covered $\frac{3}{4}$ of the width of the shear tie [Haase 2013].

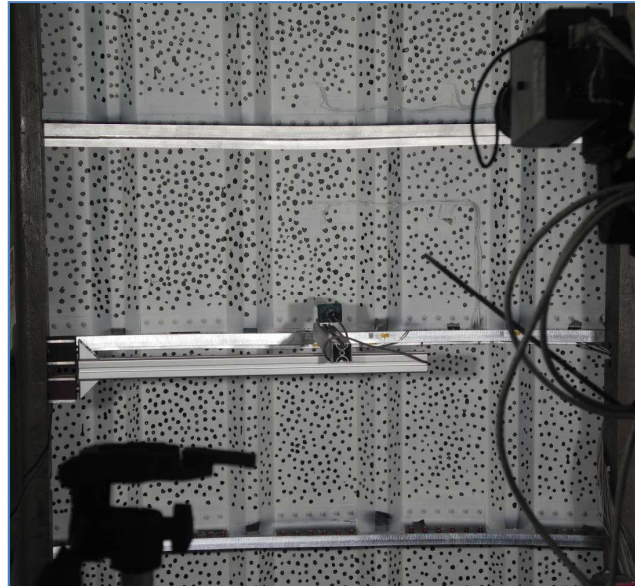
Figure 5. Panel inside at 2nd load cycle max. load [Haase 2013]

damage onset and damage growth mechanisms were audible in terms of single cracking sounds or continuous cracking sounds which were assigned to the damage to the two centre shear ties ST 2.3 and ST 3.3 as well as ST 3.4. No load drop occurred prior to the maximum load of the 2nd load cycle. Figure 5 shows the panel inside at maximum load and the slight bending of the three centre frames is visible.

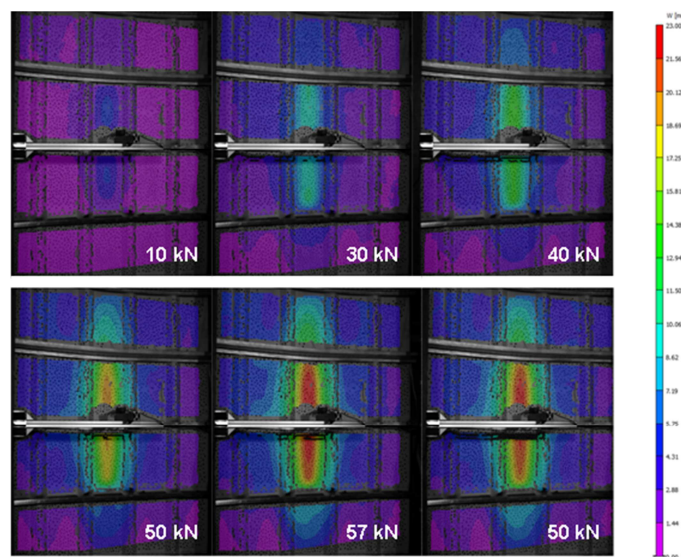
Figure 6. Panel displacement in impact direction (video correlation system): four load levels, max. load, unloading [Haase 2013]

The distribution of the panel displacement in the impact direction is displayed at six load levels in Figure 6. At the maximum load of 57 kN, a displacement of 130 mm was measured. The damage event at maximum load resulted in a load reduction to approximately 54 kN, and then a further reduction to 50 kN as the center frame relaxed in torsion, resulting in the displacement distribution displayed in Figure 6.

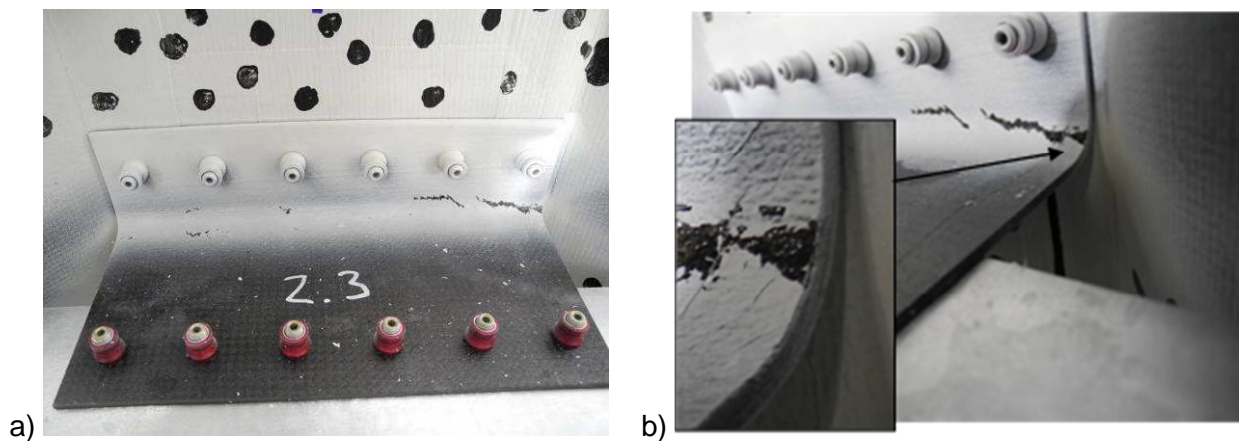
Figure 7. Shear Tie no. 2.3 after 2nd load cycle [Haase 2013]

After unloading the 2nd load cycle, the shear tie no. 2.3 exhibited initial cracking in the radius (see a. of Figure 7) along with delamination marks at the side of the radius (see b) of Figure 7). The crack in the shear tie no. 3.3 developed through the full width of the shear tie (see a) of Figure 8). Delamination was visible on both sides of the radius (see b) of Figure 8). The shear tie no. 3.3 also showed a crack along the entire width of the radius (see a) of Figure 9) and delamination of the radius (see b) of Figure 9). The delamination marks indicated delamination of multiple plies throughout the thickness of the shear ties and covering approximately the full radius curvature.

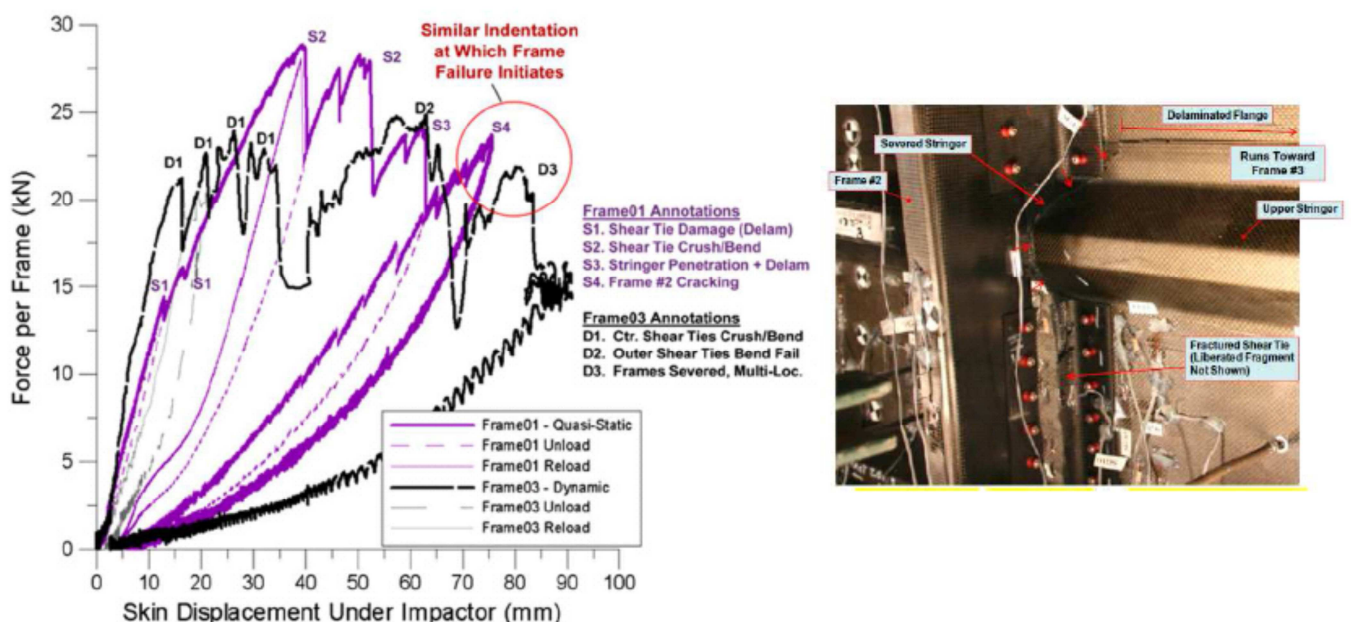
Figure 11. Force per frame comparison vs. skin displacement for quasi-static indentation (Frame01) and dynamic impact (Frame03) tests [Kim 2013].

A load-displacement plot of a quasi-static indentation (Frame01) and dynamic impact (Frame03) tests and the typical damage of Frame01 specimen is shown in Figure 11.

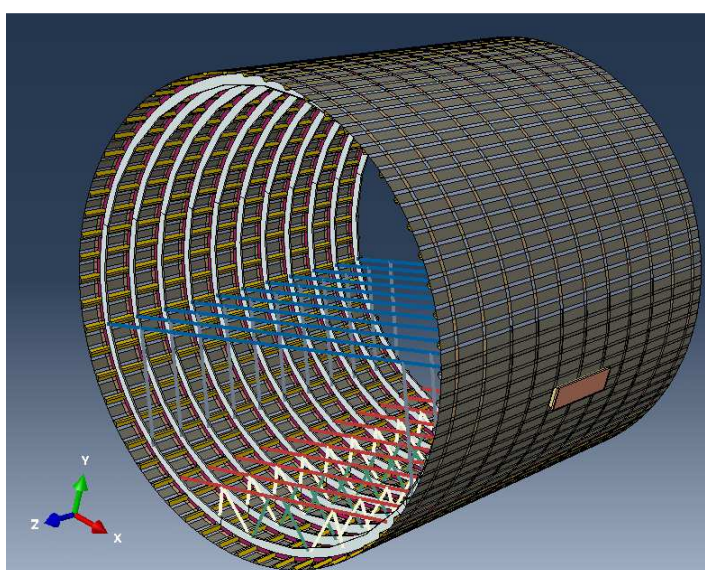
Figure 13. Full barrel FE model

The literature review and input from the UCSD were used to establish a credible baseline design for the hybrid test panel investigated in CODAMEIN III. The design is based on that of the CODAMEIN II test panel [Mikulik, Hasse 2012], i.e. in accordance with recent CS-25 aircraft design principles, and the configuration used in the UCSD work. The UCSD and the CODAMEIN I / CODAMEIN II test panels [Hasse 2013] have a similar level of complexity and were comparable due to the similarity of the majority of parts and materials. Furthermore, the stiffnesses of the frames were matched, although being of differing section and materials. The test panel configuration was chosen to represent the structure local to lower fuselage door cutouts, whilst not representing the details very local to the cut-out edge, as shown in Figure 13. This is relevant regions for this investigation since the hybrid fuselage design might be used in this region, including locally in an otherwise full composite design, where the investigated type of damage occurs under static high energy blunt impact.

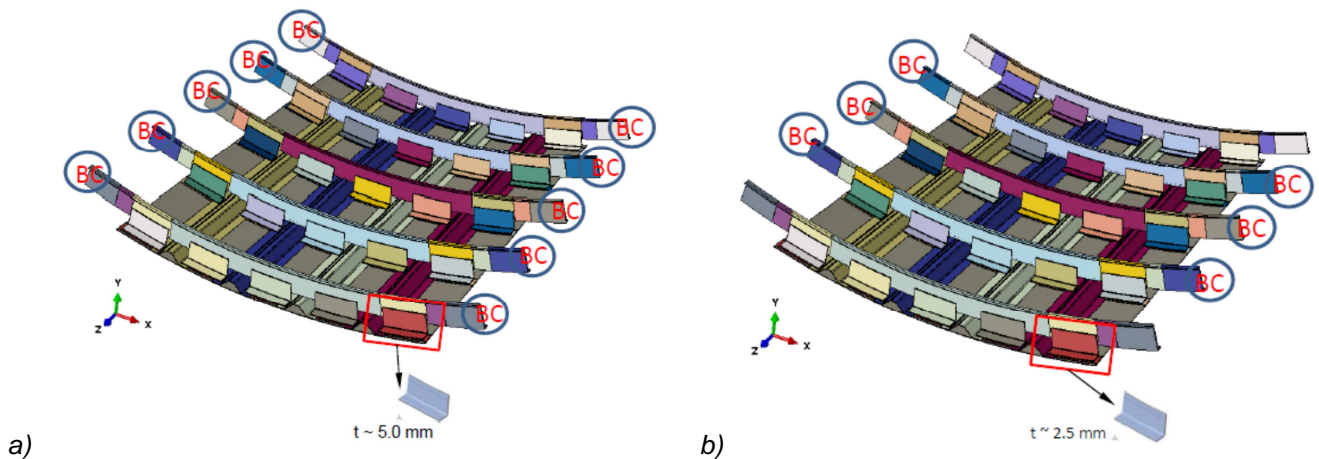
Figure 15. Overview of panels: a) CODAMEIN III panel; b) CODAMEIN II panels

The CODAMEIN III panel is generally similar to the CODAMEIN II panel. It integrates a major design change by including stronger shear ties (doubling the thickness) in order to investigate the potential for changes to the extent and modes of damage. Moreover, a minor design change at the panel boundary was incorporated, i.e. reinforcement of the boundary region of the frames. The CODAMEIN III testing expected to reach a higher level of panel deformation compared to the CODAMEIN II test. To ensure the equal flexibility of the frame attachments, the boundary stiffnesses were added to all five frame ends instead of three. An overview of the panel designs for CODAMEIN II and CODAMEIN III is shown in Figure 15.

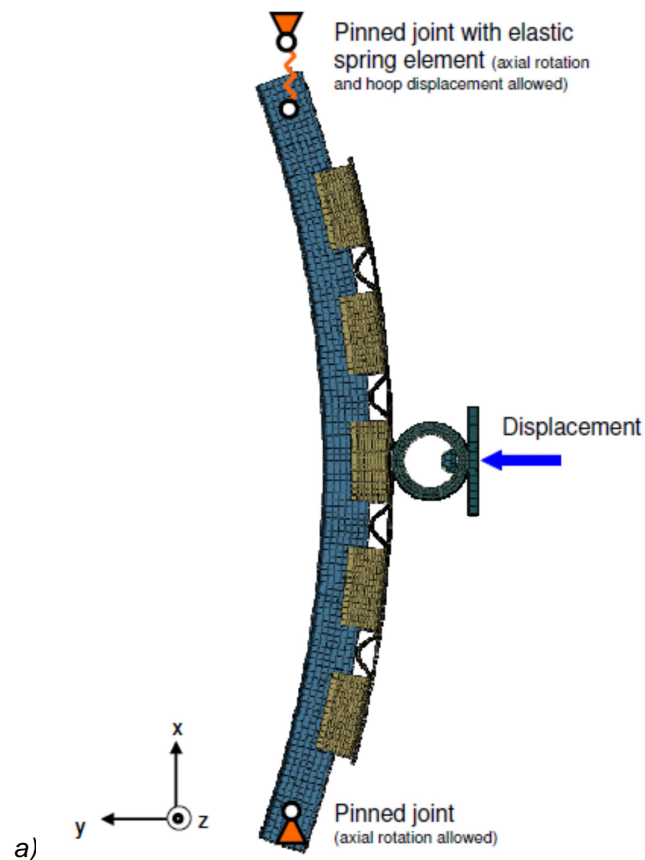
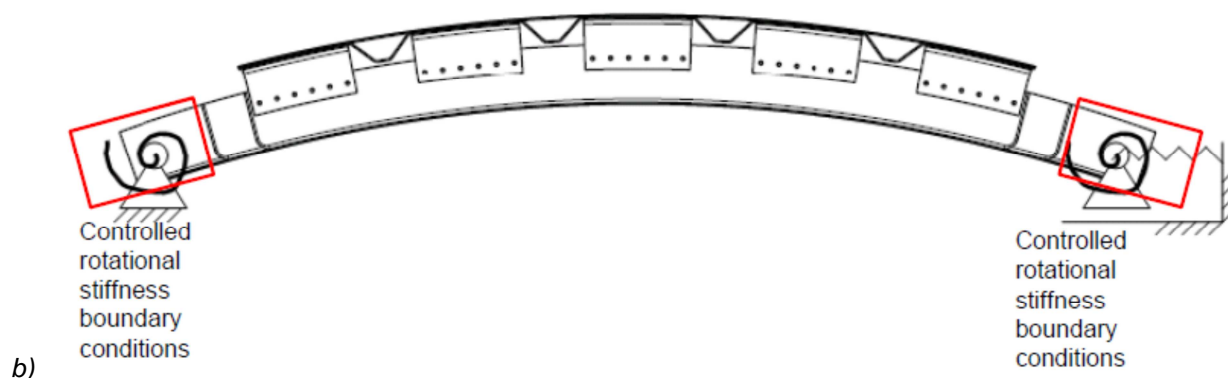
Figure 16. Boundary conditions: a) CODAMEIN II panel (top view); b) CODAMEIN III panel (axial view)

Figure 16 shows the boundary conditions in top view of the CODAMEIN II panel and axial view of the CODAMEIN III panel. For CODAMEIN II panel, the axial rotations are allowed in both frame ends. In the boundary conditions of CODAMEIN III panel, the axial rotations are controlled in such a way that the overall behaviour of the panel is comparable to the full barrel. The calculated rotational stiffness boundary conditions are added to both frame ends as highlighted.

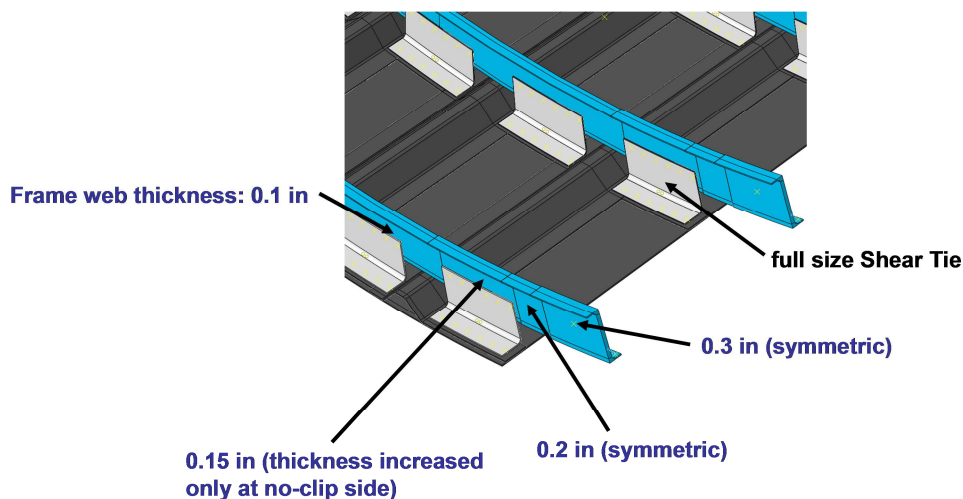
Figure 17. Frame end reinforcement details [Hasse 2013]

Moreover, the frame end region was modified for both CODAMEIN II & III panel, compared to CODAMEIN I panel. The frame web thickness was increased in three steps (see Figure 17) towards the ends. Thus the frame end was reinforced more gradually with the intention of preventing local failure, without adversely influencing the results of the tests.

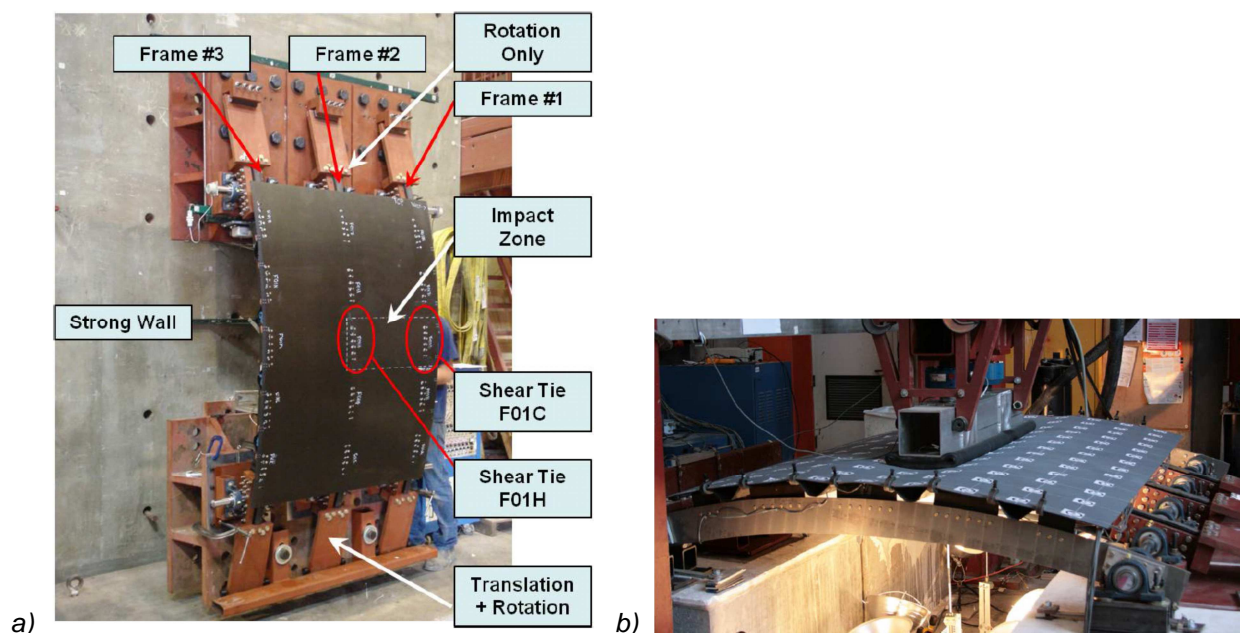
Figure 18. UCSD investigated panels: a) Stringer Panel; b) Frame Panel [Kim 2013]

The test panel design of CODAMEIN I and CODAMEIN II is based upon the component design of UCSD test panels. The UCSD performed numerous tests on specimens of different sizes and levels of detail which imply a size similar to the CODAMEIN I / CODAMEIN II panel. A set of standard components has been used for all performed tests. Thus the material, lay-up and cross section of the test panel's skin, stringers, frames and shear ties were maintained throughout the impact testing program. The size of the test panels, the number of involved components and the boundary conditions has all been evolved. Figure 18 shows the UCSD test panel types, "stringer panel" and "frame panel".

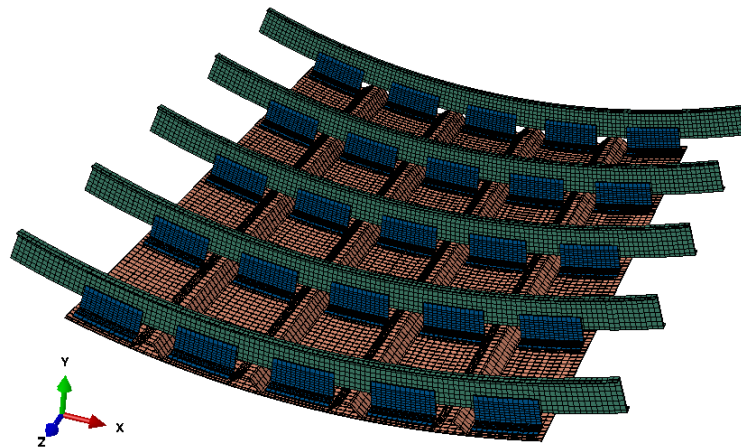
Figure 24. CODAMEIN III panel FE model

The finite element model is developed for the current numerical analysis with the FEA package (ABAQUS) employed in order to investigate the non-linear structural behavior. One of the main objectives of CODAMEIN III was to develop a numerical model that permits the simulation of the investigated impact case and subsequent impact damage formation and damage sequence. Similar to the CODAMEIN II simulation technique, an explicit integration was adopted in CODAMEIN III to deal with the high non-linearity. The FE panel model is illustrated in Figure 24.

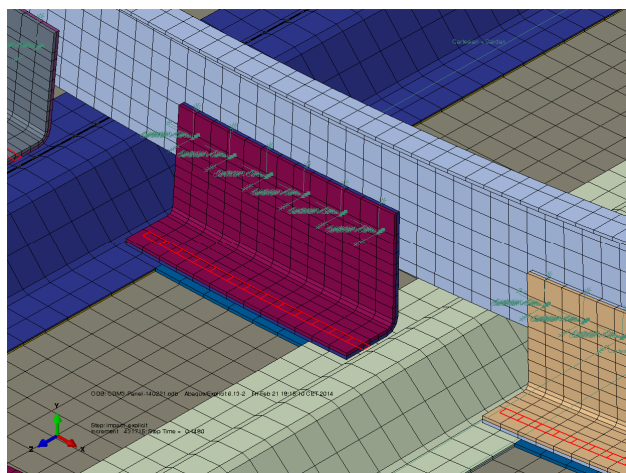
Figure 25. Connections of shear tie to stringer and frame

The fasteners attaching the shear ties to the skin were replaced by local tie constraints (DOF equalization of node pairs) to reduce the tendency of elements within the shear tie feet to undergo hourglassing modes that caused delamination. The fasteners that attached the shear ties to the frames were modelled using connectors. The connector type definition "Cartesian+cardan" allows the assignment of properties in all DOFs. For the representation of the fasteners, translational elasticity as well as axial and shear strengths were defined. The frame parts of the CODAMEIN III model are depicted in Figure 25. The geometrical detail level of the frames was kept the same as the CODAMEIN II model which involved the improved reinforcement at the frame ends and the increased bending stiffness of the frames.

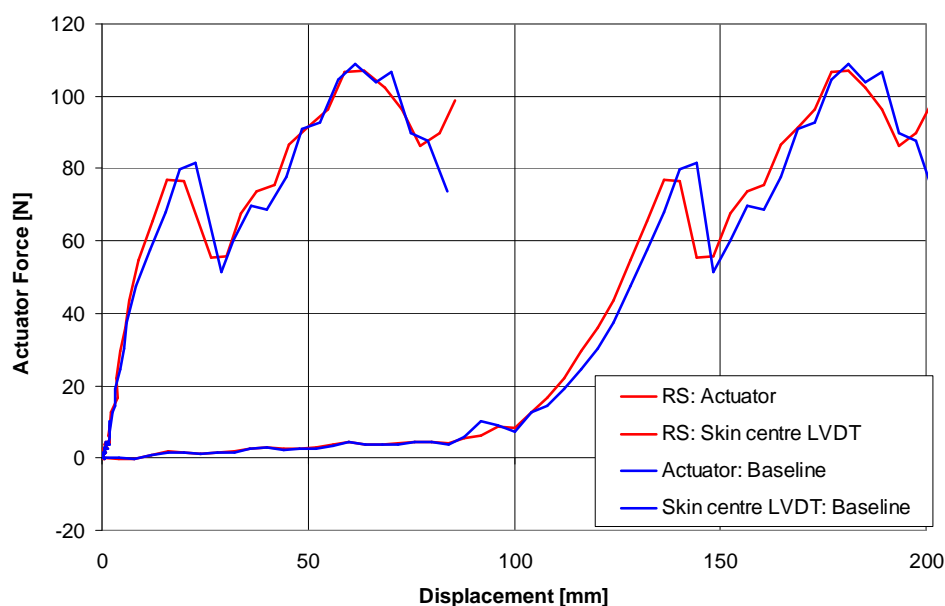
Figure 27. Load-displacement: Basic set-up and 5-Frm attachm.+ rotational stiffn. [Haase 2013]

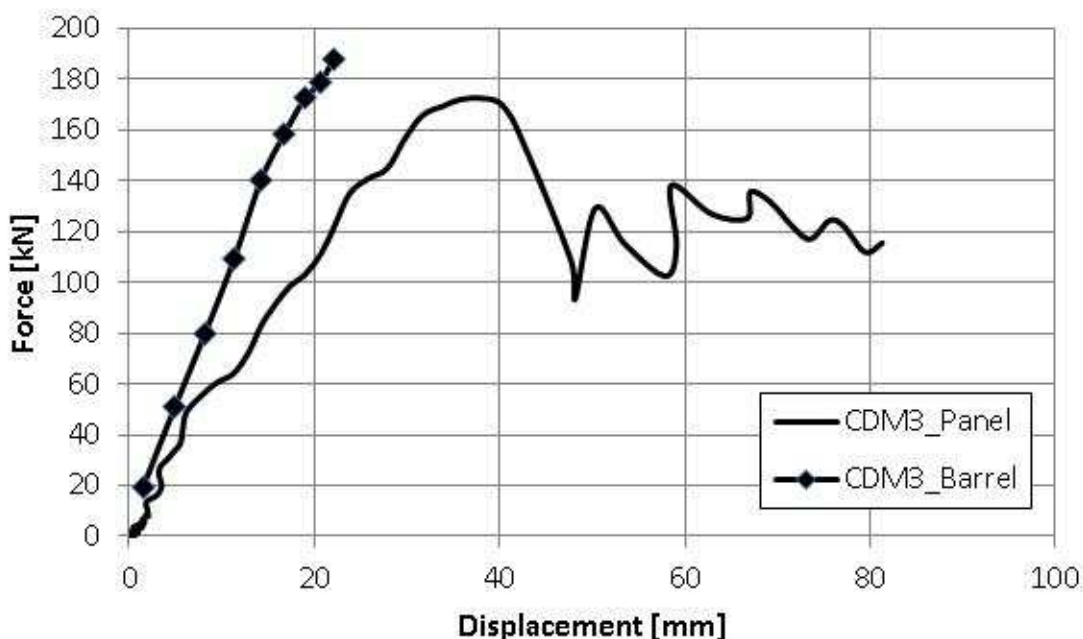
Figure 31. Load-displacement curve: panel vs. barrel in CODAMEIN III

The load-displacement curves from the baseline panel configuration (described in Section 3.2.2) and the barrel is depicted in Figure 31. It shows that the barrel is significantly stiffer than the panel. The panel boundary conditions need to be modified to more closely match the barrel stiffness. It is noted that the translational stiffness is determined not to change from CODAMEIN II test panel as it is important to limit some parameters in order to clarify the influence of the added rotational stiffness.

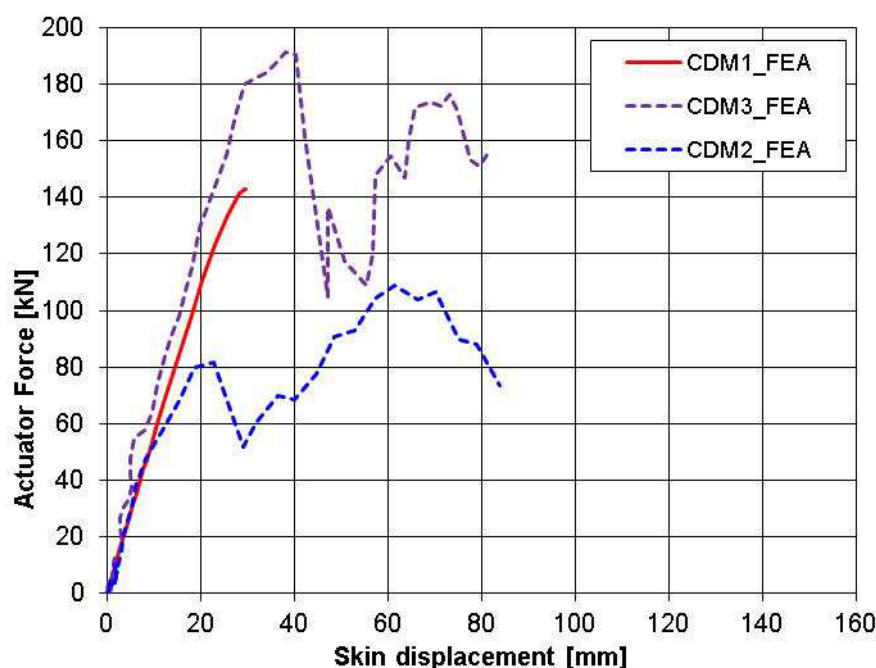
Figure 32. Load-displacement curve comparison: CODAMEIN I, CODAMEIN II, CODAMEIN III panels

Figure 32. The comparison of the predicted peak loads for each of three stages of CODAMEIN is reported in Table 5. As reported in CODAMEIN I documentation [Mikulik, Haase 2012], the accuracy of the FE models was limited to approximately 30 kN when the test panel's behaviour became non-linear due to damage growth since no failure criteria were implemented in the FE models. Nevertheless, the panels from three stages of CODAMEIN were able to predict a similar stiffness in the pre-damage phase. It can be observed that the first load drop of the CODAMEIN III panel was higher than that of CODAMEIN II panel, mainly due to the stronger shear tie design.

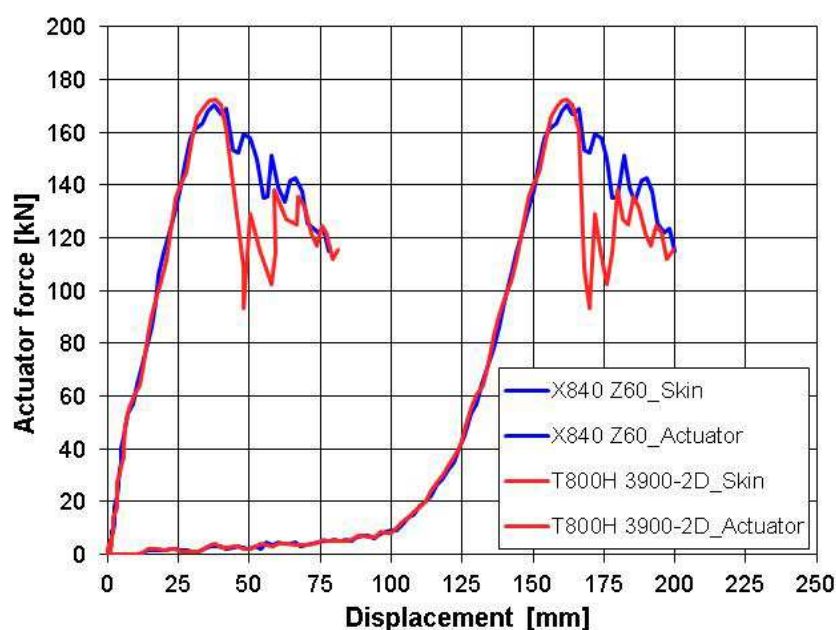
Figure 34. Load-displacement curve: different materials comparison

In the current study, the material properties were investigated in order to compare the material T800H-39002D PW and X840 Z60 PW on the new shear ties. The load-displacement curves are illustrated in Figure 34. In addition, the reasonable variations in the material properties (an increase of 5% in the elastic stiffness of shear tie, 10% in strength of the composite material, 25% damage progression of the composite material as reported in Table 2) were investigated to determine the effect of these variations and the load-displacement curves are depicted in Figure 35. The deviation of the peak load is most likely exaggerated since the FEA used a low output frequency and the two peak points lay on adjacent output points while the real peak points have less offset. The parameters of the test panel FE model that had the most significant influence on its response to the blunt impact loading, will be simulated in the later sensitivity study in section 3.4.2. Those parameters include mass scaling, strength of the adhesive surface, damage progression of the adhesive material, stiffness of the rubber bumper and impactor mass. As mentioned earlier, an increase of 5% in the elastic stiffness of shear tie, 10% in strength of the composite material, 25% damage progression of the composite material is introduced to the models presented in Figure 34 and Figure 35.

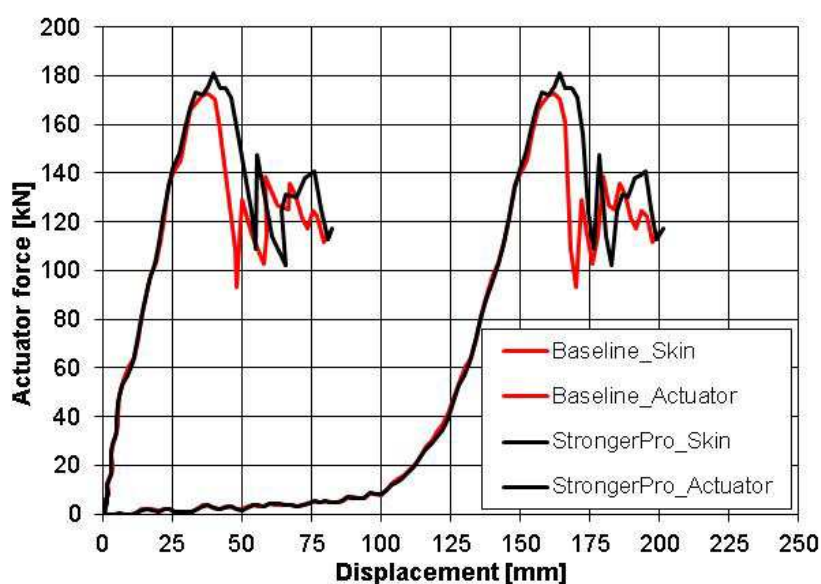
Figure 35. Load-displacement curve: baseline and stronger material comparison

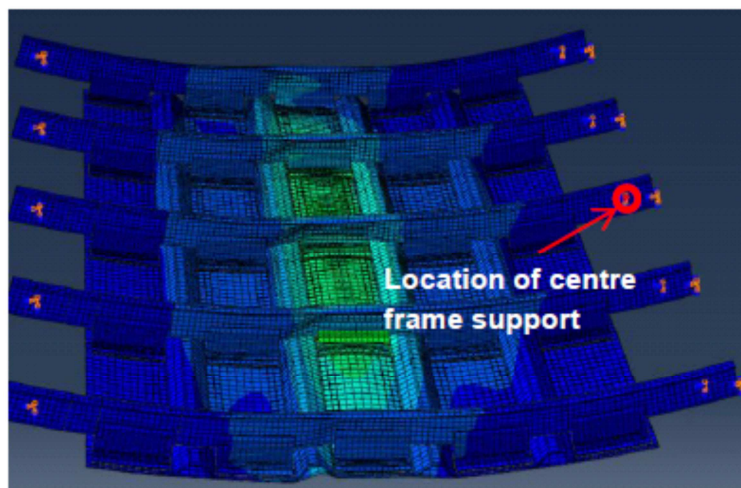
Figure 36. Reference frame in the panel

UCSD had performed an iterative process to determine the appropriate value of boundary stiffness such that boundary displacements and frame rotation are equivalent. The same procedure should have also been followed to match the hoop-direction and rotation displacement between the panel and the full barrel. As UCSD stated, doing so would achieve equivalence, thereby making results measured from the panel applicable to the full barrel. The displacements and rotations will be taken from the centre frame (Fr 3.) of the panel (see Figure 36) and the centre frame of the impact region of the full barrel.

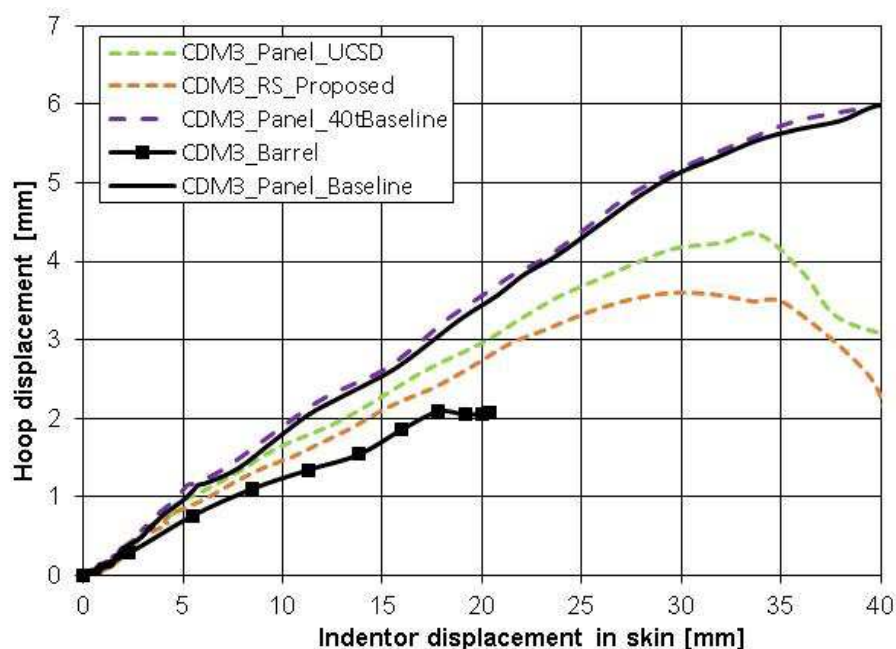
Figure 37. Hoop displacement for different rotation stiffness of panel and full barrel model

Figure 37 and Figure 38 display the predicted frame hoop displacement and rotation with respect to skin displacement caused by the impactor, for different values of rotational stiffness. It can be observed that the panel, in the case of lower rotational stiffness, exhibits much larger hoop displacement at the higher indenter displacement than the full barrel. This is because of the low in-plane displacement constraint at the boundaries result in the bending moment distribution across the span of the panel which is different from the full barrel model. However, the higher rotational stiffness matches rotation angle better than the barrel model. In this case, a proper representation of the boundary stiffness values plays an important role in obtaining equivalence.

From Figure 37, the hoop displacements with UCSD value also correlates better than the others compared to the full barrel model. It should be noted the indentation on the skin is shown up to 40 mm but the stiffness mentioned is determined by the data collected from only the initial linear deformation range. As shown in Figure 38, it can be seen that the UCSD rotational stiffness (5000 N-mm/radian) and 2.0×10^5 N-mm/radian (40 times baseline value as a trial value) yields rotation displacements that match closely with the full barrel model. The rotation at the centre frame predicted in the panel with the increased rotational stiffness value correlated well with the barrel.

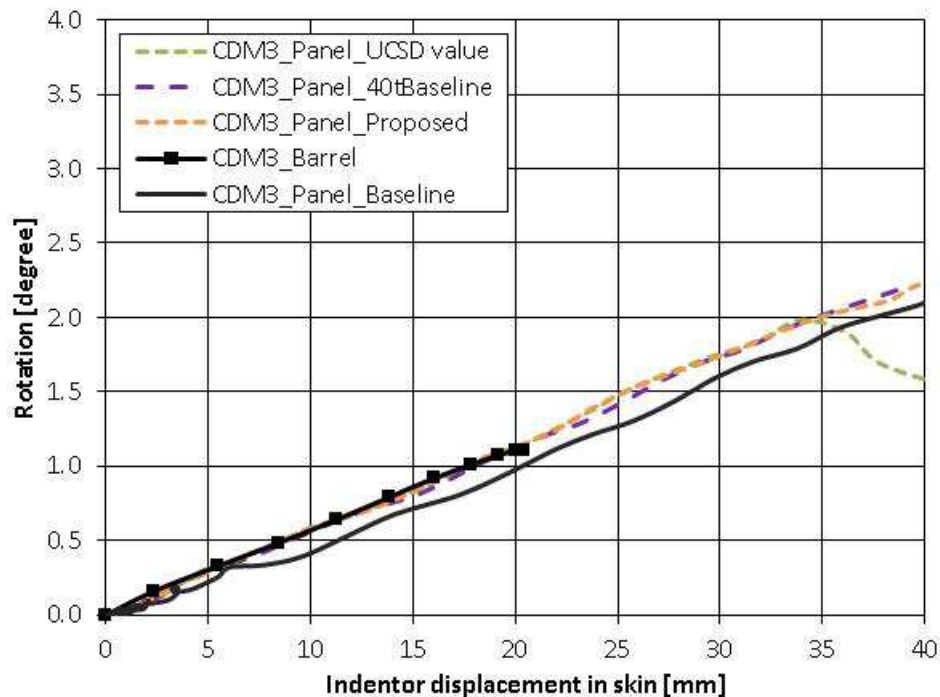
Figure 38. Rotation at the support location of panel and full barrel model

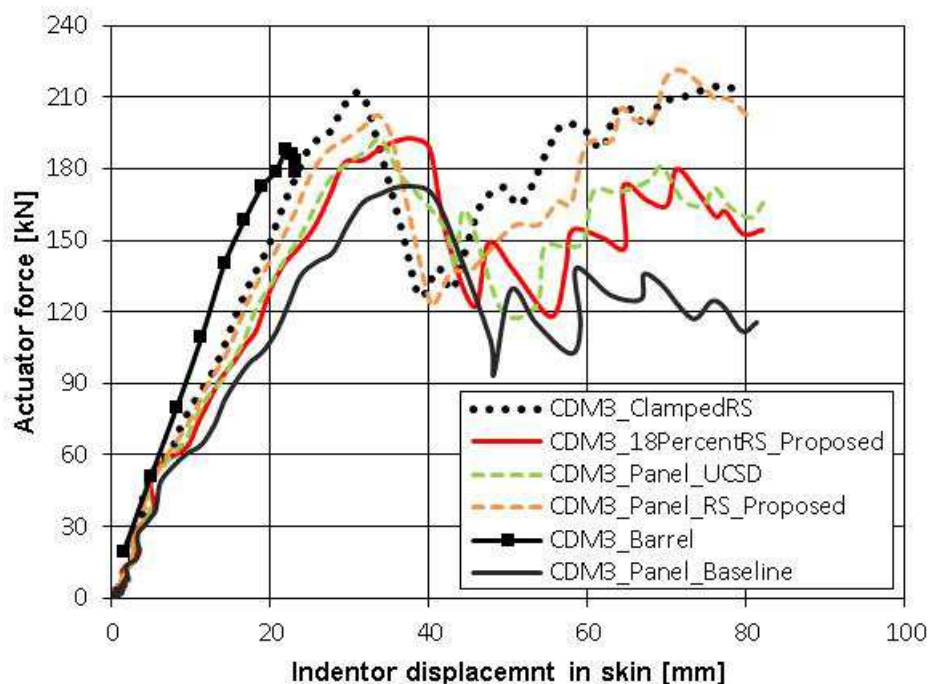
Figure 39. Load-shortening curve comparison

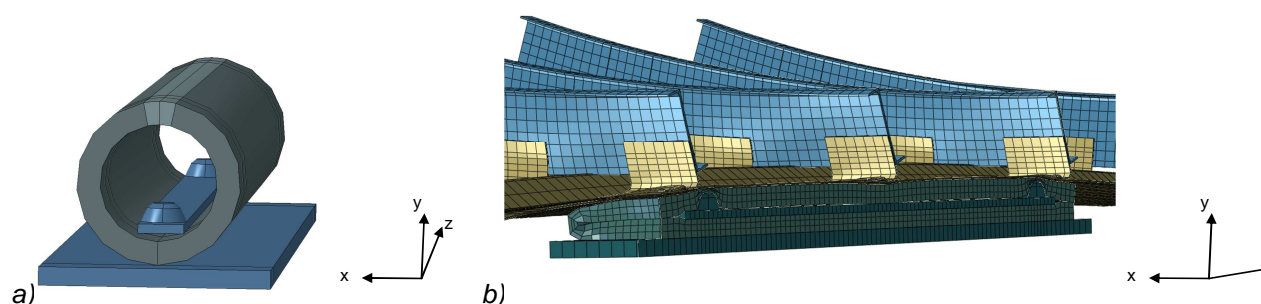
Figure 41. Rubber bumper assembly: a) geometry; b) cut view of the meshed deformed state [Haase 2013]

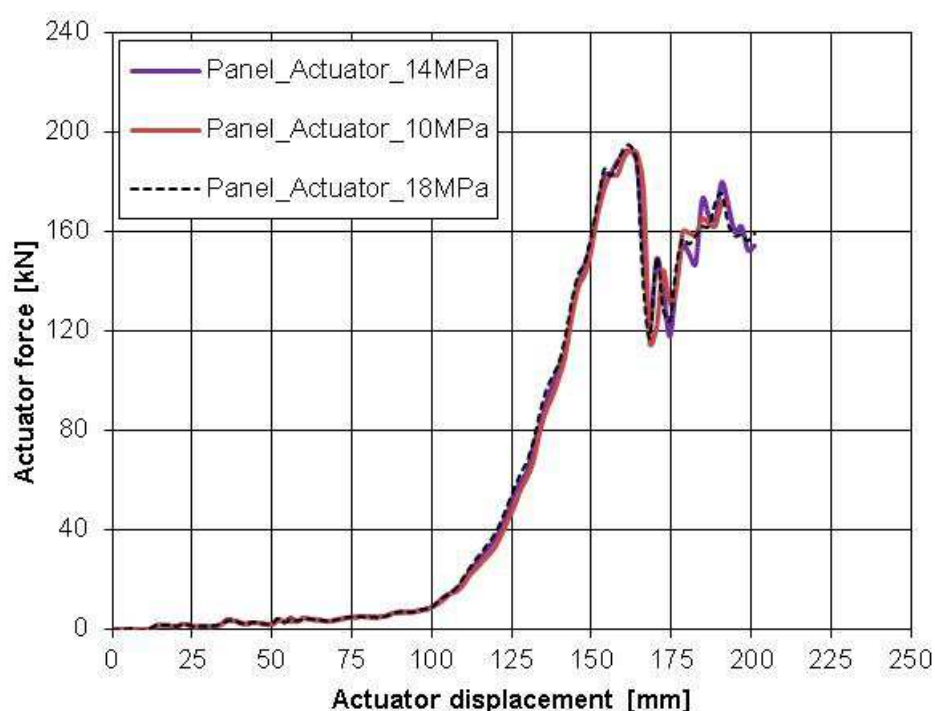
Figure 42. Rubber bumper material properties investigation

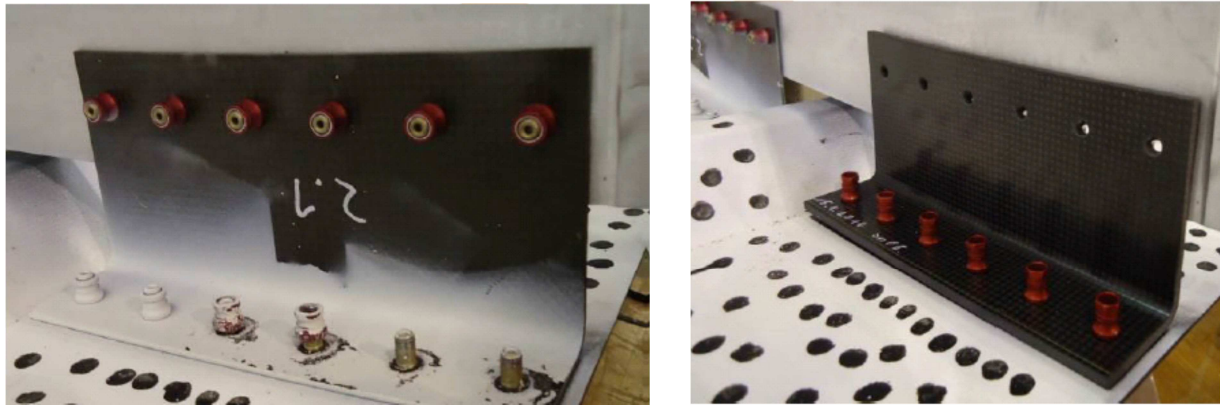
Figure 44. Shear tie replacements [Hernandez 2014]

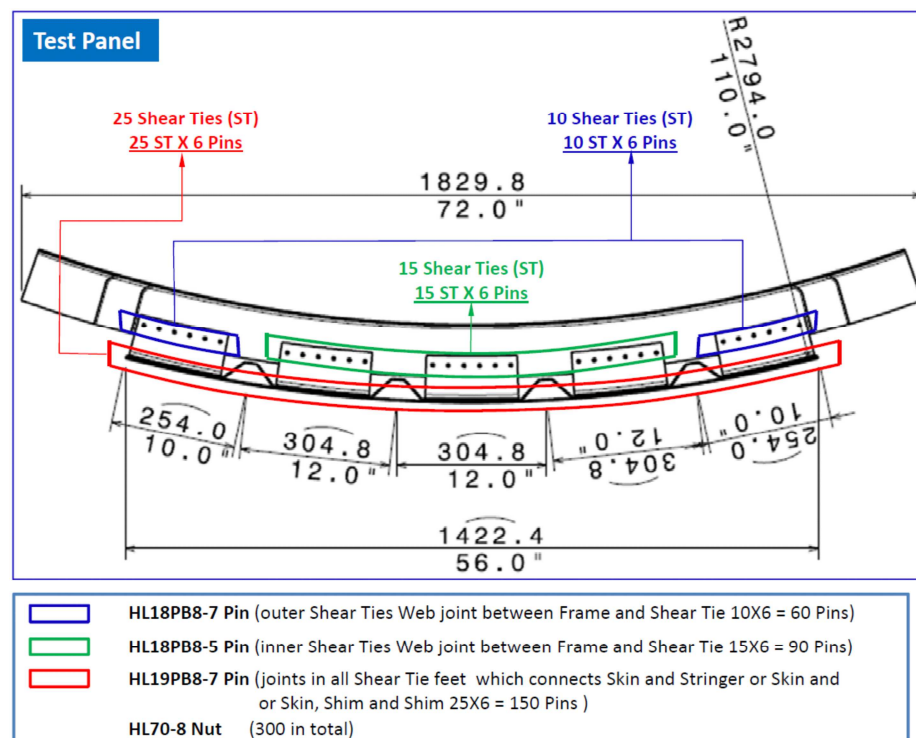
Figure 45. Pins used in shear tie replacements

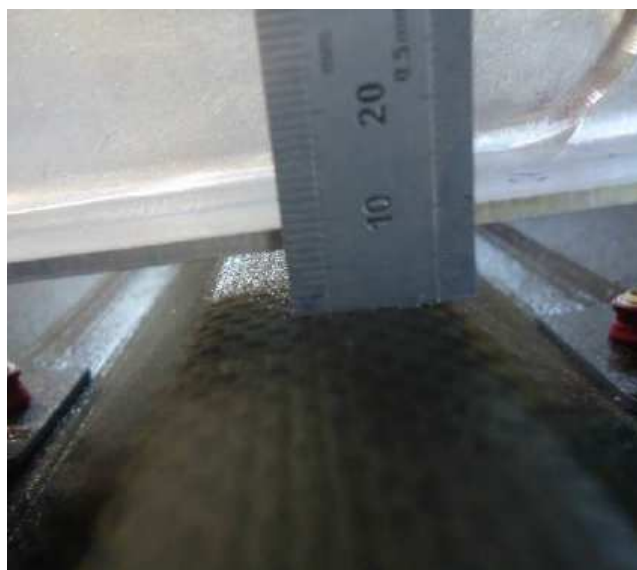
Figure 46. Distance between the stringer and frame

mm Hi-Lok HL18 PB8-5 alloy countersunk fasteners. A gap of 7 mm existed between the stringer and frames, as depicted in Figure 46.

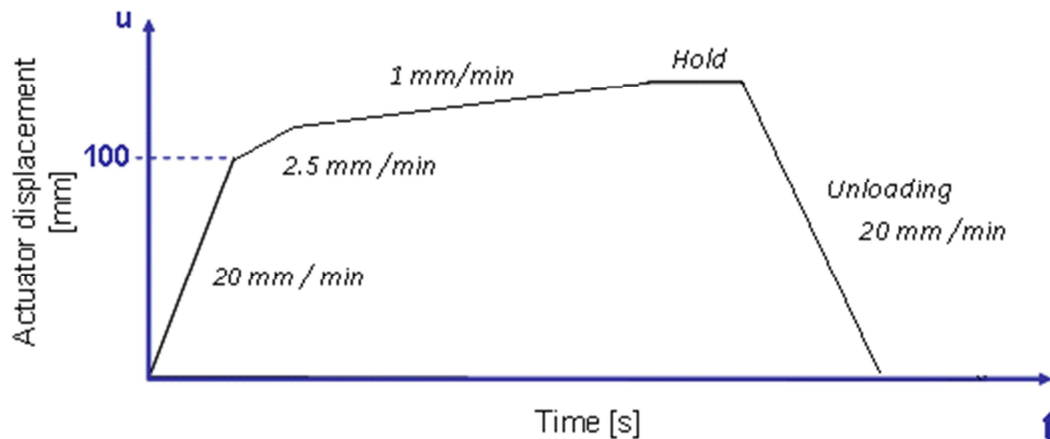
Figure 52. Loading scheme

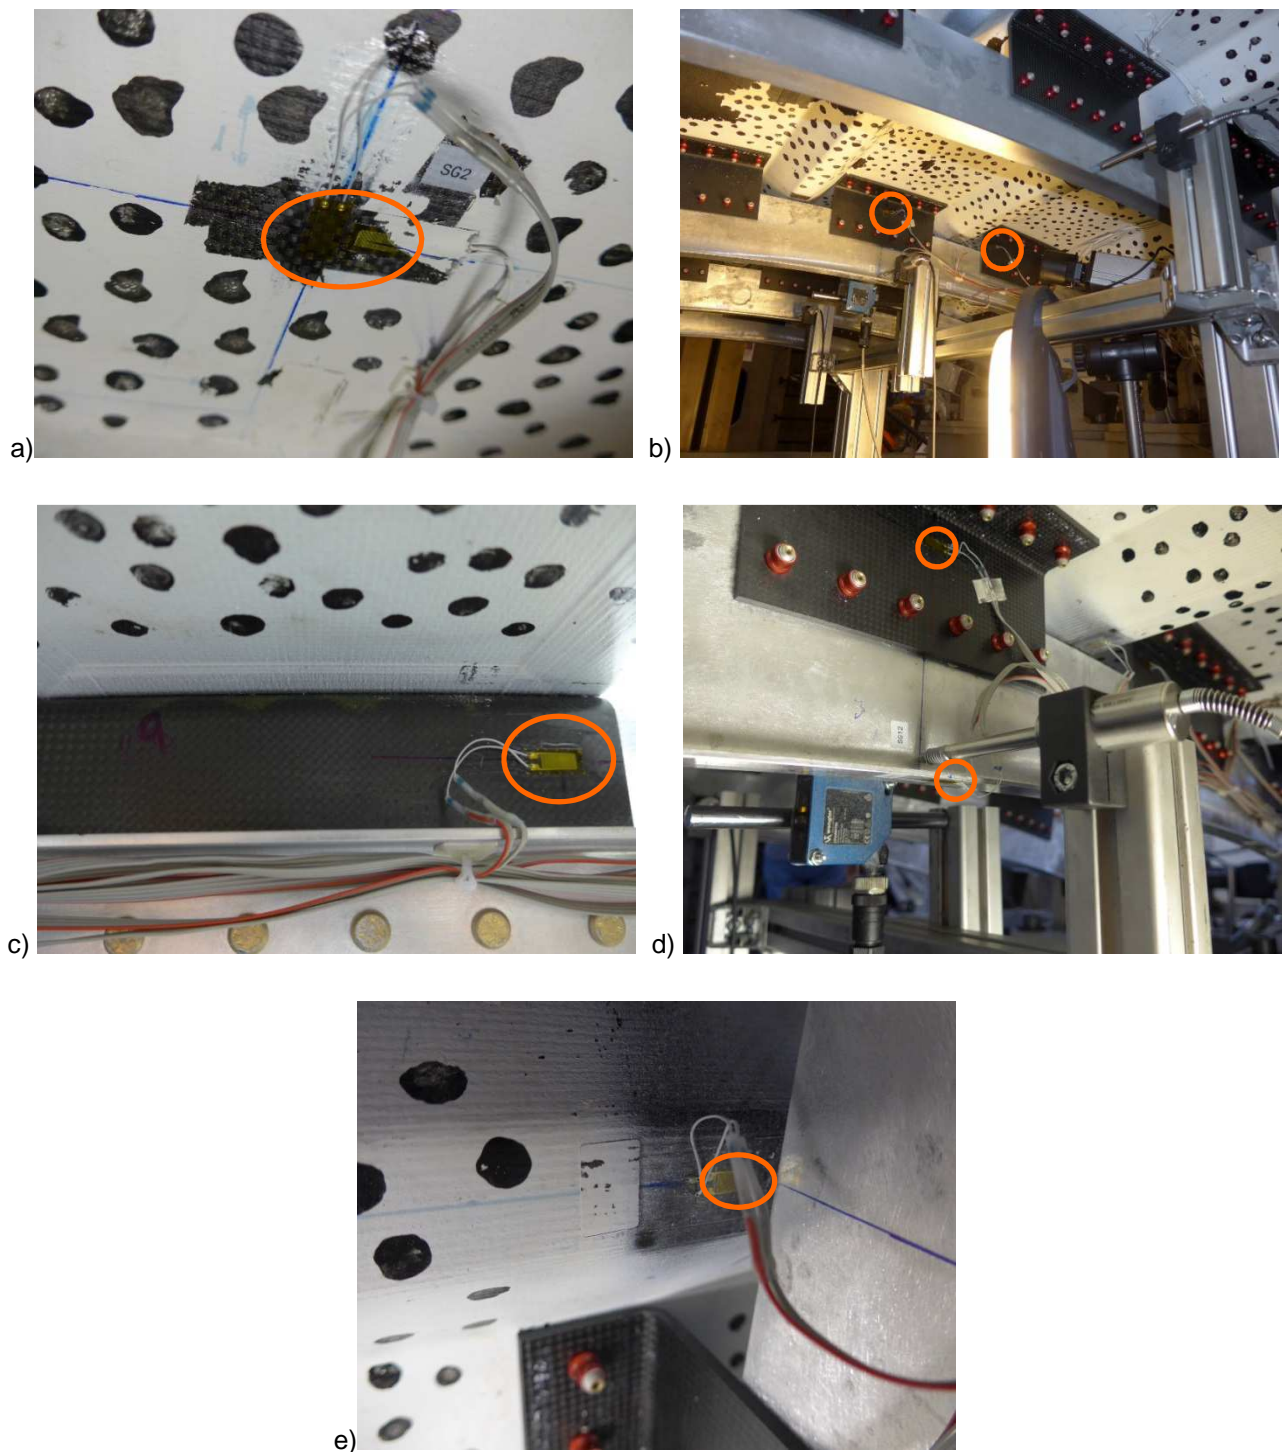
Figure 57. Strain Gauge positions on the panel: a) Strain gauge 1,2; b) Strain gauge 27,29;c) Strain gauge 28;d) Strain gauge 13, 14; e) Strain gauge 9 on the stringer foot.

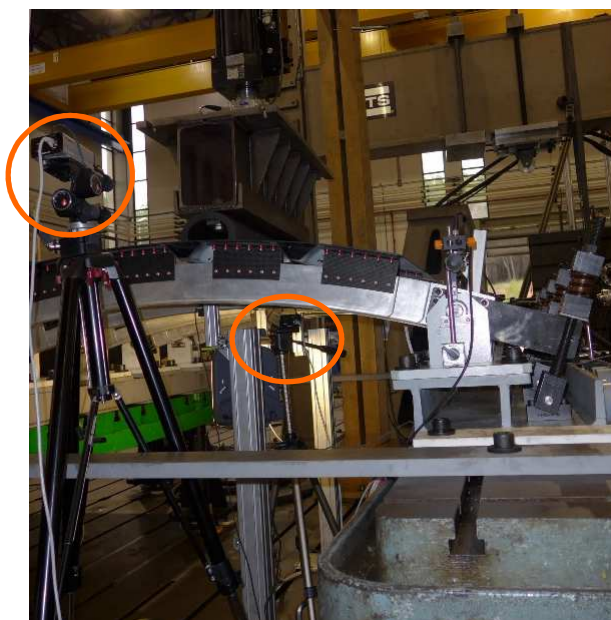
Figure 58. Video cameras location
