EASA
European Aviation Safety Agency

Final Report EASA_REP_RESEA_2013_3

CODAMEIN III

**Composite Damage Metrics and Inspection
(high energy blunt impact) – 3rd phase**

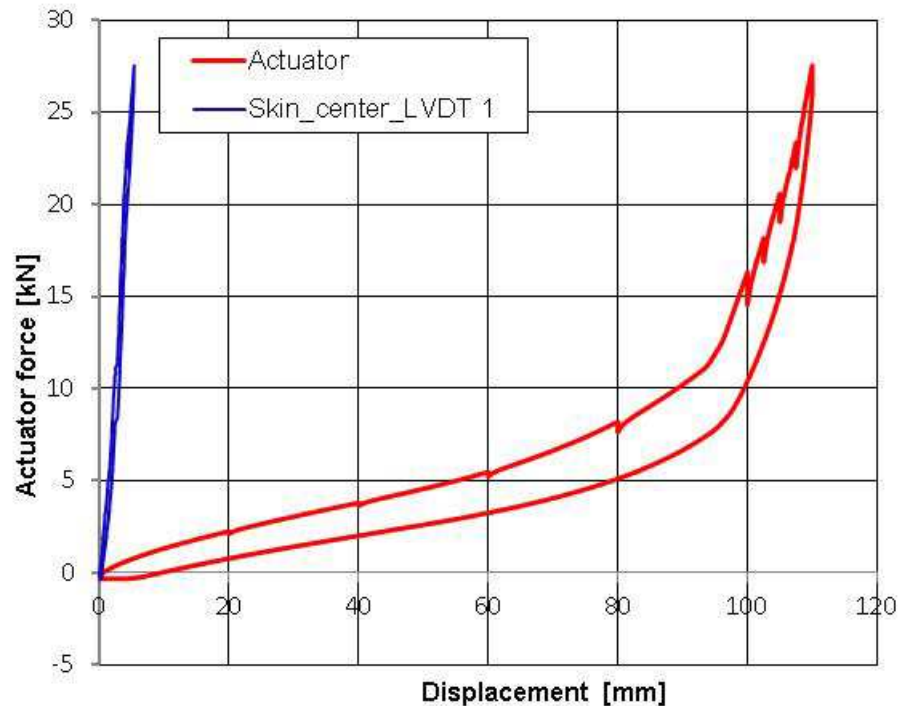
Figure 59. Load-displacement curve: skin & actuator displacement vs. actuator force (LC1)

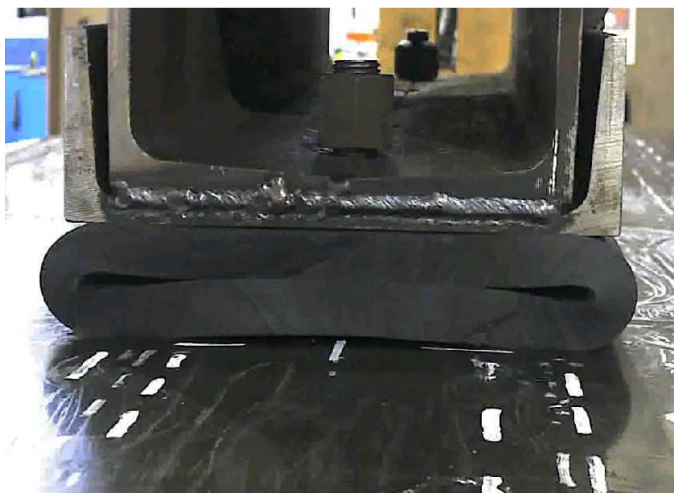
Figure 62. Bumper in contact with panel at 2nd load cycle max. load

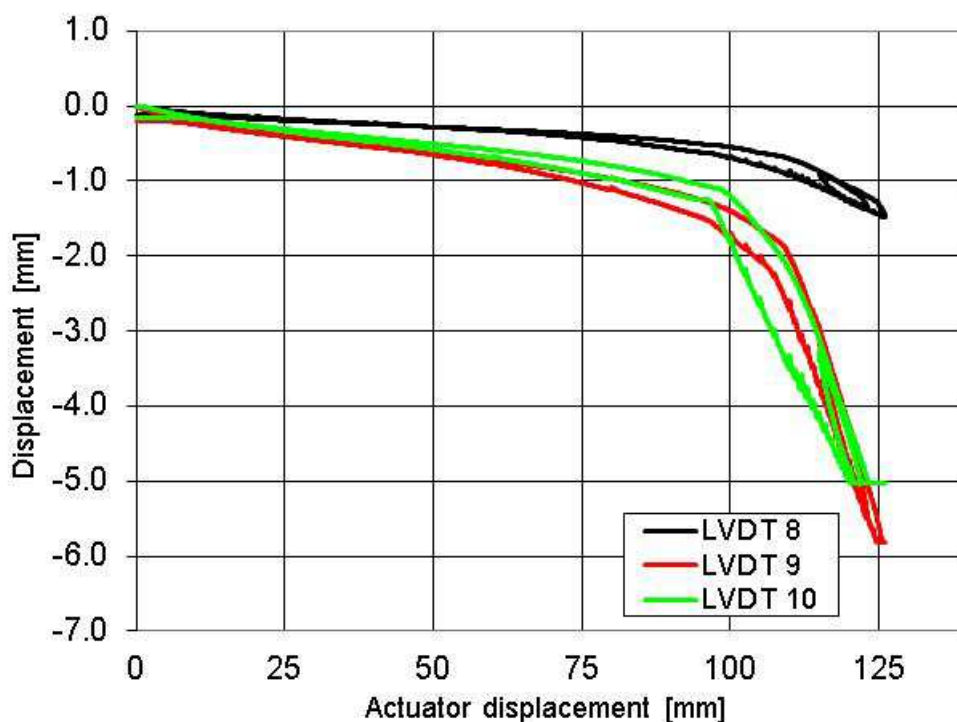
Figure 63. Displacement of LVDTs 8, 9, 10 vs. actuator displacement

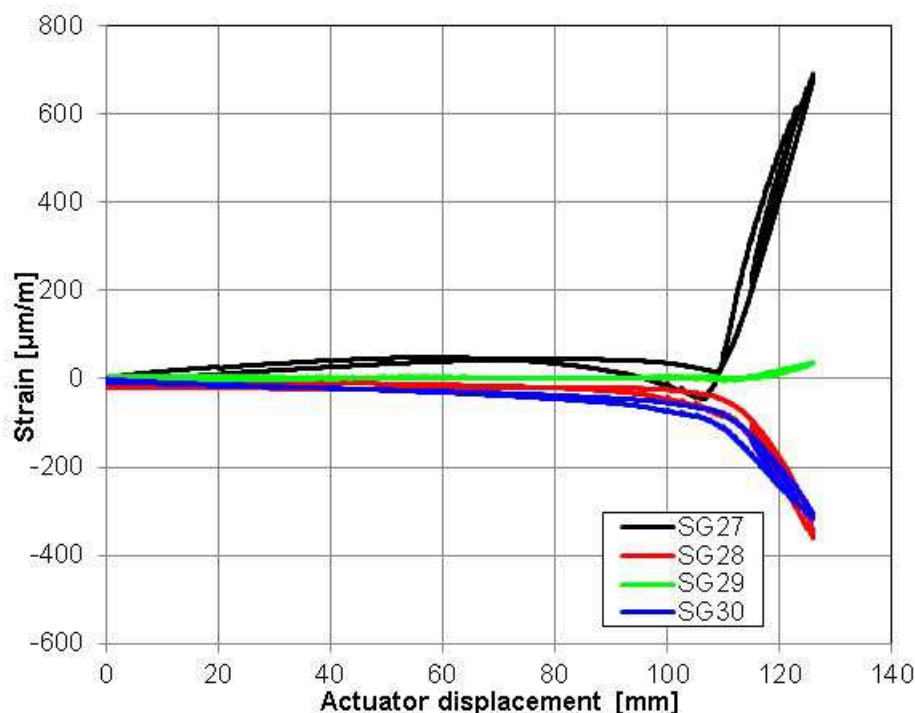
Figure 64. Shear tie strain gauges: strain vs. actuator displacement (LC2)

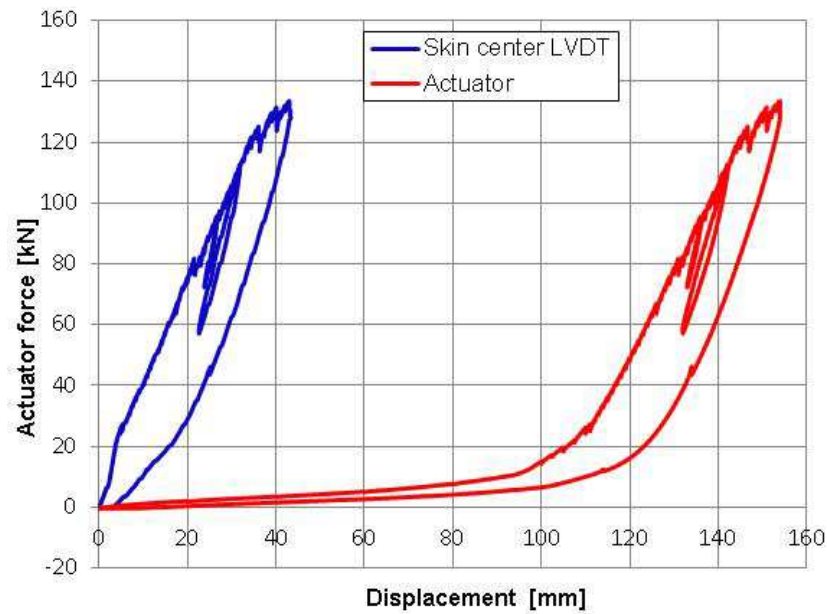
Figure 65. Load-displacement curve: skin & actuator displacement vs. actuator force (LC3)

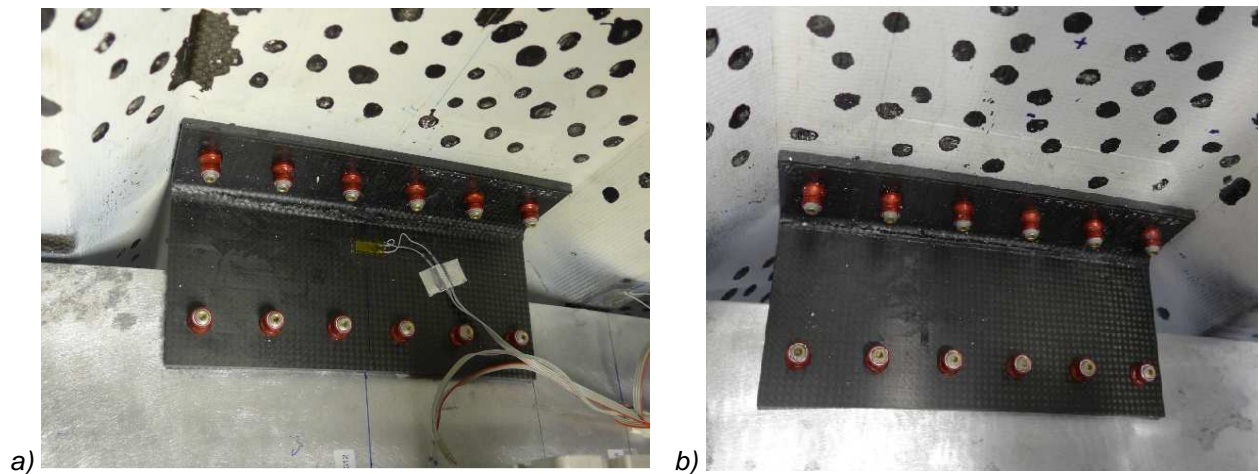
Figure 66. Shear tie damages after the third load cycle: a) shear tie 3.3; b) shear tie 2.3

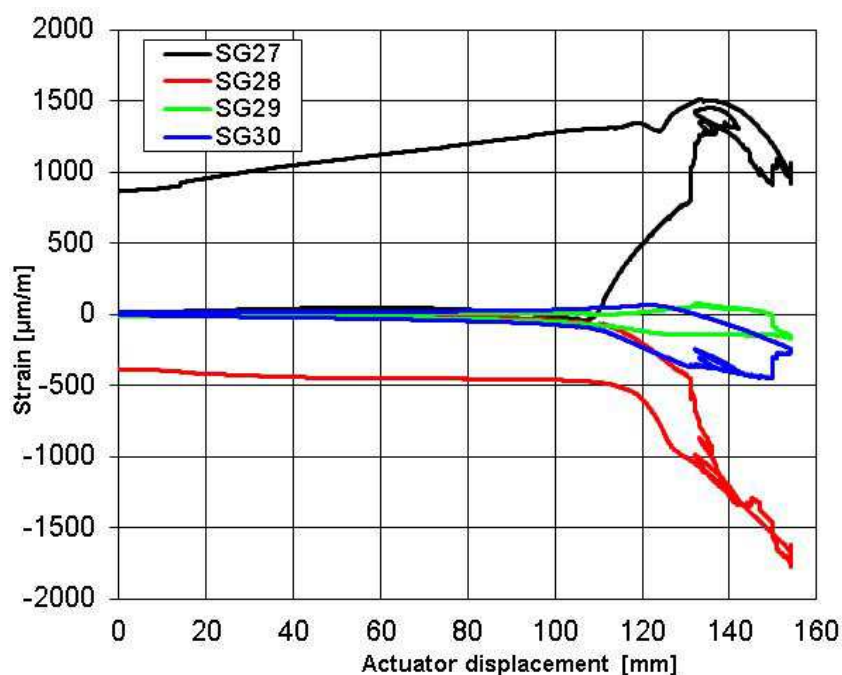
Figure 67. Shear tie strain gauges: strain vs. actuator displacement

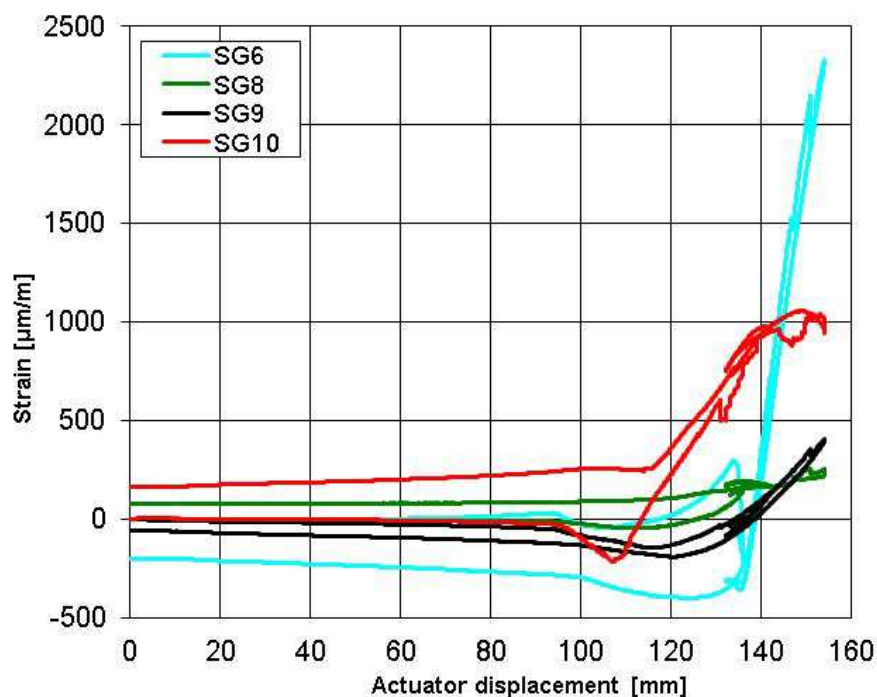
Figure 68. Skin & stringer axial strain gauges: strain vs. actuator displacement

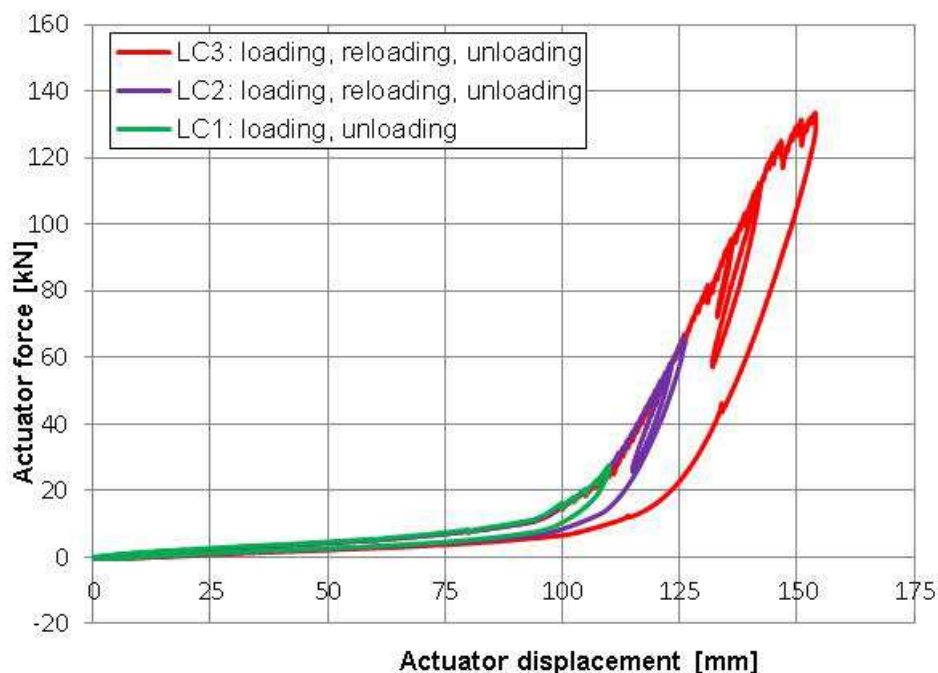
Figure 74. Force comparison vs. actuator displacement: three load cycles

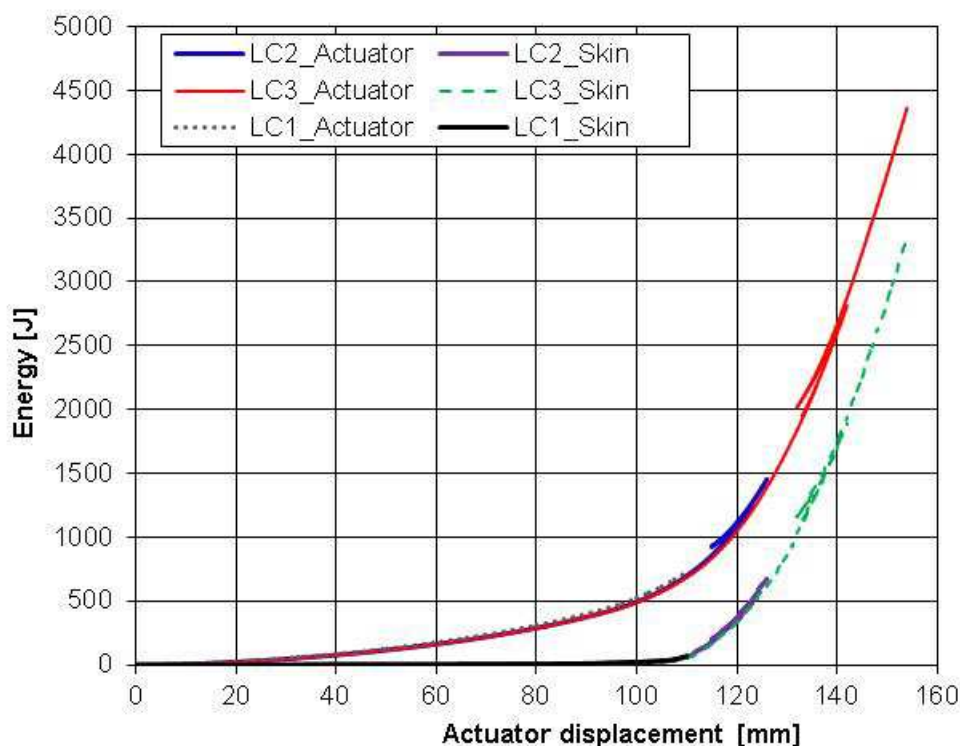
Figure 75. Energy levels in three load cycles

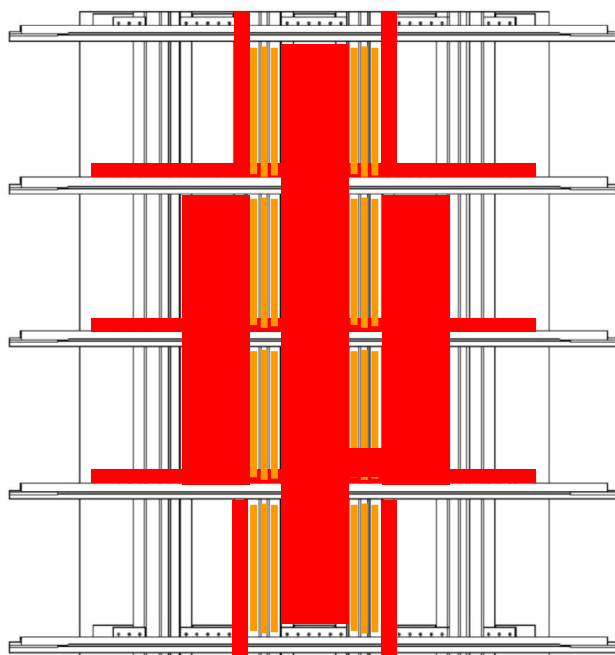
Figure 76. A-Scan inspection pattern

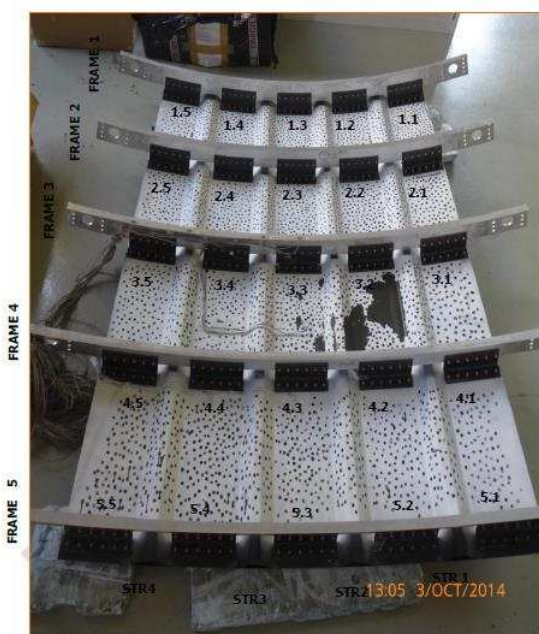
Figure 77. Panel inside and shear tie numbering [Bergo Soto 2014]

The frames and shear ties were numbered, as illustrated in Figure 77.

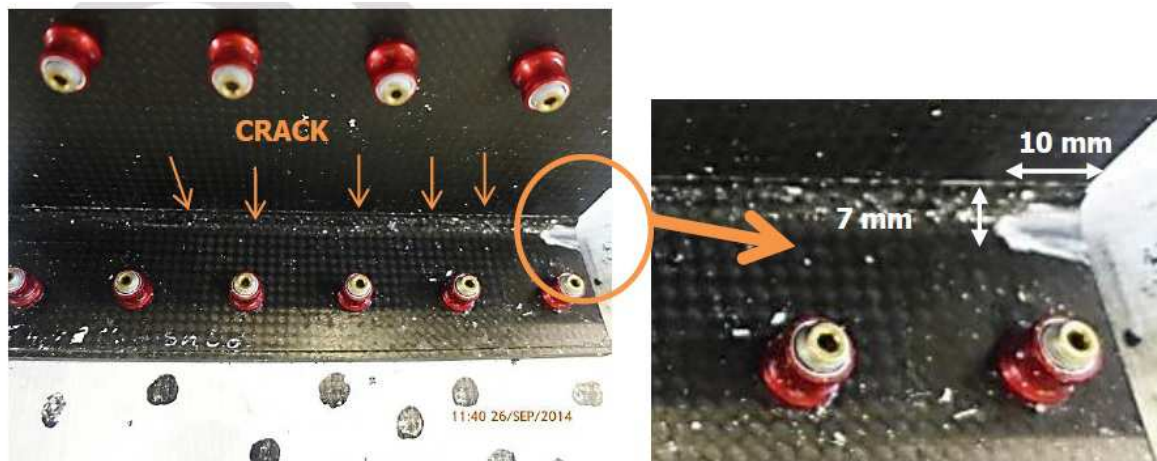
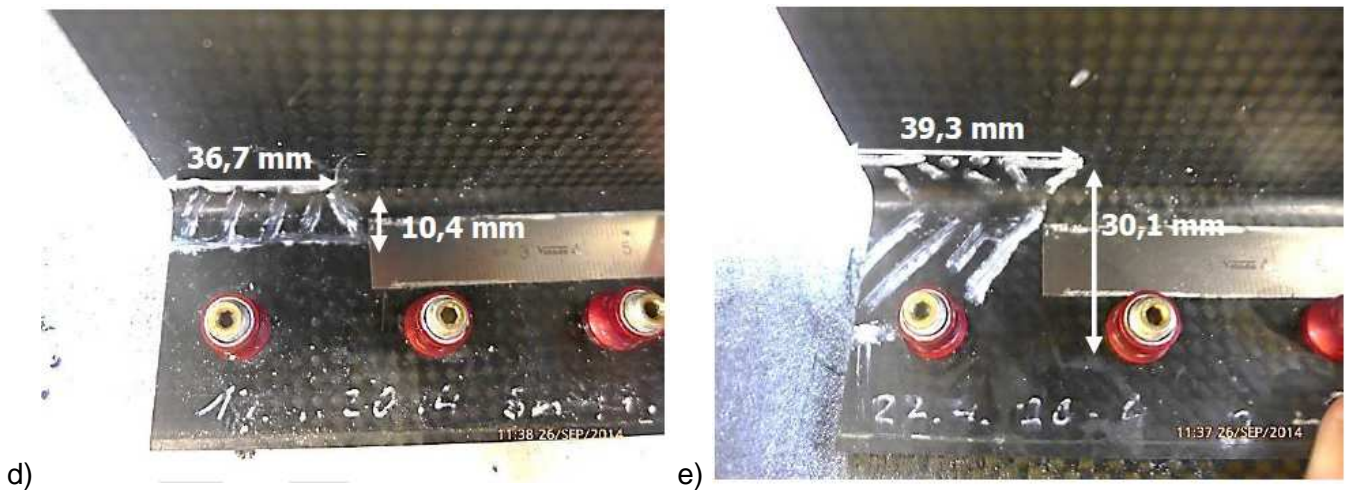
Figure 78. Damages detected in shear ties: a) shear tie 2.3; b) shear tie 3.3; c) shear tie 4.3; d) shear tie 4.2; e) shear tie 5.2 [Bergo Soto 2014]

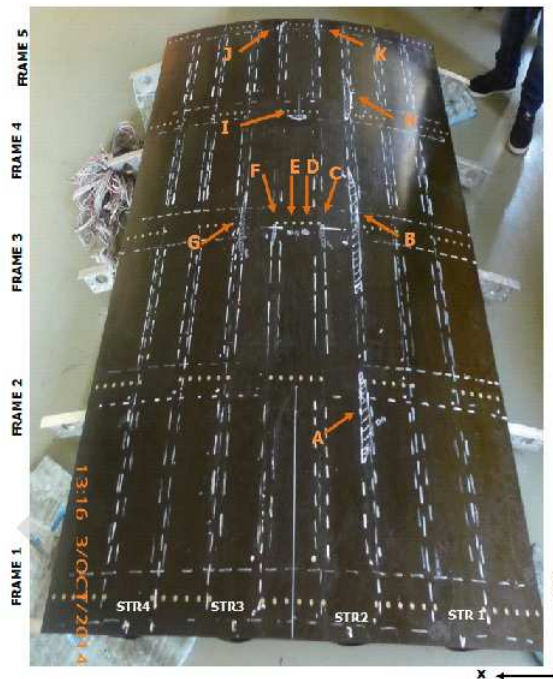
Figure 79. Locations of the delaminations after inspection [Bergo Soto 2014]

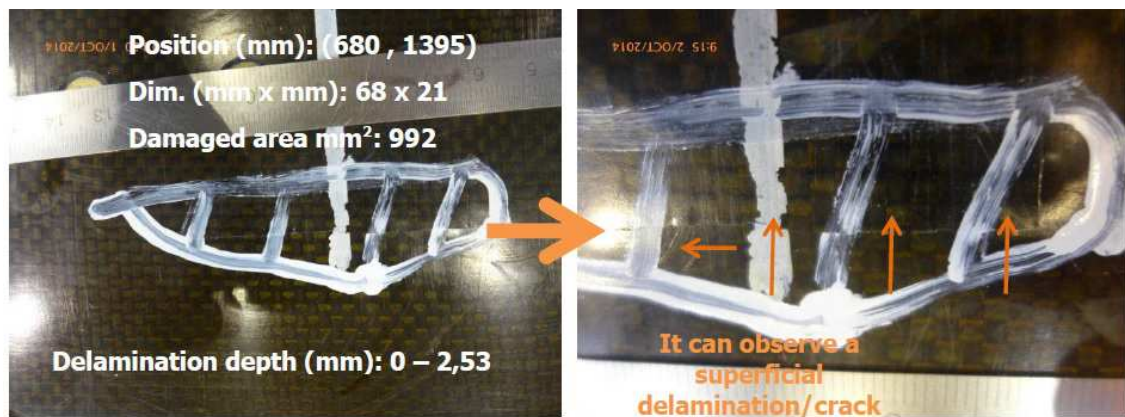
Figure 82. Characterization of delamination: Damage I [Bergo Soto 2014]

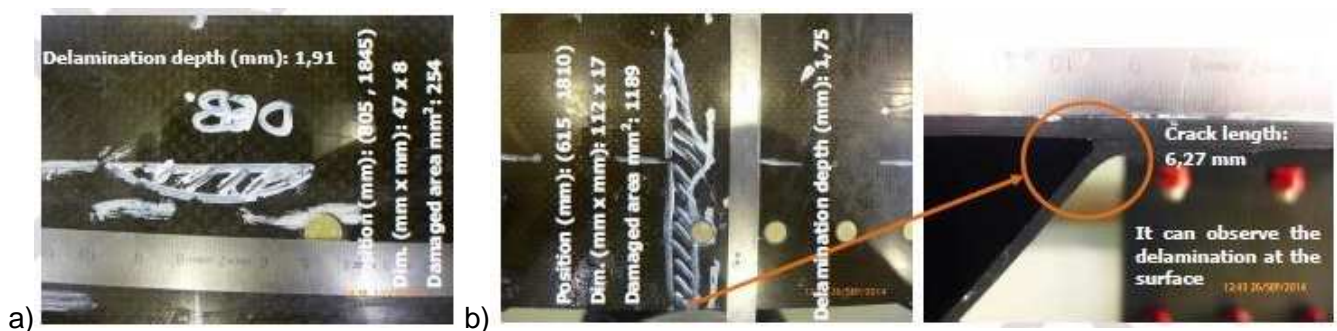
Figure 83. Characterization of delamination: a) Damage J; b) Damage K [Bergo Soto 2014]

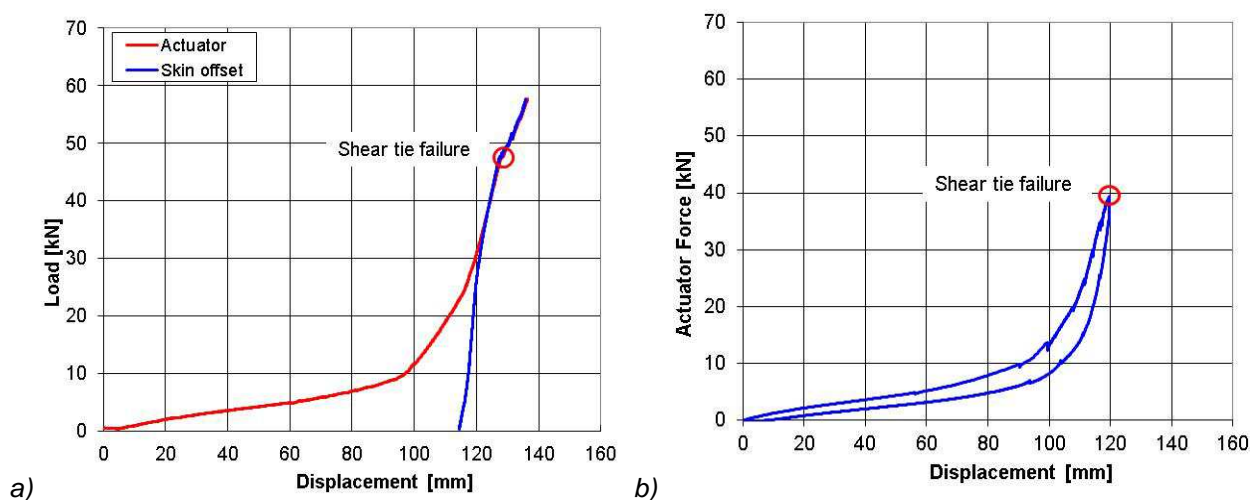
Figure 85. Shear tie failures: a) CODAMEIN I 2nd load cycle; b) CODAMEIN II 1st load cycle

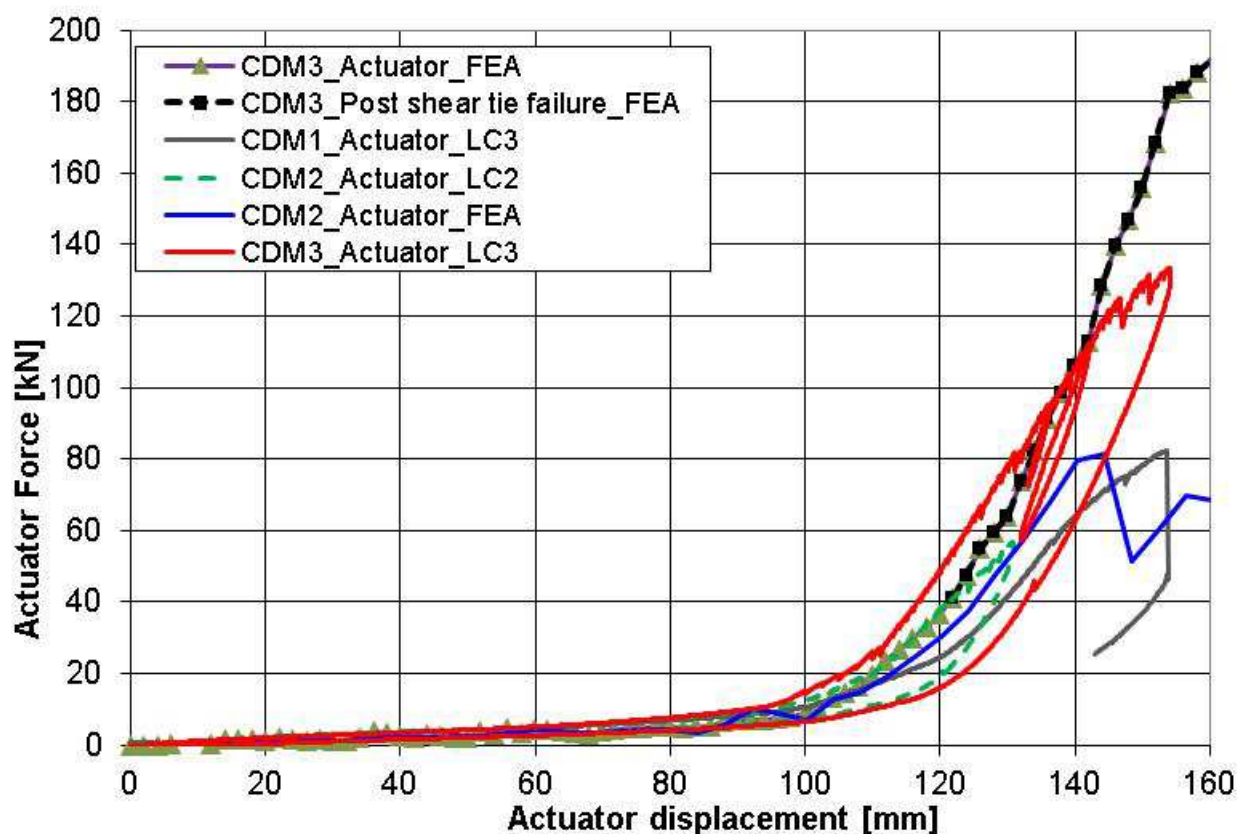
Figure 86. Load-Displacement curves comparison of tests and FE predictions: CODAMEIN I, CODAMEIN II and CODAMEIN III

FE Prediction	Test
Shear tie failure initiation	122 mm	131 mm
Large frame rotation	154 mm	154 mm (test stop)

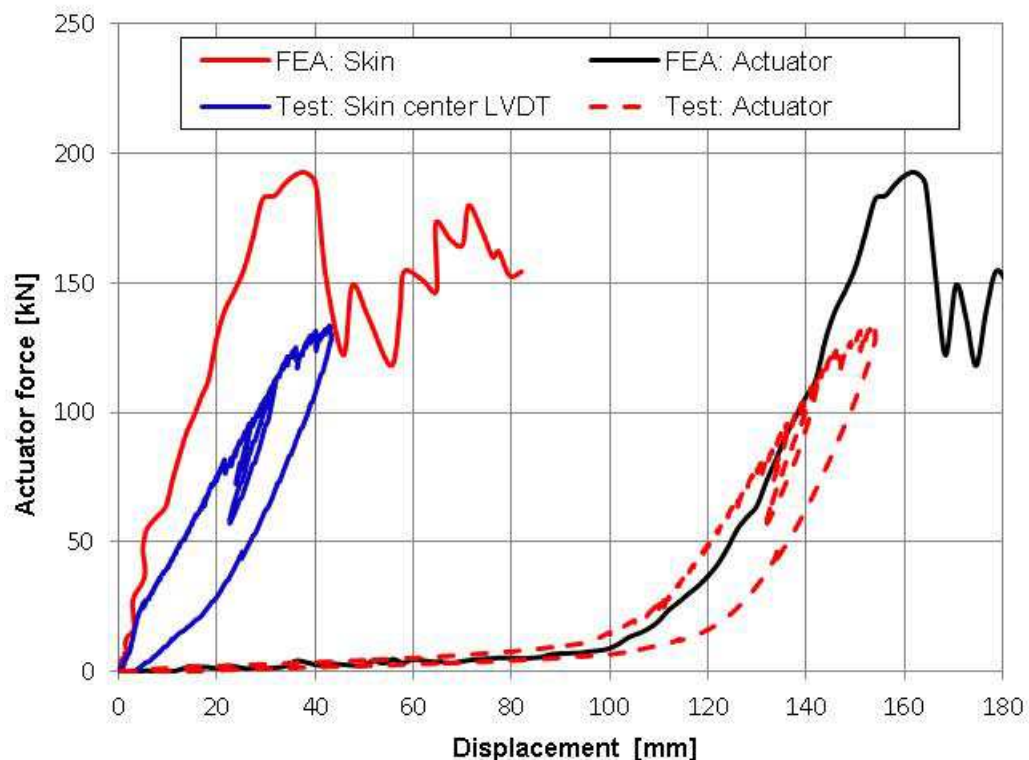
Figure 87. Load-Displacement curves comparison: skin and actuator displacement from tests and FE prediction

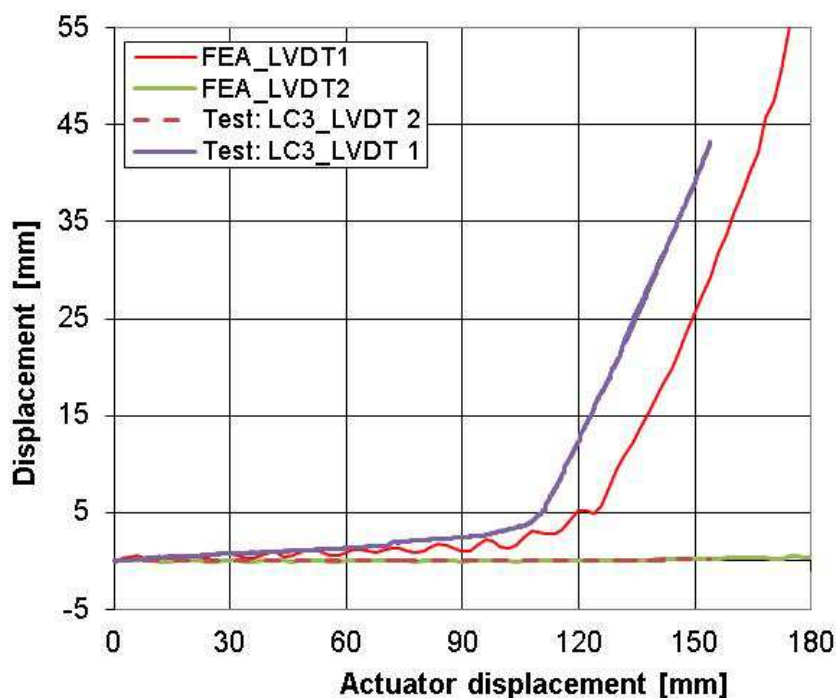
Figure 88. Test and FEA: Displacements of LVDTs 1 and 2

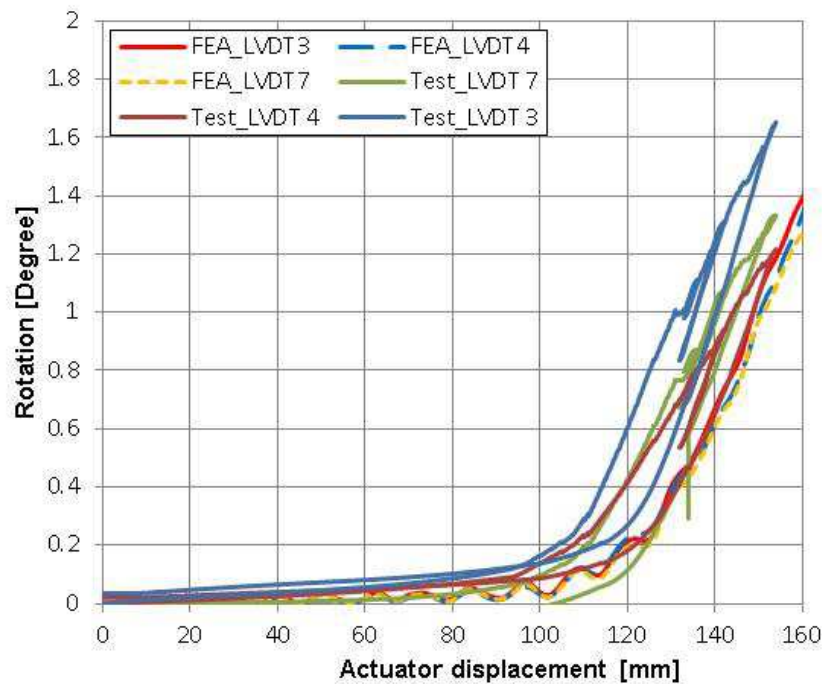
Figure 89. Test and FEA: Rotation of LVDTs 3,4,7

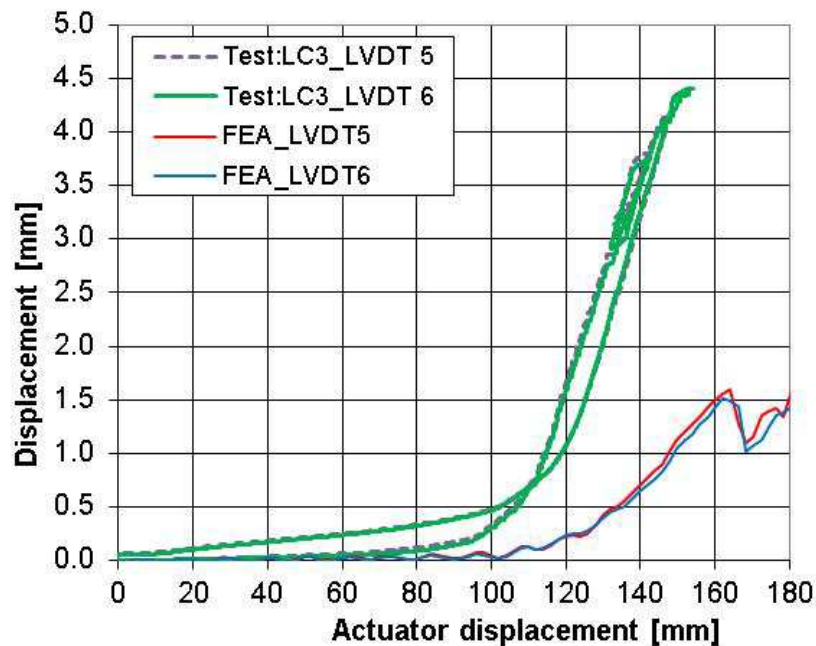
Figure 91. Test and FEA: Compression of LVDTs 5 and 6

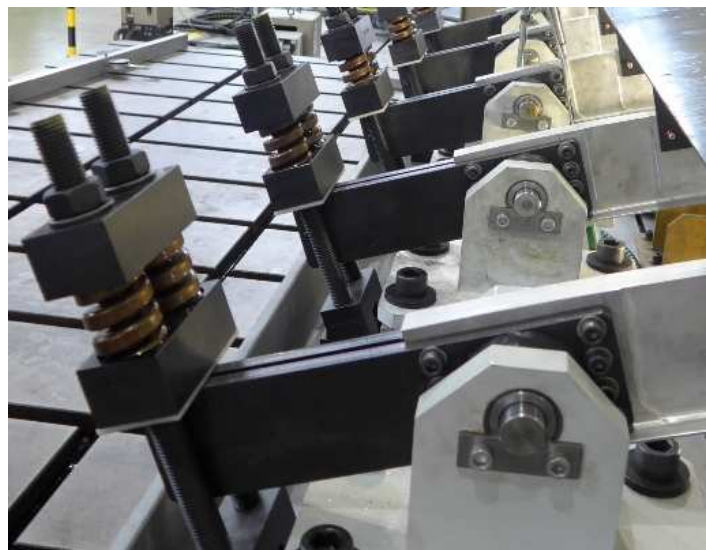
Figure 92. Test fixture: mass influence and friction

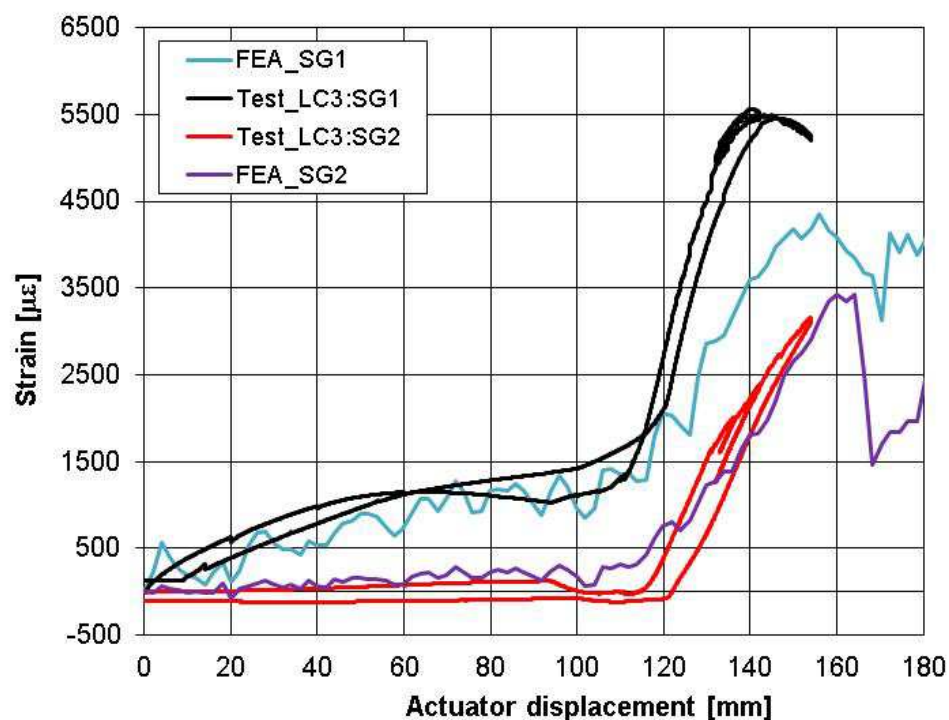
Figure 93. Test and FEA: Strain gauges 1 and 2

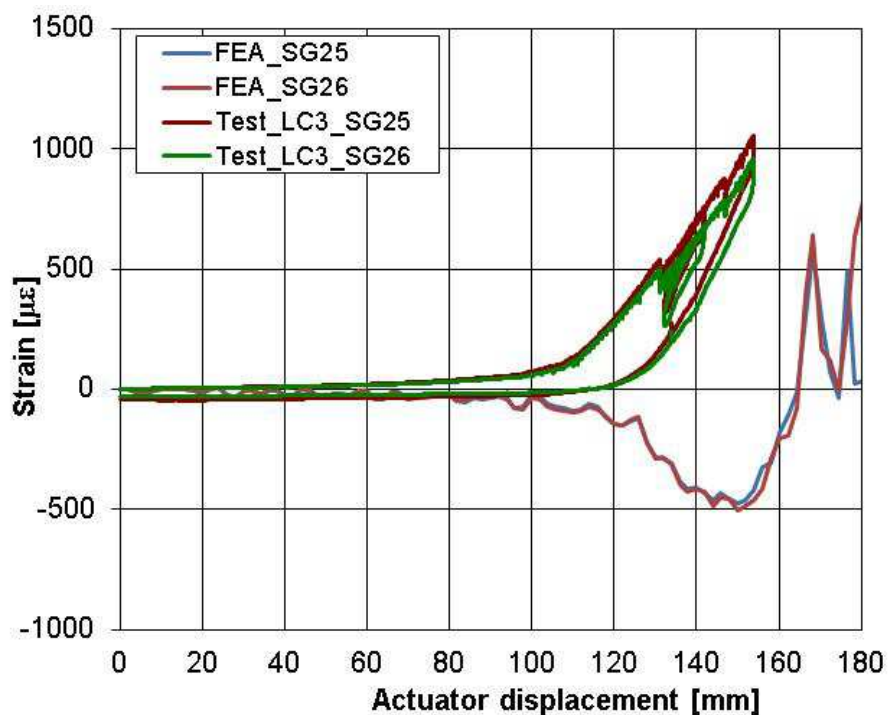
Figure 107. Test and FEA: Strain gauges 25 and 26

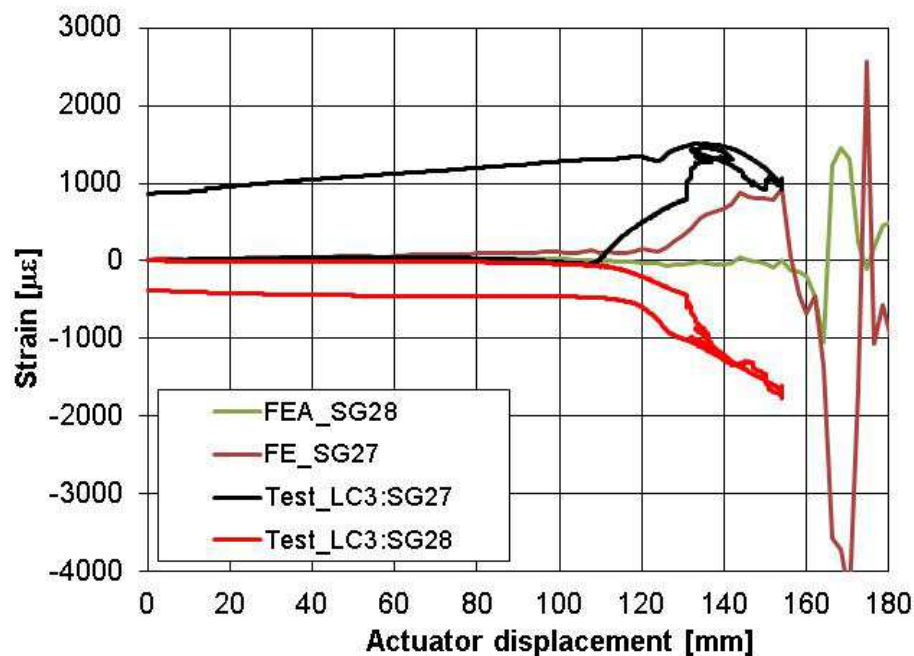
Figure 108. Test and FEA: Strain gauges 27 and 28

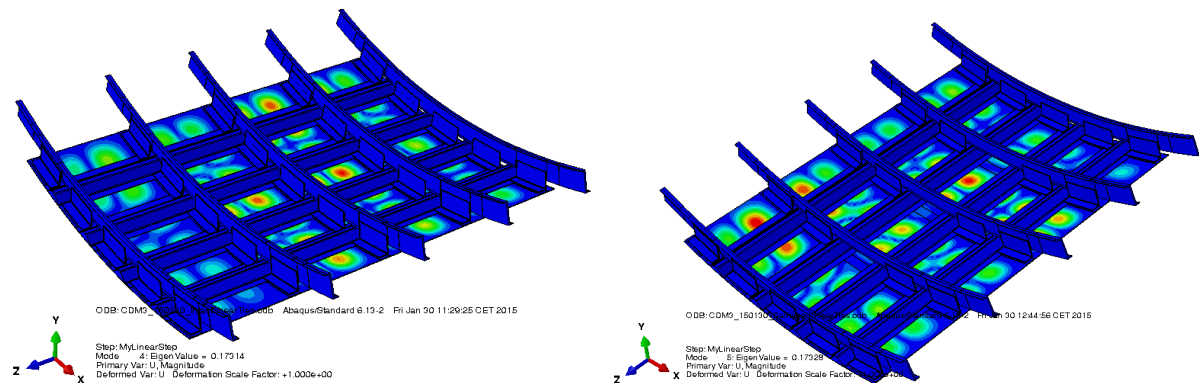
Figure 110. Buckling mode shapes in the skin-inner surface: undamaged model (left); damaged model (right).

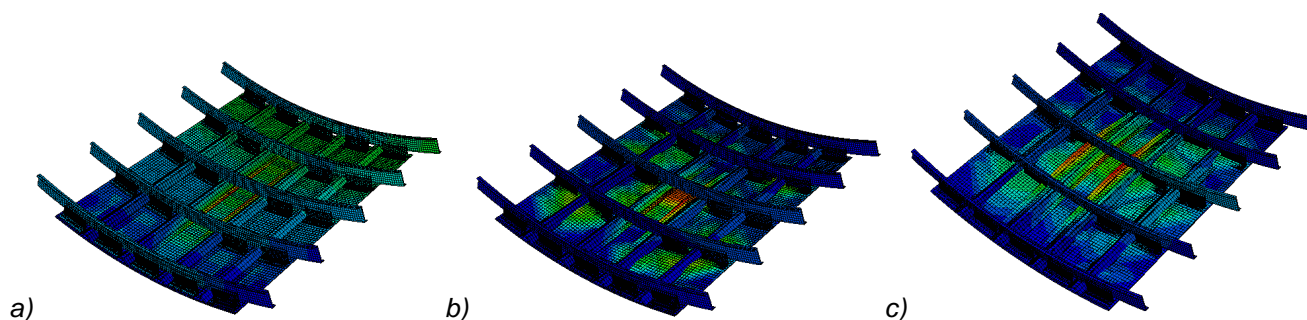
Figure 112. Deflections of the panel at different load levels: a) 88 kN; b) 125 kN; c) 292 kN

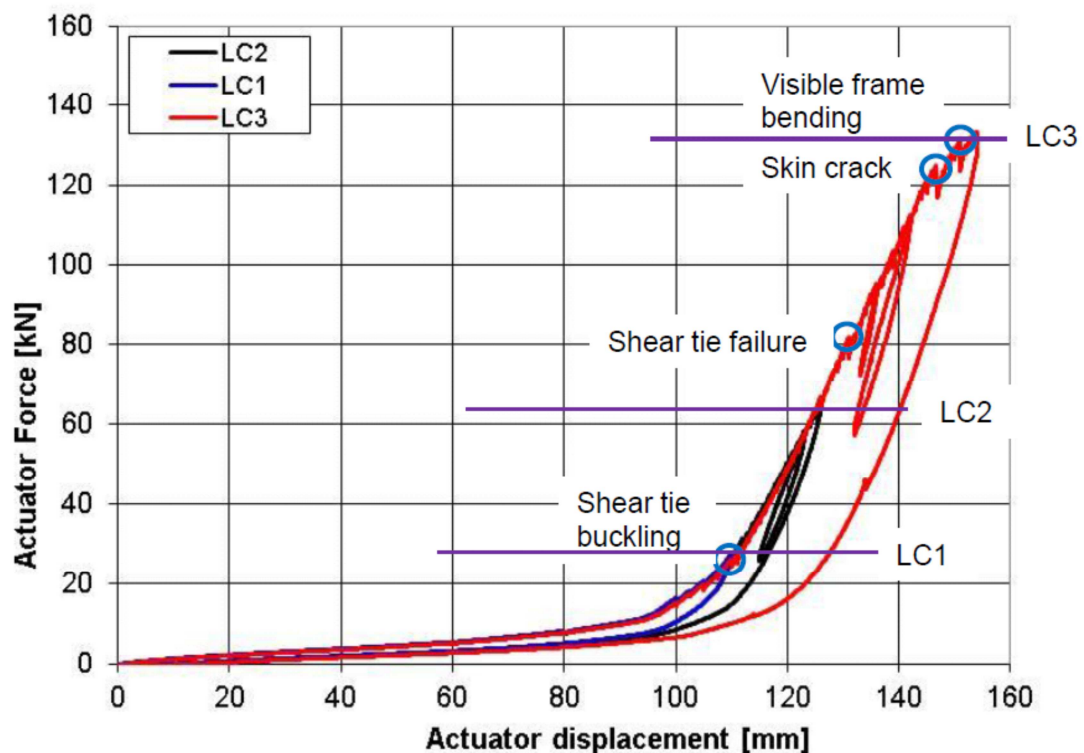
Figure 113. Damage progression during testing
