Project EASA.2008.C19

Burnthrough Resistance of Fuselage

***BURNTHROUGH RESISTANCE OF FUSELAGE
(EASA SERVICE CONTRACT NUMBER EASA 2008.C19)***

Issue 5

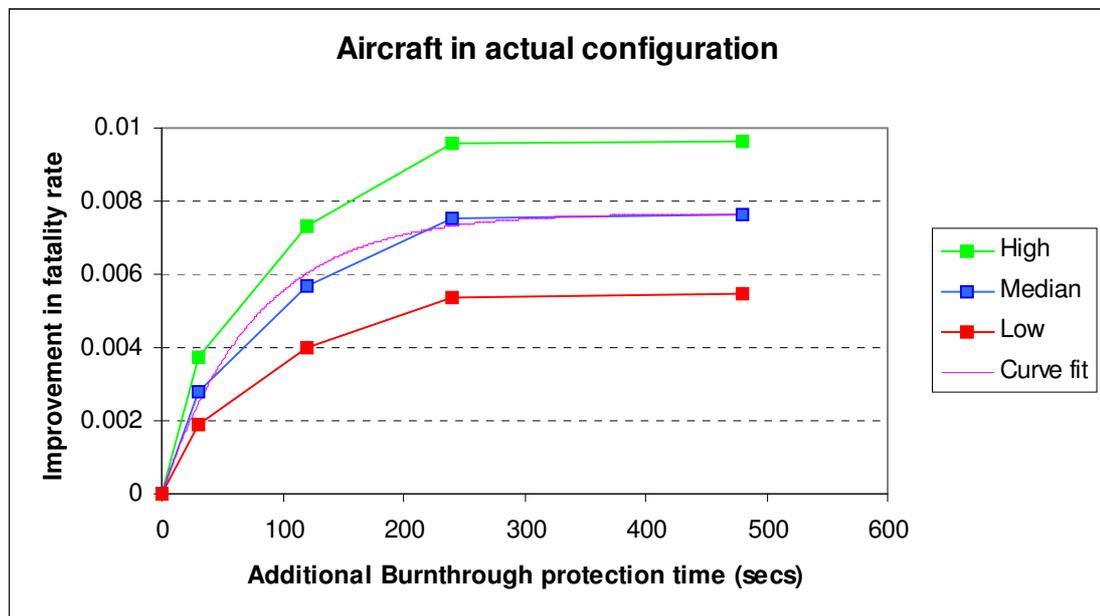
Figure 1: Variation of Improvement in Fatality Rate with Additional Burnthrough Protection Time for Aircraft with Metallic Fuselages Configured to Later Requirements

(Note: The curves shown in Figure 1 were derived taking into account the number of lives that would have been saved had the aircraft been configured to later requirements relating to Floor Proximity Lighting/Marking, Seat Blocking Layers, Fire Hardening of Cabin Interior Materials and Improved Access to Type III Exits .)

The curves shown in Figure 1 were the basis for the conclusion that there is “limited improvement beyond the four to eight minute additional protection point”.

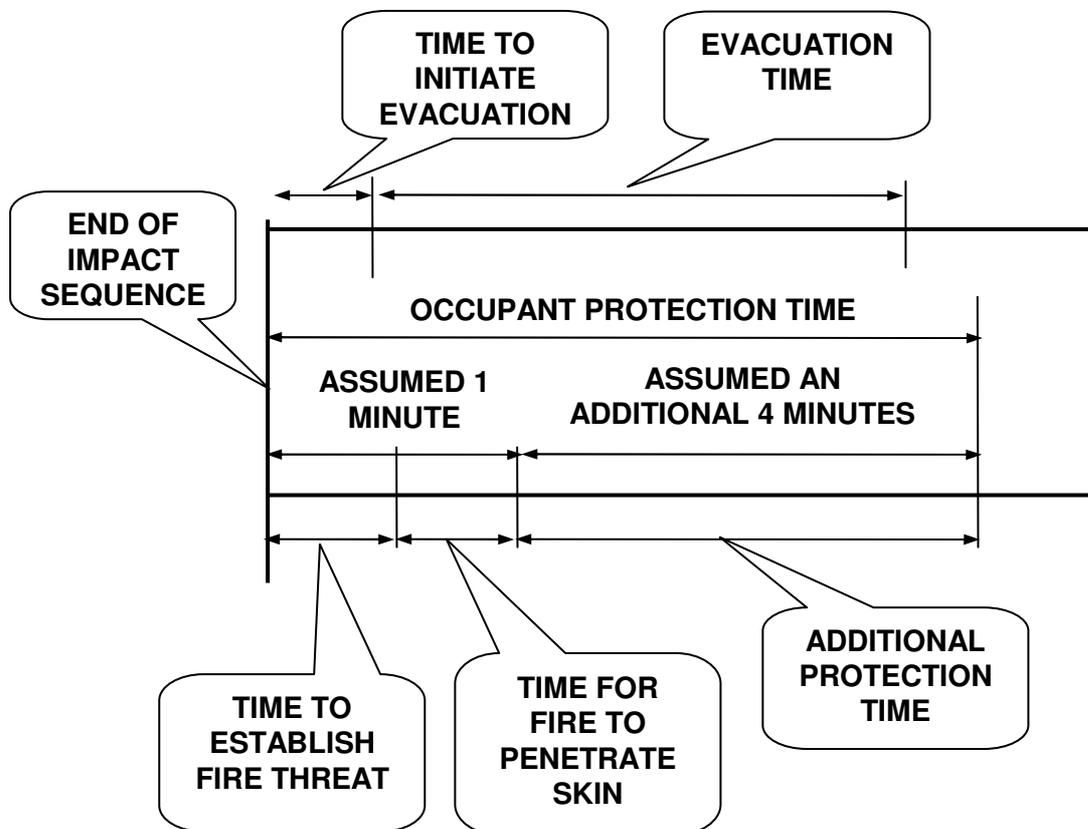
If it were assumed that the time from the end of the impact sequence to the time that the fuselage skin was penetrated was approximately one minute then the *Occupant Protection Time* would be five minutes as illustrated in Figure 2. The time for the fire to penetrate the skin is discussed in Section 4.2.2.

Figure 2: Evacuation and Burnthrough Time Sequence – Aircraft with Metallic Fuselages

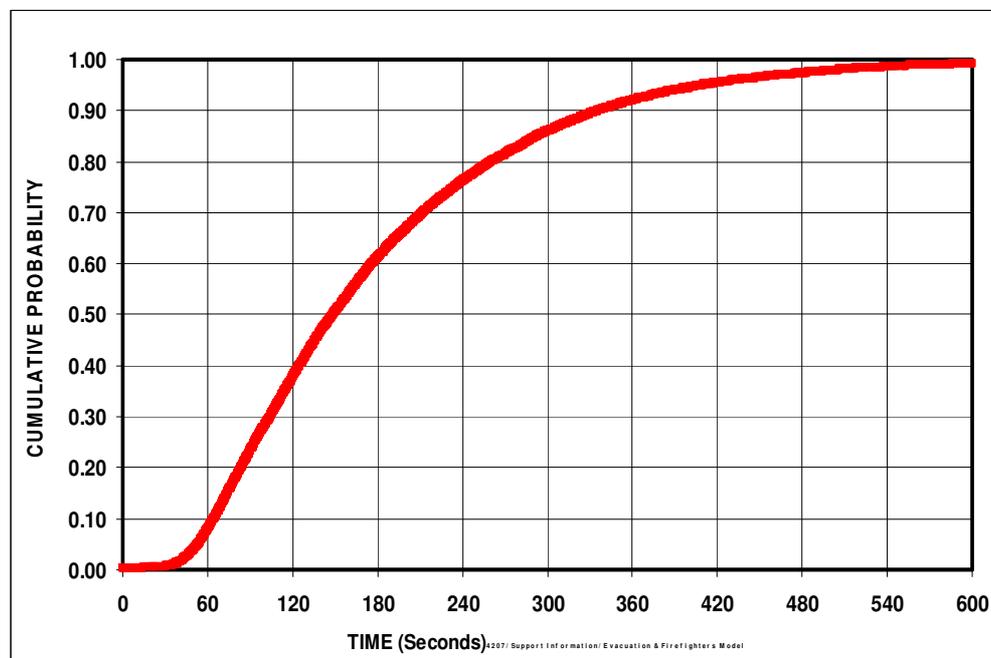
The distributions for each of these data sets were combined to achieve a distribution of the time taken from the end of the impact sequence to the end of the evacuation, unless the fire-fighters had established control beforehand i.e. the time that mobile occupants are under threat from the fire. This time is the required *Occupant Protection Time* and the cumulative probability of its value, as derived from the Monte Carlo simulation model, is shown in Figure 3. It may be seen from Figure 3 that an *Occupant Protection Time* of five minutes would afford protection to mobile occupants in approximately 86% of pool fire accidents.

Figure 3: Cumulative Probability Distribution of Required Occupant Protection Time

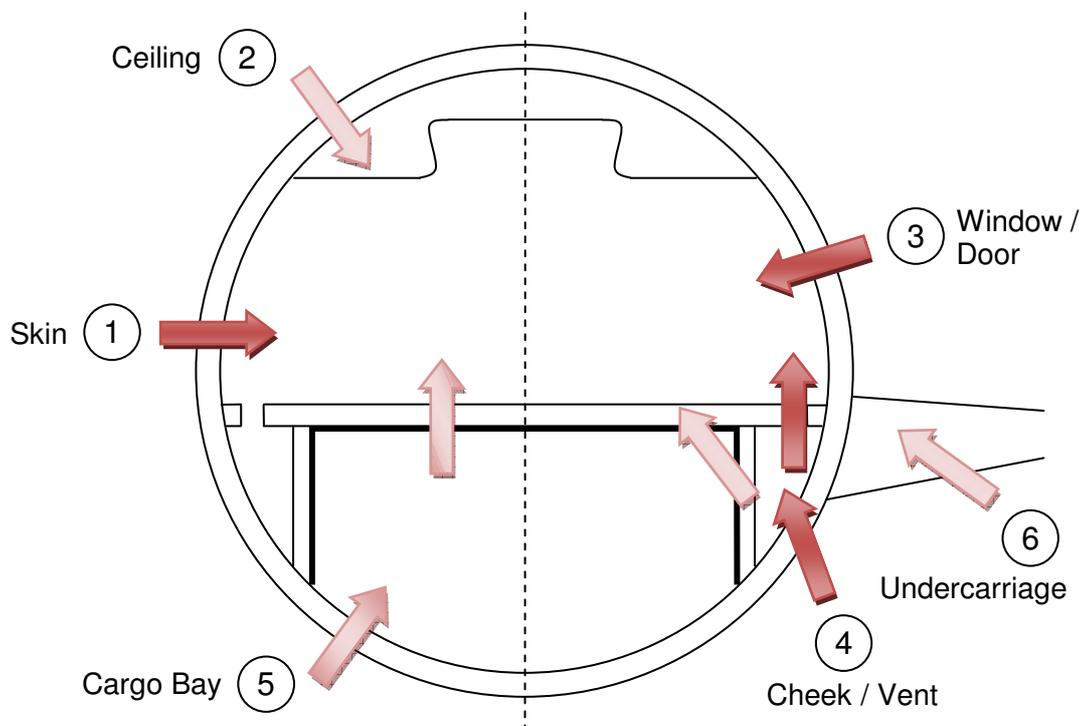
Figure 4: Typical Fire Paths into the Passenger Cabin

The fire path indicated by (1) in Figure 4 represents a direct burnthrough in the side of the passenger cabin. The CAA study indicated that the fire would need to penetrate the fuselage skin, insulation system and cabin sidewall panel. In fire path (2), the fire penetrates the upper fuselage skin, insulation system and then ceiling panels or overhead storage bins. In these areas, smoke is likely to penetrate into the cabin before fire due to the gaps between the cabin interior panels.

Fire paths through the lower fuselage (4) include burnthrough of the fuselage skin and then the insulation bags into the cheek area. The cheek area can often span a significant length of the fuselage (normally only stopped by wing box/main landing gear stowage), allowing fire to spread down the length of the fuselage and follow any path available into the passenger cabin. Once in the cheek area, the primary paths for fire to enter the cabin are either through the main cargo compartment or through the return air grills in the dado panel. For new Part 25 aircraft carrying passengers only, a class C compartment (see CS 25.857) would be used for the main cargo compartment, which consists of sidewall and ceiling cargo liners tested to CS-25 Annex F Part III (see CS 25.855). This presents a significant fire barrier and therefore the immediate threat to the cabin will be through the return air grills. Fire path (5) through the lower fuselage into the cargo compartment would require penetration of the fuselage skin, insulation bags and then the cargo compartment floor and liner. Unlike the sidewall and ceiling liners, the floor liner of a class C cargo compartment needs only meet the less stringent CS-25 Annex F Part I test, however the fire would still need to penetrate the ceiling liner, cabin floor and its covering before entering the passenger compartment. Additionally, full-scale fire testing conducted by the FAA (Reference 7) indicated that the aircraft is less vulnerable to path (5) when the gear is collapsed; however, the exposed cheek area (path 4) is a likely area for flame penetration with gear in either position.

The final fire path (6) identified in the CAA study was through the main landing gear bay. With the landing gear extended, fire may enter the bay and have direct access to the pressure floor. To enter the cabin, the fire would need to burnthrough the pressure floor, insulation system and then cabin floor. The extent of opening into the landing gear bay is dependent on the aircraft design; some aircraft may have the doors open and others may be partially or fully closed when the landing gear is extended. A similar situation would exist for the nose gear bay.

In summary, the fire path of least resistance to the passenger cabin from the upper fuselage is likely to be through the skin (path 1) or a cabin window (path 3). Through the lower fuselage, burnthrough into the cheek area can provide direct entry into the passenger cabin through the return air grills. These are indicated in Figure 4 by the darker arrows. When considering the entire aircraft length, there are additional lower fuselage fire paths in areas without the cargo compartment, which would present a similar fire path as the cheek areas. The FAA testing (Reference 7) indicated that the aircraft is more vulnerable with the gear extended, due to the larger surface area exposed to the fire. This configuration exposes additional paths through the main and nose landing gear bays that may be open.

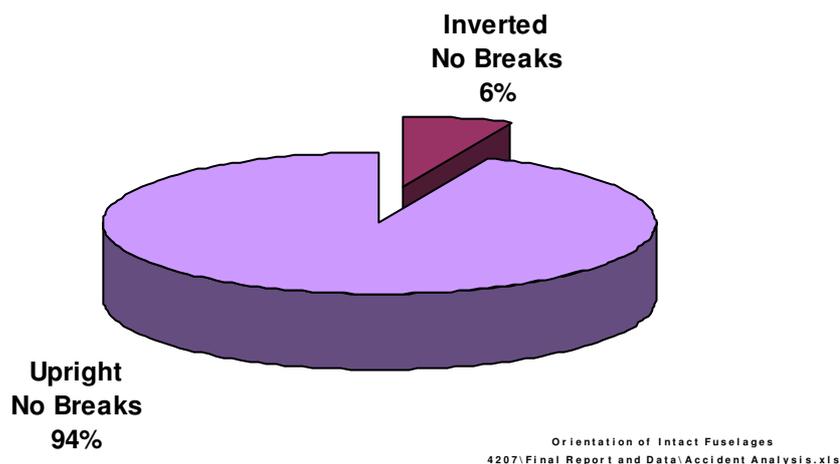
As shown in Figure 12, for pool fire accidents where the fuselage remains substantially intact as a result of the impact, 6% involve an inverted fuselage.

Figure 12: Proportion of Inverted Fuselages in Ground Pool Fire Accidents Not Involving Fuselage Breaks

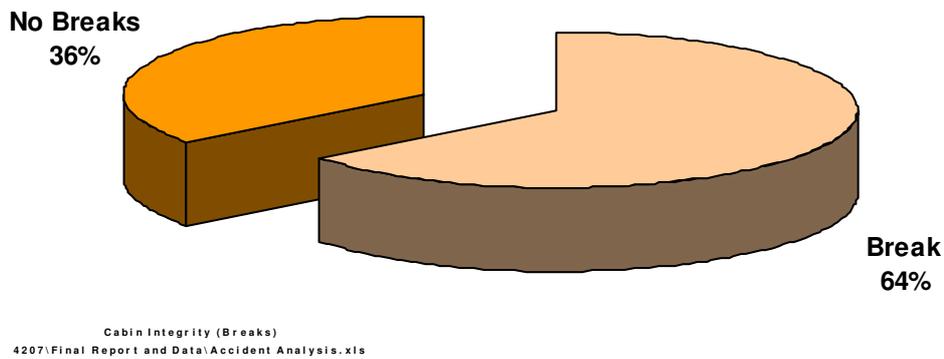
Figure 13 shows the proportion of pool fire accidents involving fuselage breaks - approximately 64%.

Figure 13: Proportion of Pool Fire Accidents involving Fuselage Breaks

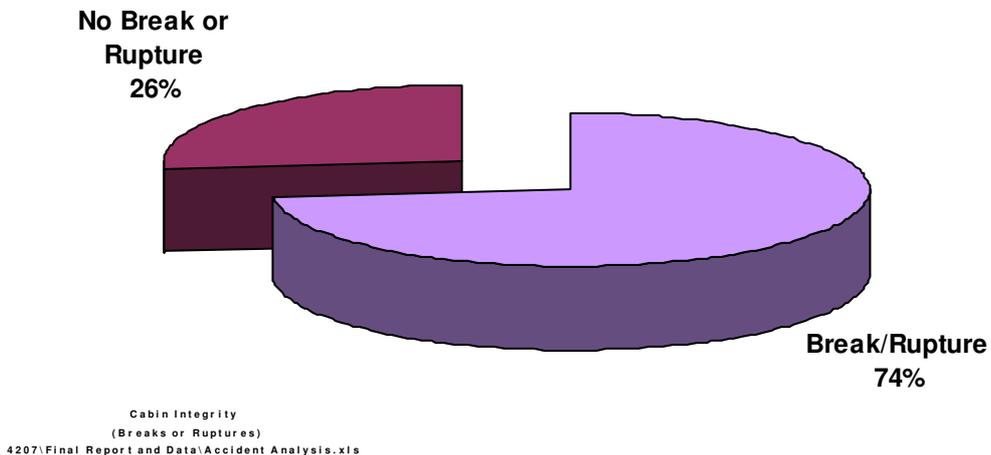
Figure 14 shows the proportion of pool fire accidents involving fuselage breaks and ruptures – approximately 74%.

Figure 14: Proportion of Pool Fire Accidents involving Fuselage Breaks or Ruptures

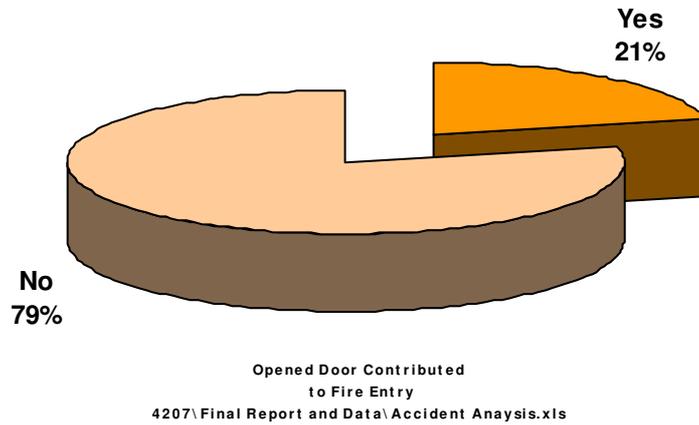
Figure 15 shows that in approximately 21% of the pool fire accidents studied, an open door contributed to fire entry into the cabin prior to the end of the evacuation sequence.

Figure 15: Proportion of Pool Fire Accidents where an Open Door Contributed to Fire Entry

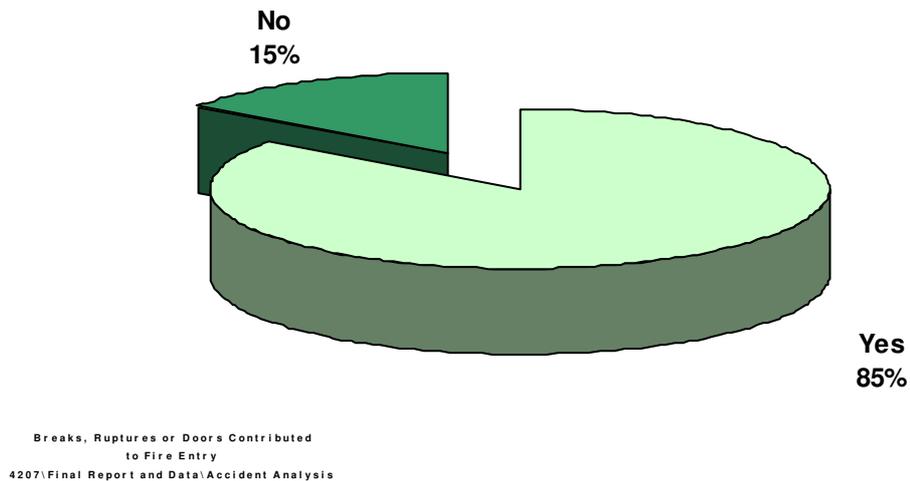
As illustrated in Figure 16 the review of pool fire accidents suggested that in 85% of the accidents there was a threat to occupants from fire entry through fuselage breaks or ruptures or through open doors. It is also estimated that approximately 75% of the fatalities occurred in accidents where this fire threat existed.

Figure 16: Proportion of Pool Fire Accidents where Breaks, Ruptures, or an Open Door Contributed to Fire Entry

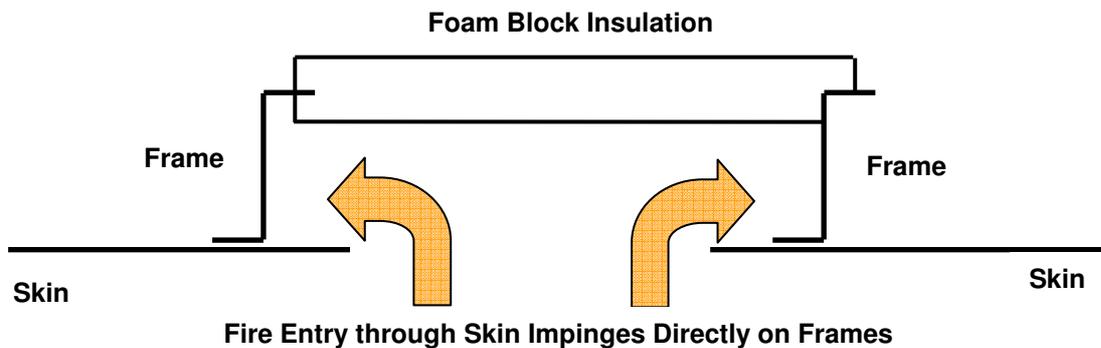
However, some aircraft are insulated with rigid foam blocks that slot between the fuselage frames. This type of installation may be designed with a large gap between the outermost face of the insulation block and the fuselage skin. Consequently, the frames are not protected by the fire barrier, as they would be with insulation blankets. They would become directly exposed to the fire once the skin has melted as shown in Figure 17. Whilst the foam block insulation may be capable of resisting burnthrough, it may not prevent the fuselage frames from melting and collapsing, thereby allowing the fire barrier to fall out of the fuselage.

Figure 17: Typical Installation of Foam Block Insulation System

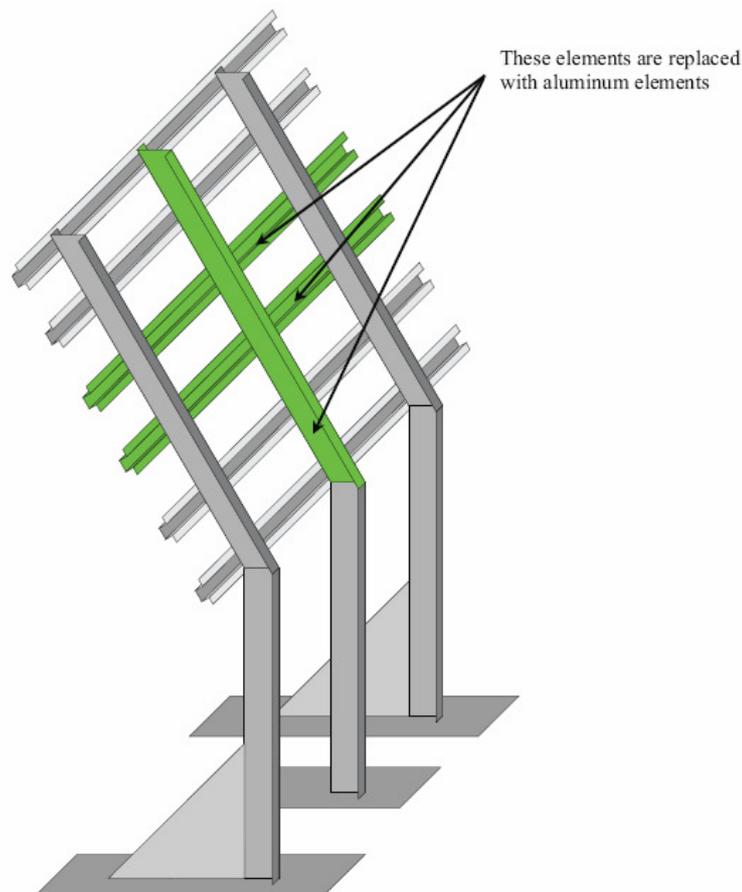
The modifications required to the test frame are shown in an extract from the Advisory Circular - see Figure 18. It can be seen that the elements of the frame that are required to be replaced by aluminium alloy components are minimal compared with the area of fuselage skin and frames that would be exposed to the fire plume and thus be susceptible to collapse in a real accident. It is possible that during the test, the rigidity of the foam will prevent collapse because only a relatively small area of frame will be destroyed by the burner.

It is therefore considered that the FAA kerosene burner test may not cover a sufficient area of fuselage to demonstrate adequately that frame collapse will not occur when rigid foam systems are used to provide fuselage burnthrough protection.

Figure 18: FAA Kerosene Burner Test Frame Modified with Aluminium Frame and Stringers

Conclusion 11: Whilst frame collapse may be unlikely due to the protection afforded to the frames by insulation blankets, this may not be the case with rigid foam insulation materials. Furthermore, the provisions within the advisory material to CS 25.856 may not adequately address this issue.

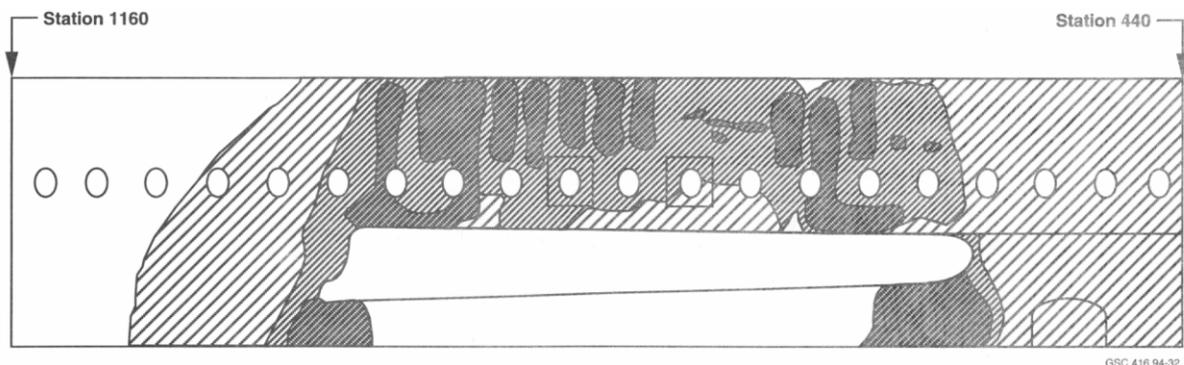
GSC 416.94-32

“There was a 2- by 2-foot section above the trailing edge of the wing into the overhead section of the aircraft where the skin completely melted away.”

“The fire penetrated the cabin in three places. The first was in the vicinity of the leading edge of the wing. Here a large section of the skin was burned away at the cheek area at the aft end of the forward cargo compartment allowing access to the floor grills. Fire penetrated through the grill and ignited the sidewall panel above the grill. The second penetration occurred through the cabin window directly above the trailing edge of the wing. The ceiling panel and the sidewall panels surrounding and above the window ignited. The third penetration occurred in the ceiling overhead. The fire was caused by a large flame penetration through the skin directly into the overhead. There was no evidence that suggested the fire traveled up through the fuselage from below the floor to the ceiling.”

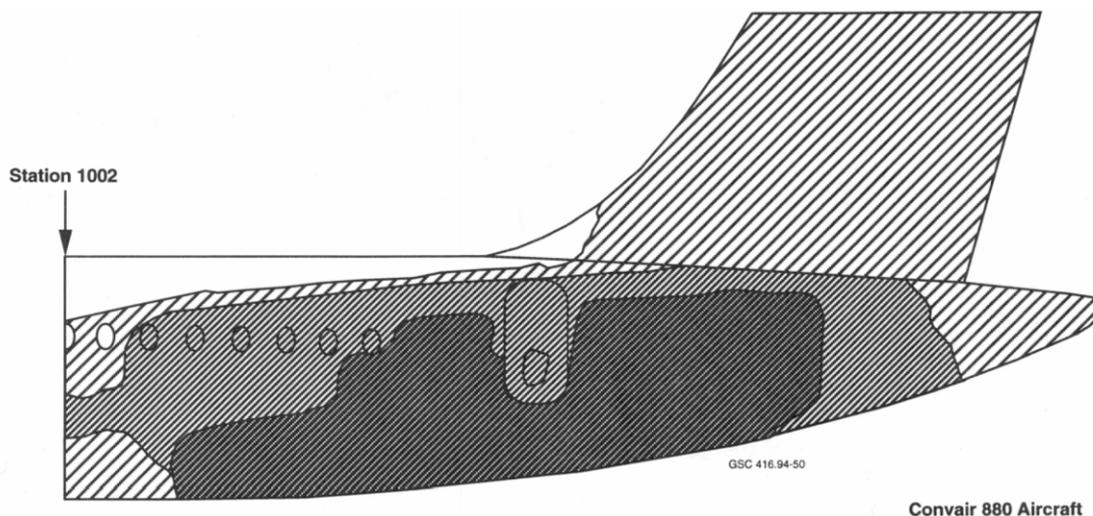
"The initial penetration into the aircraft occurred in the empennage crawlthrough area behind the cargo compartment. This area is only partially insulated. The fire penetrated the skin and then the floor of the cabin.

Penetration into the cargo compartment was through the aft bulkhead separating the cargo compartment from the crawlthrough area. The cabin floor was initially penetrated by flames above the crawlthrough area in 1 minute 43 seconds and the cargo compartment in 2 minutes 14 seconds. The cargo compartment appeared to provide some protection to the cabin against a pool fire of this type".

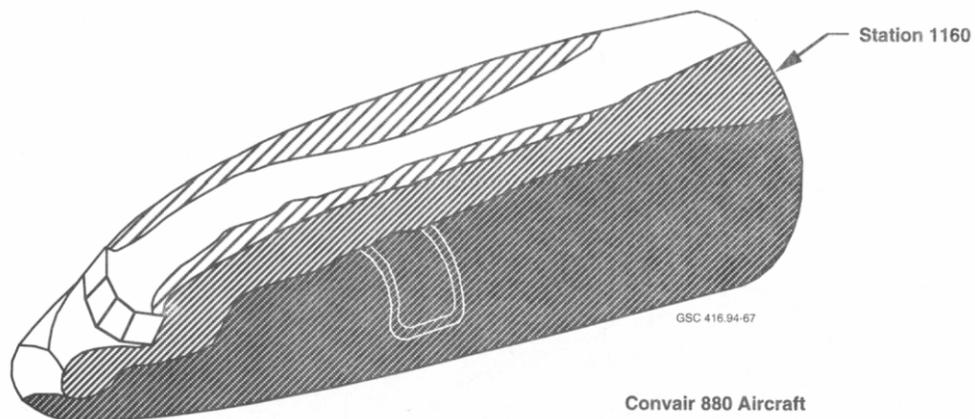
“The nose section was severely damaged by the fire. The port side was completely destroyed up to the centerline of the top of the fuselage. The cockpit windows were still intact; all other windows on the port side were gone. The starboard side fared a little better.”

“Initial smoke penetration came from the cockpit area. The cockpit, however, did not receive the most extensive damage. The fire may have come into the cabin through the electronics bay and up through the crew access tunnel. The electronics bay was not insulated.”
