Boeing 737 MAX Return to Service Report

Overview of the Technical Investigation Activities Performed by EASA

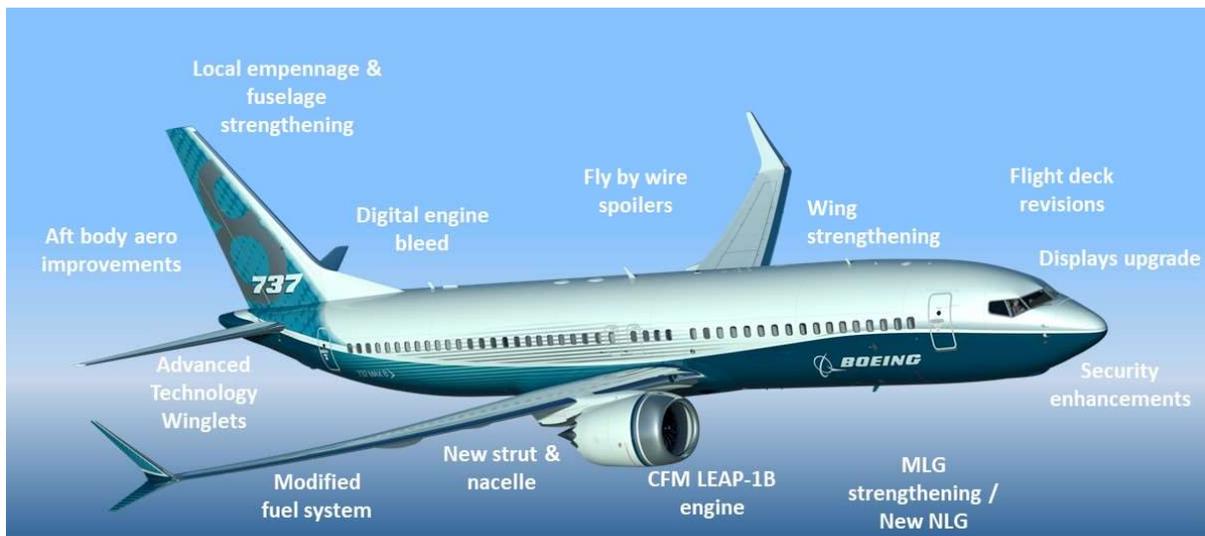
Figure 2: 737-8 Main modifications

The 737-8 incorporated not only the new CFM LEAP-1B engine. The 737-8 modifications included a new Advance Technology winglet, a lengthened nose landing gear to provide ground clearance for the new larger engine, and other improvements. The wing spoilers were changed from mechanically driven to fly-by-wire to support certification to reduce weight and build time. Additional systems and structures changes were made to meet the latest certification requirements. Figure 2 provides an overview of the modifications introduced for the 737-8.
