## **Annex A**      Buoyancy Analysis Results

<b>CONTRACT NUMBER:</b>	EASA.2020.C02
<b>CONTRACTOR / AUTHOR:</b>	DART Aerospace
<b>IPR OWNER:</b>	European Union Aviation Safety Agency
<b>DISTRIBUTION:</b>	Public

Annex A	Buoyancy Analysis Results.....	1
	CONTENTS	3
1.	Buoyancy Analysis General Set Up and Assumptions .....	4
2.	CS29 Results.....	5
2.1	CS29 Air pocket Analysis: No Critical Compartment Damaged	6
2.2	CS29 Air pocket Analysis: Primary EFS Critical Compartment Damaged	10
2.3	CS29 Air pocket Analysis: High Mounted EFS Critical Compartment Damaged	14
3.	CS27 Results.....	18
3.1	CS27 Air pocket Analysis: No Critical Compartment Damaged	19
3.2	CS27 Air pocket Analysis: Primary EFS Critical Compartment Damaged	21
3.3	CS27 Air pocket Analysis: High Mounted EFS Critical Compartment Damaged	24

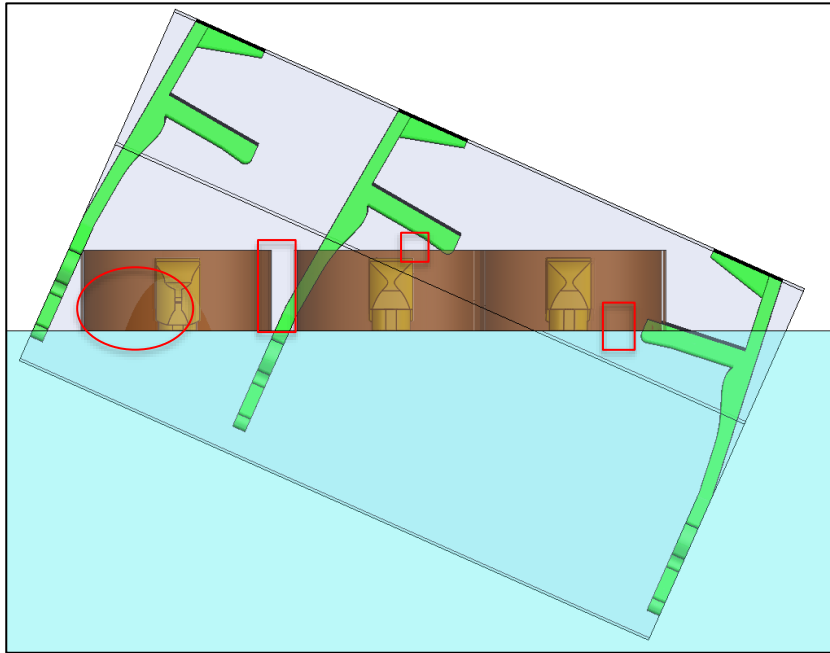
2.1.1 CS29 HEFS, Heavy FWD CG, No Compartment Damaged, NPA 2016-01 Air pocket: Fail.

Figure 1: NPA Air Pocket Side View: collision with walls, seats, back rest and other air pockets

Damaged Compartment	Air Pocket Type	Result	Comment
No Damage	NPA 2016-1	FAIL [2.1.1]	NPA air pockets collide with seats and other air pockets
No Damage	Tapered	PASS [2.1.2]	No Collisions
Primary EFS, LH FWD Chamber	NPA 2016-1	FAIL [2.2.1]	NPA air pockets collide with floor, seats, and other air pockets
Primary EFS, LH FWD Chamber	Tapered	PASS [2.2.2]	No Collisions
HEFS, LH FWD Chamber	NPA 2016-1	FAIL [2.3.1]	NPA air pockets collide with floor, seats, and other air pockets
HEFS, LH FWD Chamber	Tapered	Pass [2.3.2]	No Collisions

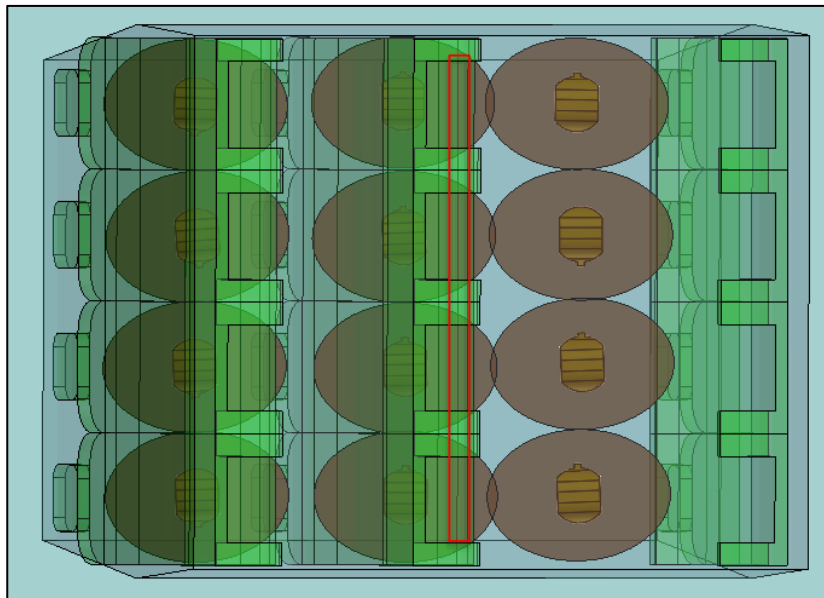
Figure 2: NPA Air Pocket Top View: collision with other air pockets

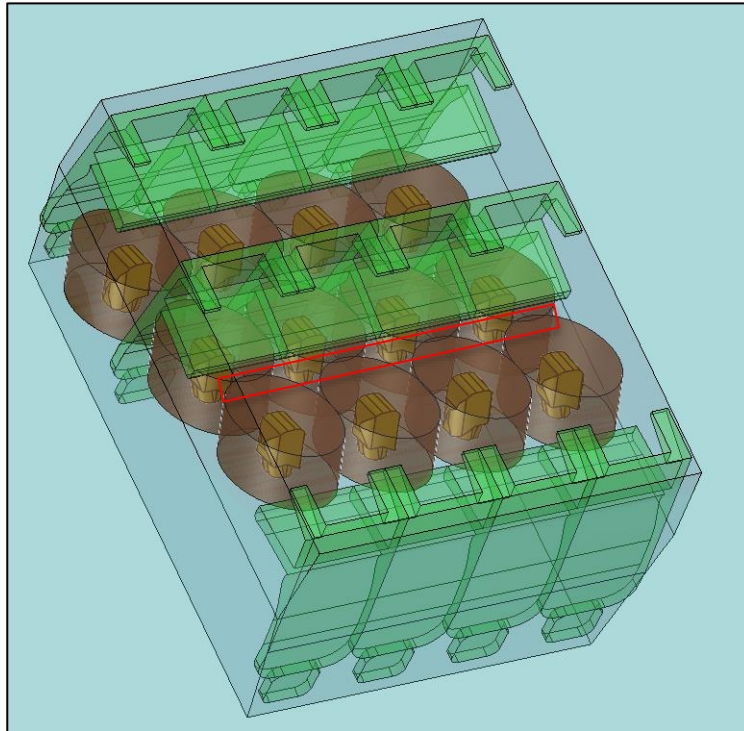
*Figure 3: NPA Air Pocket Iso. View: collision with other air pockets*

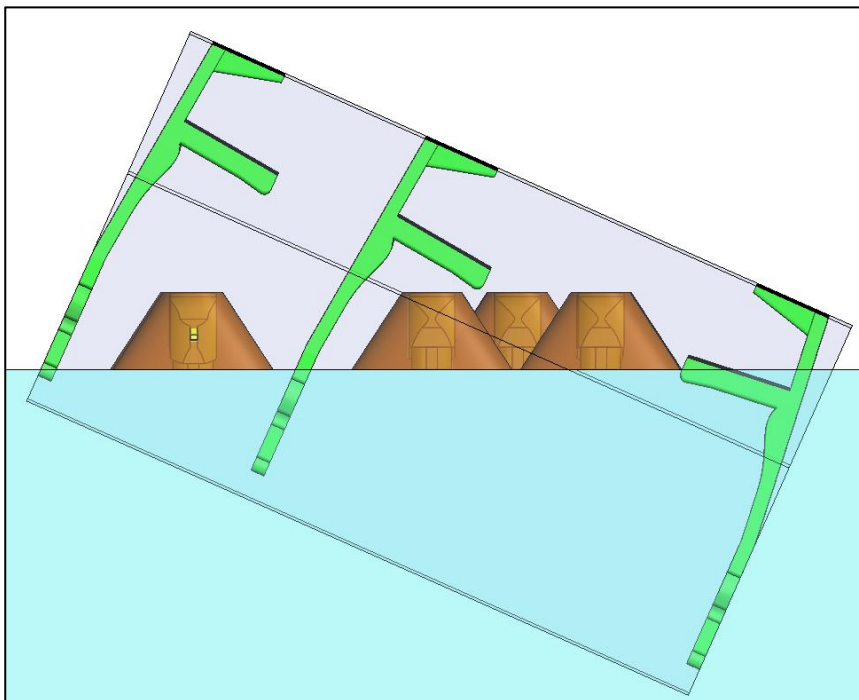
### 2.1.2 CS29 HEFS, Heavy FWD CG, No Compartment Damaged, Tapered Air Pocket: Pass.

*Figure 4: Tapered Air Pocket Side View: No Collisions*

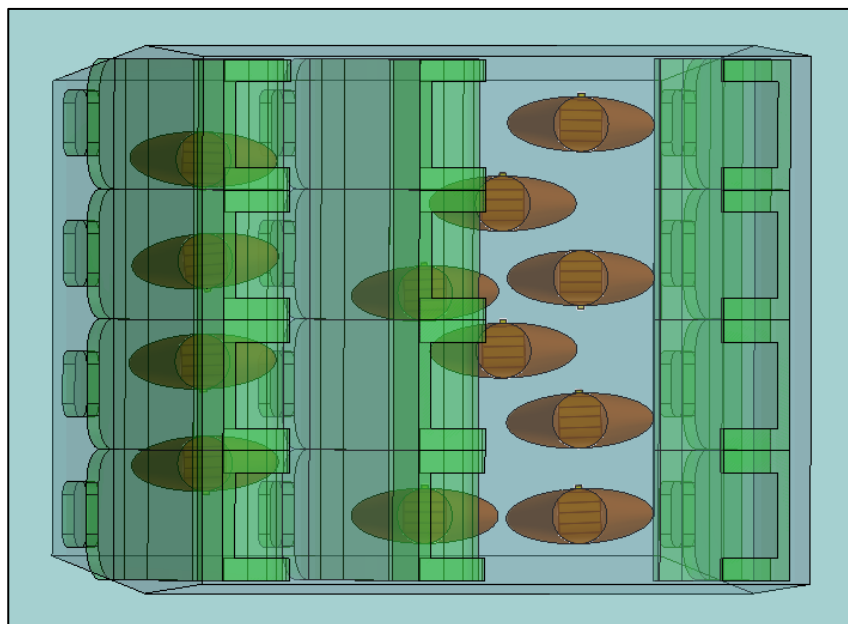
*Figure 5: Tapered Air Pocket Top View: No Collisions*

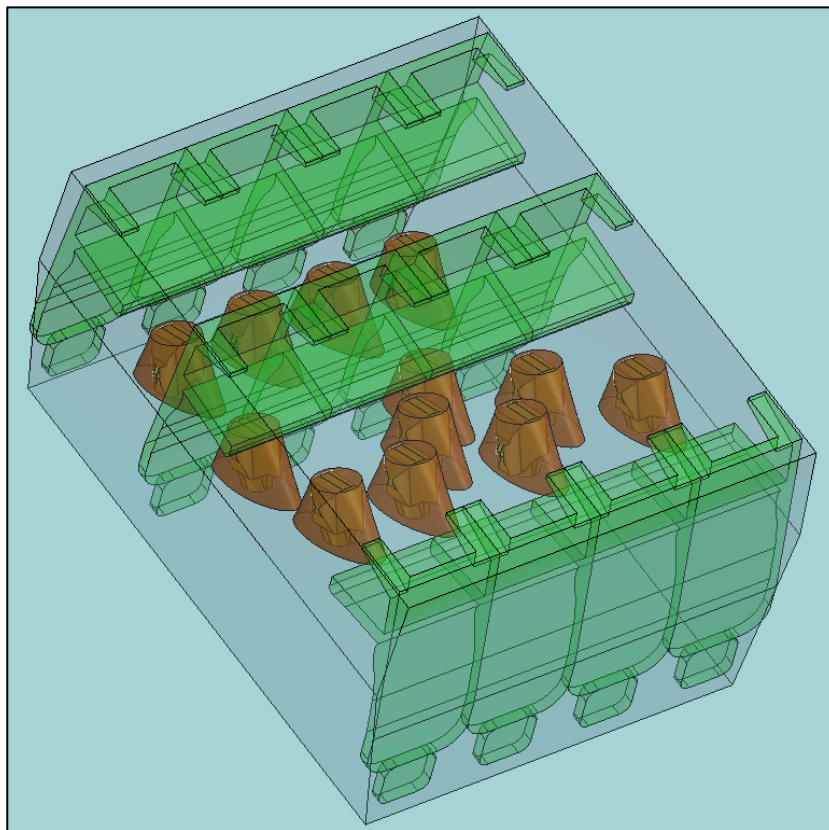
*Figure 6: Tapered Air Pocket Iso. View: No Collisions*

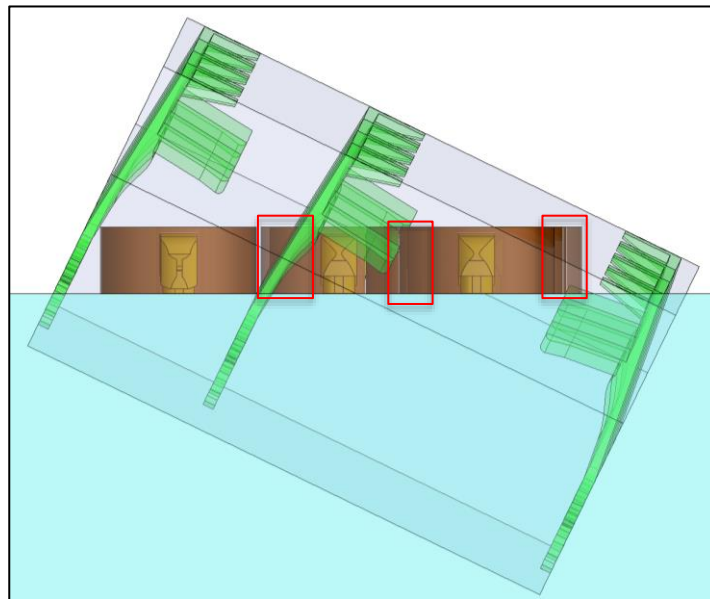
### 2.2.1 CS29 HEFS, Heavy FWD CG, Primary EFS LH FWD-Most Compartment Damaged, NPA 2016-01: Fail.

*Figure 7: NPA Air Pocket Side View: Collision with floor, back rest, seats, and other air pockets*

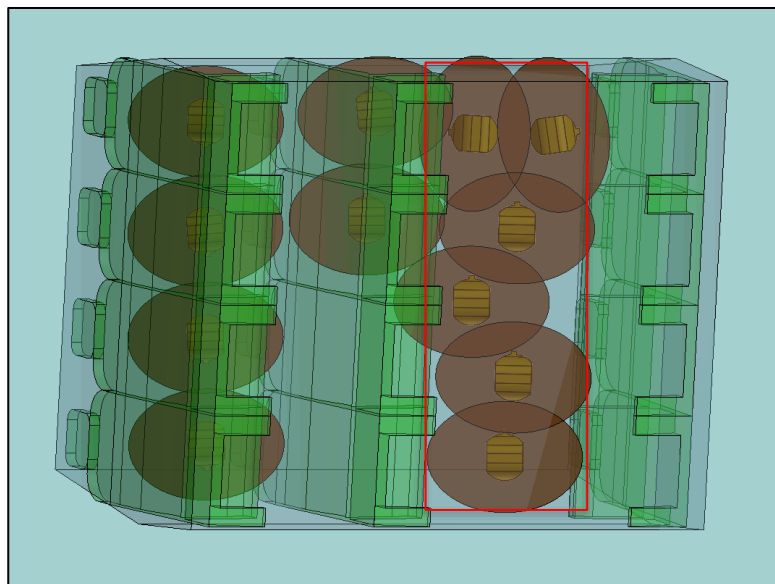
*Figure 8: NPA Air Pocket Top View: Collision with floor, back rest, seats, and other air pockets*

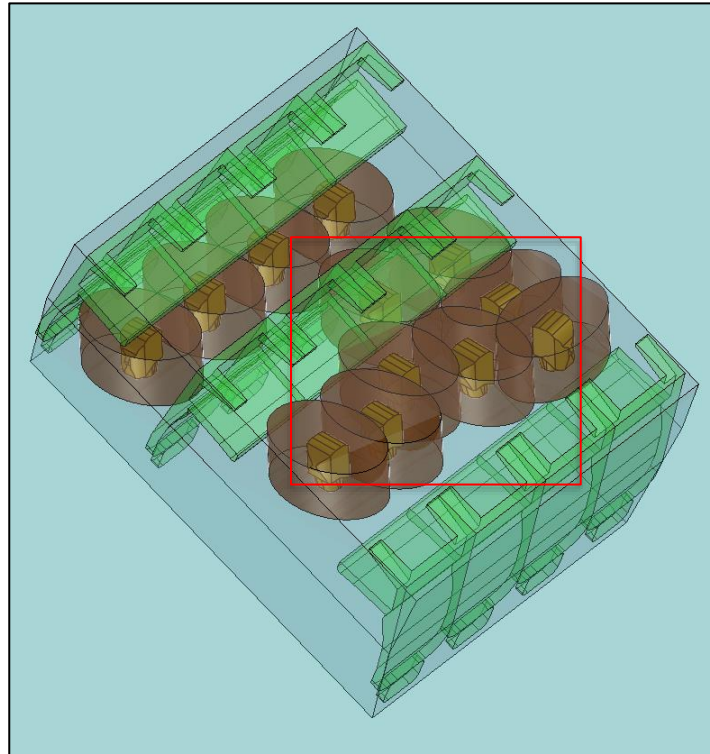
*Figure 9: NPA Air Pocket Iso. View: Collision with floor, back rest, seats, and other air pockets*

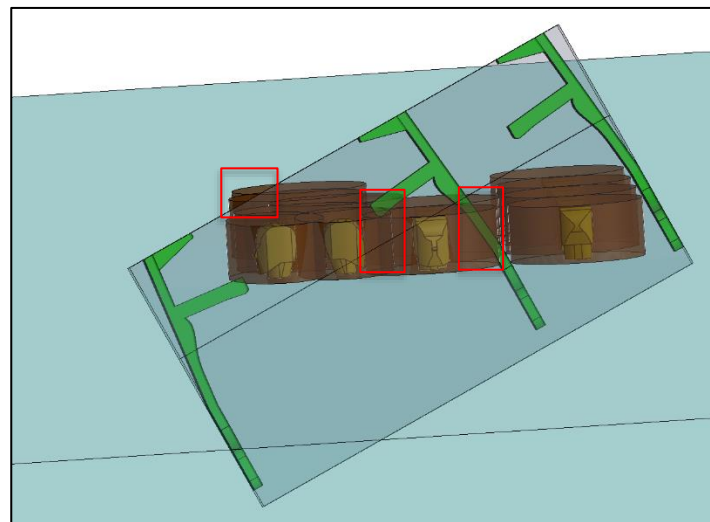
*Figure 10: NPA Air Pocket Normal to Cabin/Seats View: Collision with floor, back rest, seats, and other air pockets*

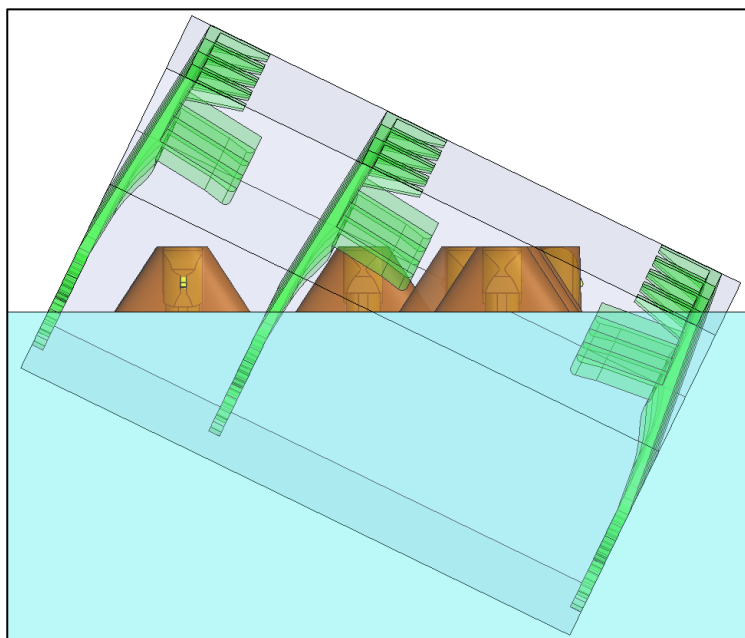
2.2.2 CS29 HEFS, Heavy FWD CG, Primary EFS LH FWD-Most Compartment Damaged, Tapered: Pass.

*Figure 11: Tapered Air Pocket Side View: No Collisions*

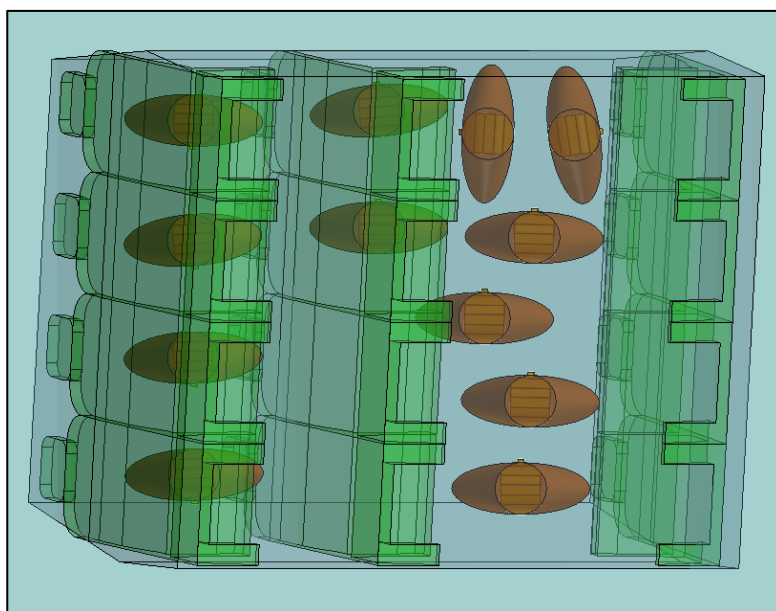
*Figure 12: Tapered Air Pocket Top View: No Collisions*

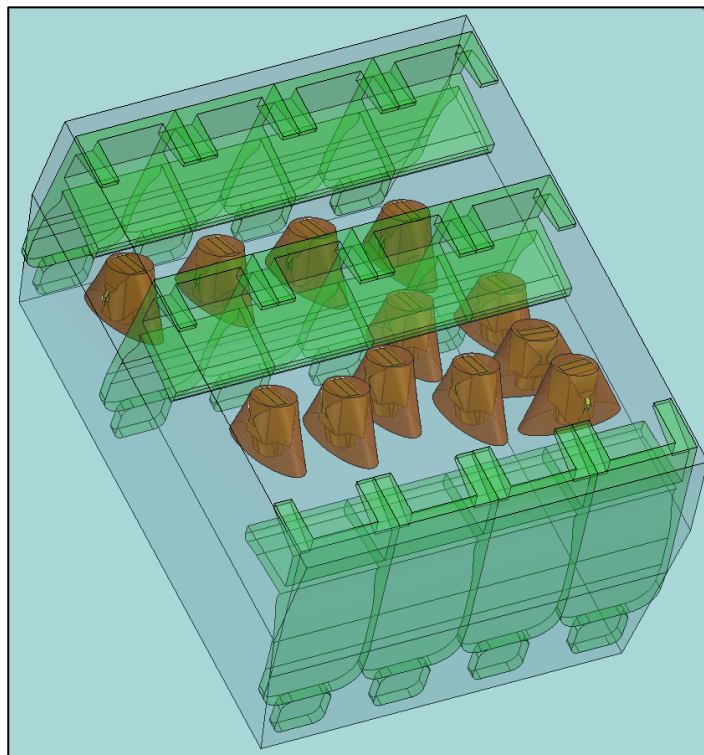
*Figure 13: Tapered Air Pocket Iso. View: No Collisions*

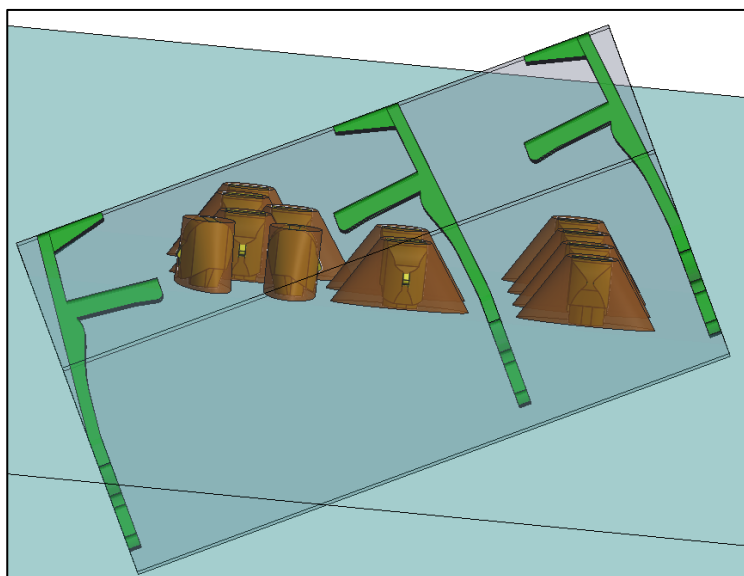
*Figure 14: Tapered Air Pocket Normal to Cabin/Seats View: No Collisions*

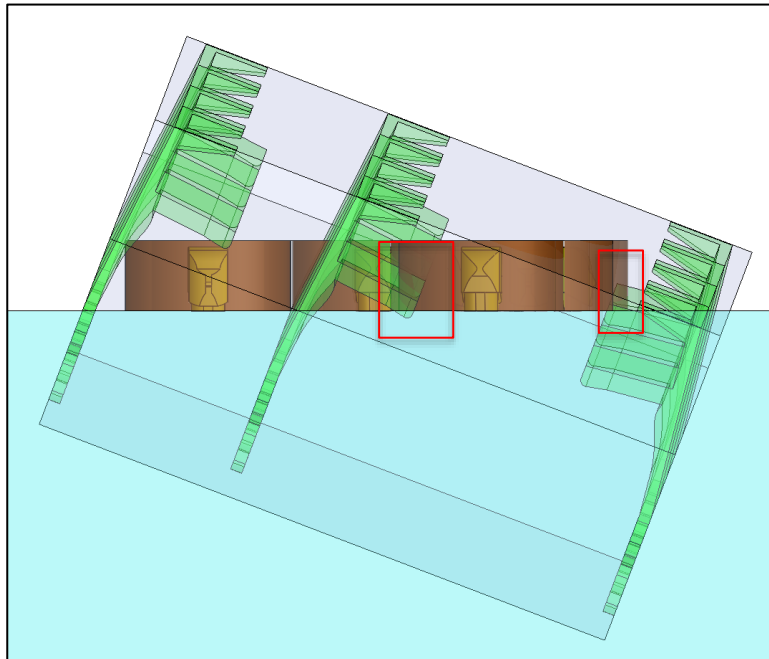
### 2.3.1 CS29 HEFS, Heavy FWD CG, HEFS LH FWD-Most Compartment Damaged, NPA 2016-01: Fail.

Figure 15: NPA Air Pocket Side View: Collision with floor, back rest, seats, and other air pockets

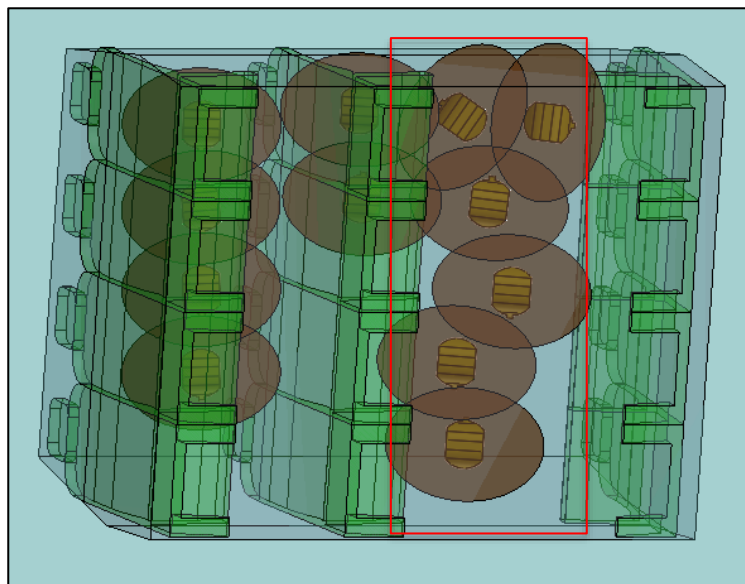
Figure 16: NPA Air Pocket Top View: Collision with floor, back rest, seats, and other air pockets

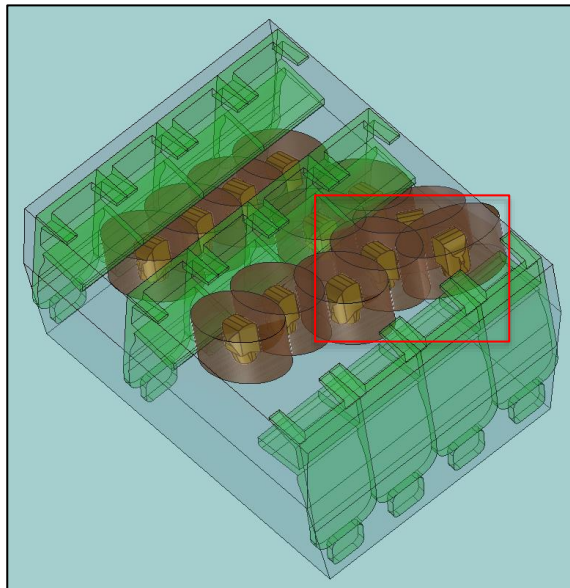
Figure 17: NPA Air Pocket Iso. View: Collision with floor, back rest, seats, and other air pockets

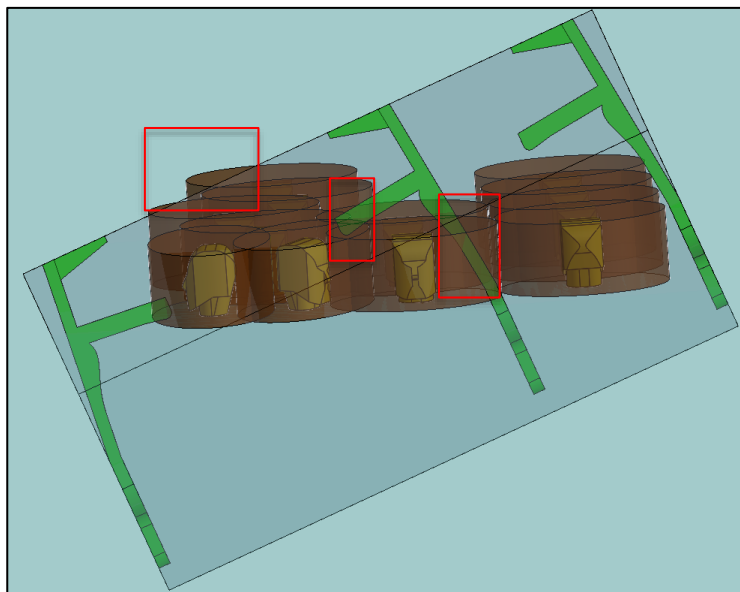
Figure 18: NPA Air Pocket Normal to Cabin/Seats View: Collision with floor, back rest, seats, and other air pockets

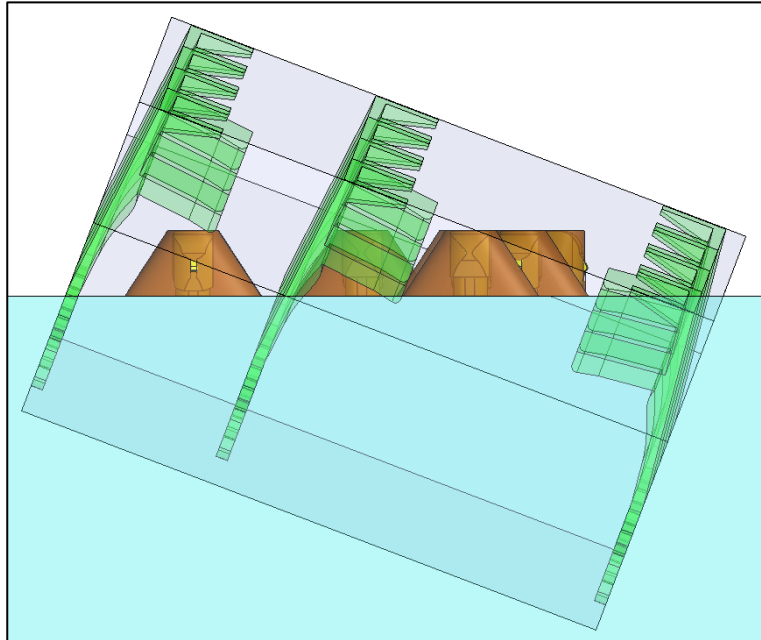
### 2.3.2 CS29 HEFS, Heavy FWD CG, HEFS LH FWD-Most Compartment Damaged, Tapered: Pass.

*Figure 19: Tapered Air Pocket Side View: No Collisions*

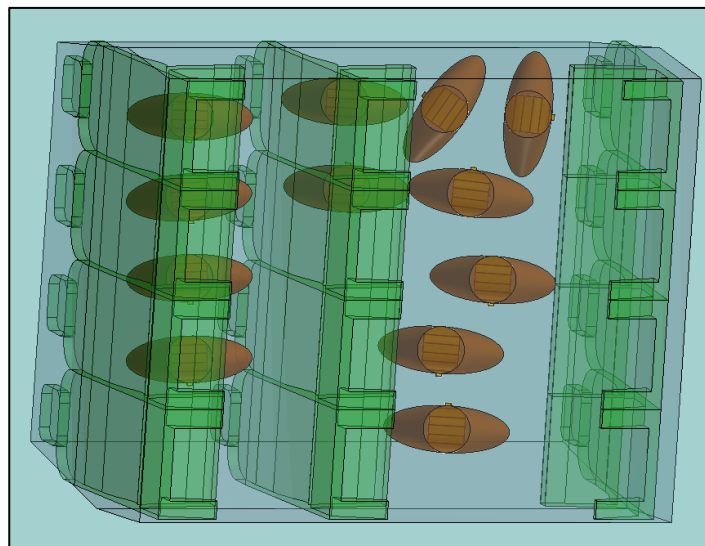
*Figure 20: Tapered Air Pocket Top View: No Collisions*

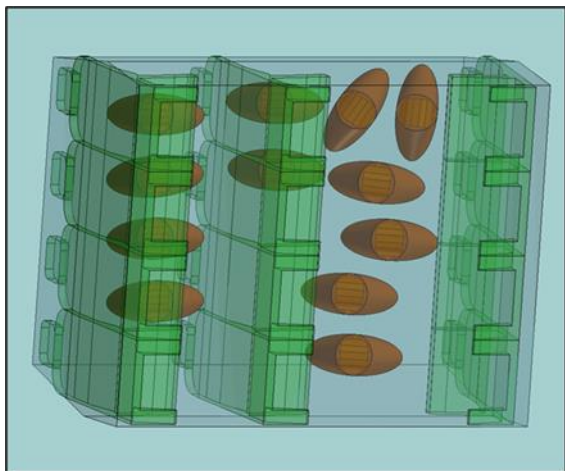
Figure 21 Revised Tapered Air Pocket Top View: No overlap

It should be noted that initially the buoyancy analysis was performed with the elliptical airpocket volume as recommended in the NPA 2016-01 (EASA, 2016). In a second iteration, a new airpocket volume and shape was defined: 'tapered airpocket'. In the first iteration of the tapered airpocket the nose of the head model remained outside of the volume. In a second iteration of the tapered airpocket (final recommended airpocket volume) the volume was adjusted to fit the nose within the airpocket. Feasibility of the revised tapered air pocket was verified in the worst-case airpocket scenario only.

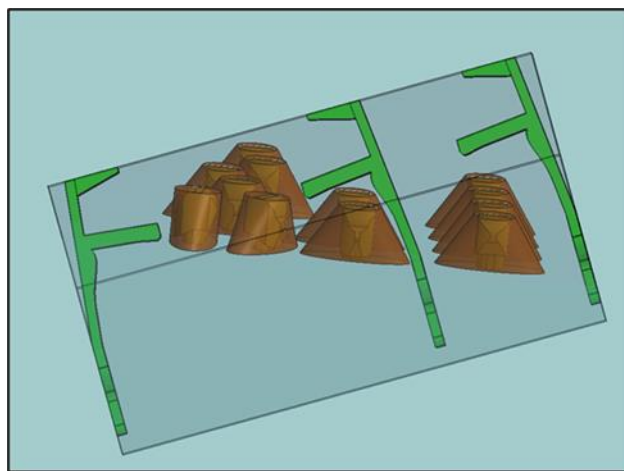
Figure 22 Revised Tapered Air Pocket Side View: No overlap

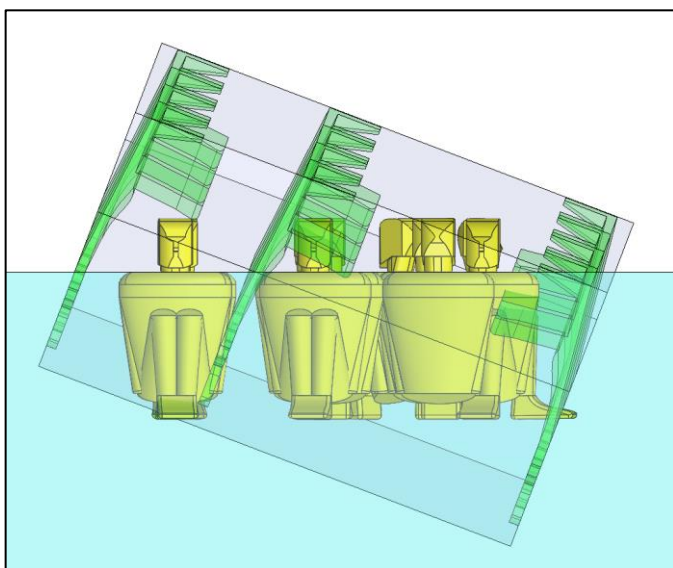
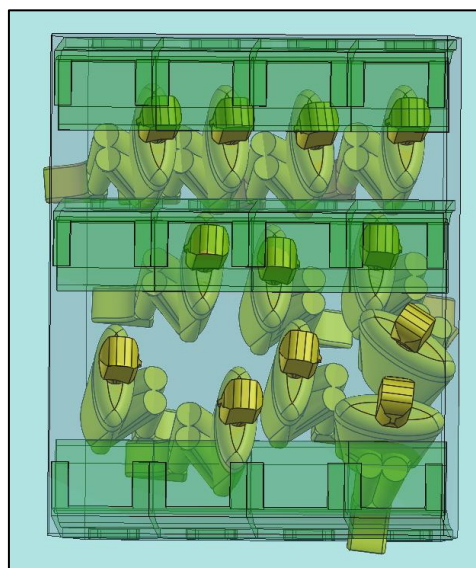
Figure 23: CS29 Full Scale Test HEFS Critical Compartment Damaged, body models

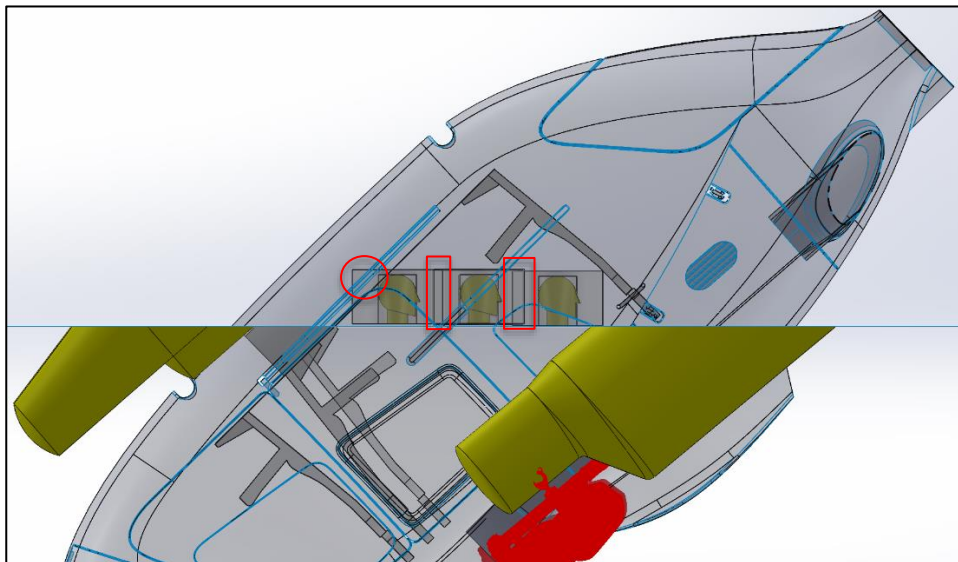
#### 3.1.1 CS27 HEFS, Heavy FWD CG, No Compartment Damaged, NPA 2016-01 Air pocket: Fail.

*Figure 24: NPA air pocket: collision with floor, and other air pockets*

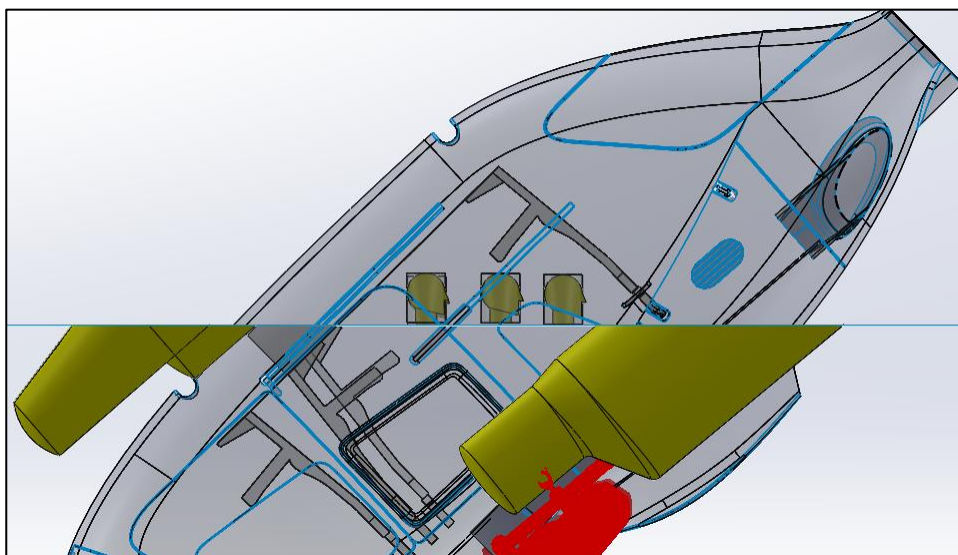
#### 3.1.2 CS27 HEFS, Heavy FWD CG, No Compartment Damaged, Tapered Air pocket: Pass.

*Figure 25: Tapered Air Pocket: no collisions*

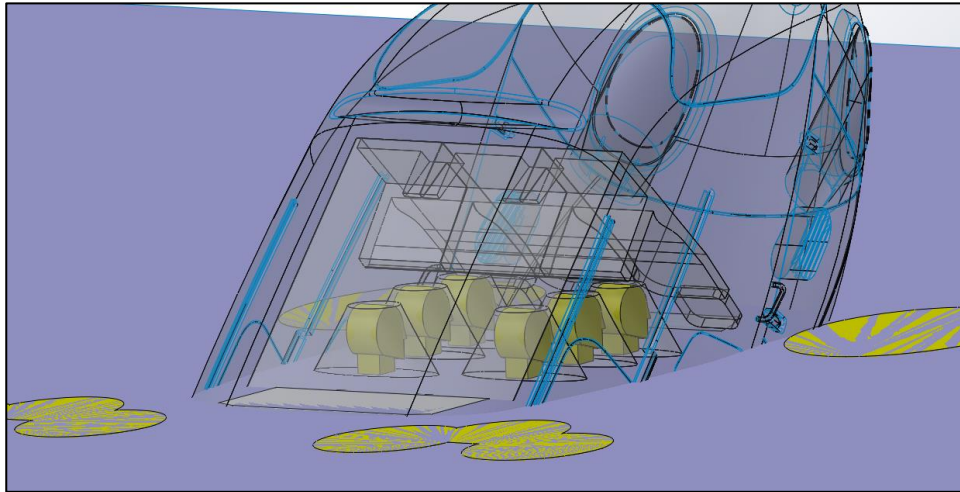
*Figure 26: Tapered Air Pocket: no collisions*

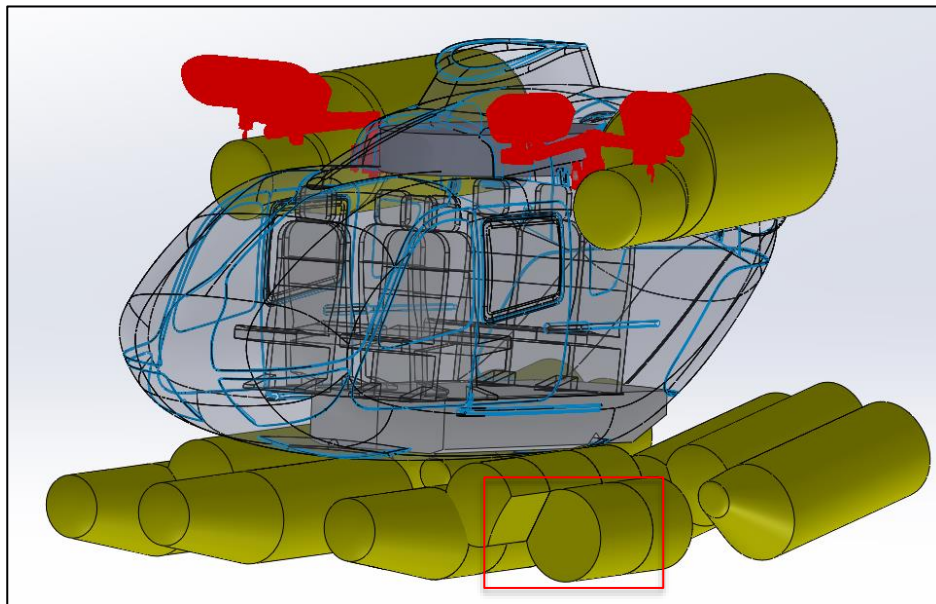
### 3.2.1 CS27 HEFS, Heavy FWD CG, Primary EFS LH FWD-Most Compartment Damaged, NPA 2016-01: Fail.

*Figure 27: LH FWD Primary EFS Damaged*

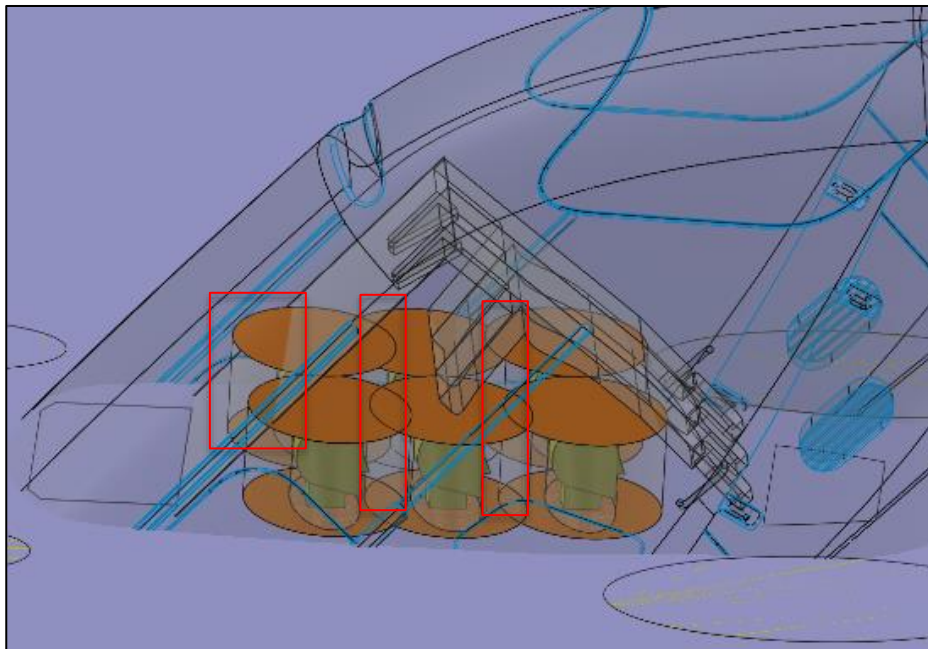
*Figure 28: NPA air pocket: collisions with floor, and other air pockets*

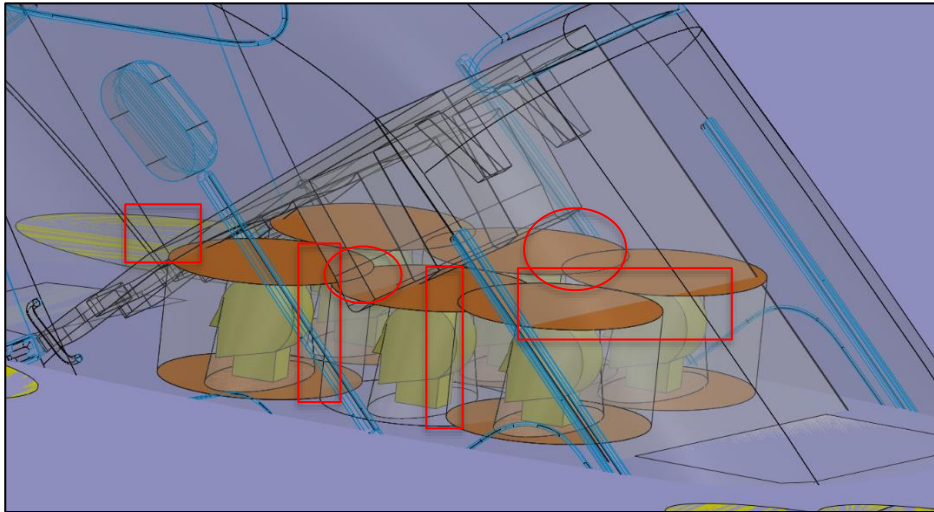
Figure 29: NPA air pocket: collisions with floor, seat, back rest, and other air pockets

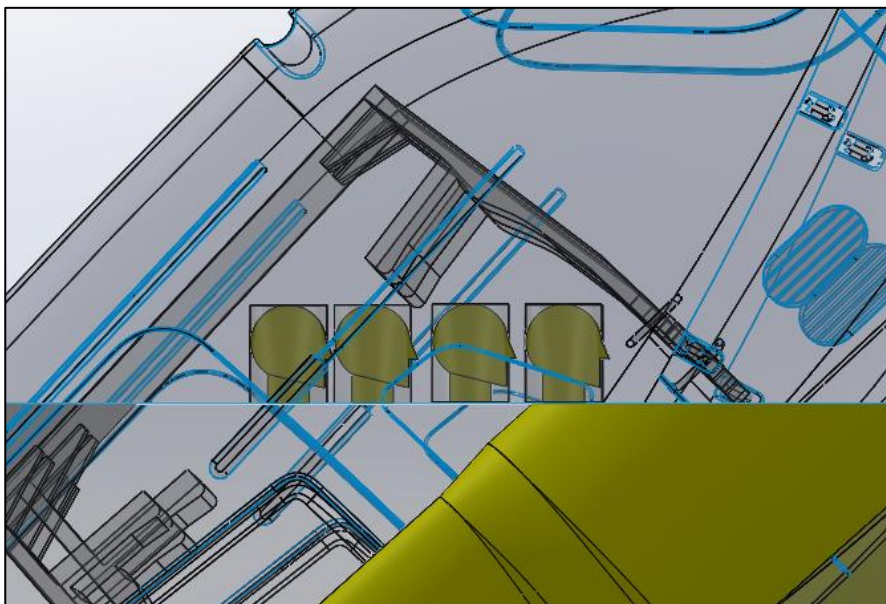
### 3.2.2 CS27 HEFS, Heavy FWD CG, Primary EFS LH FWD-Most Compartment Damaged, Tapered: Pass.

Figure 30: Tapered air pocket: no collisions with other air pockets or floor

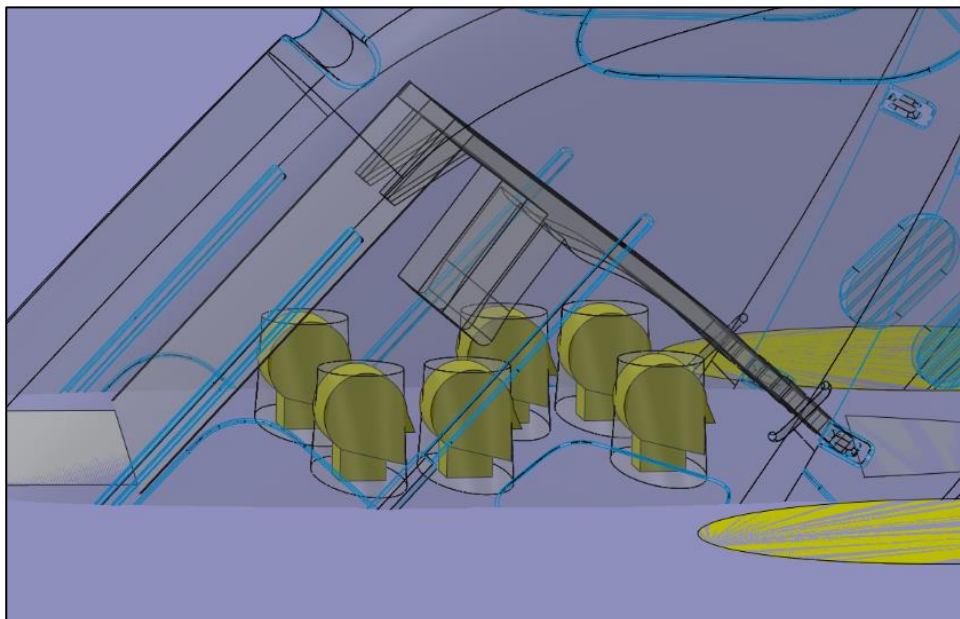
*Figure 31: Tapered air pocket: no collisions with back rest*

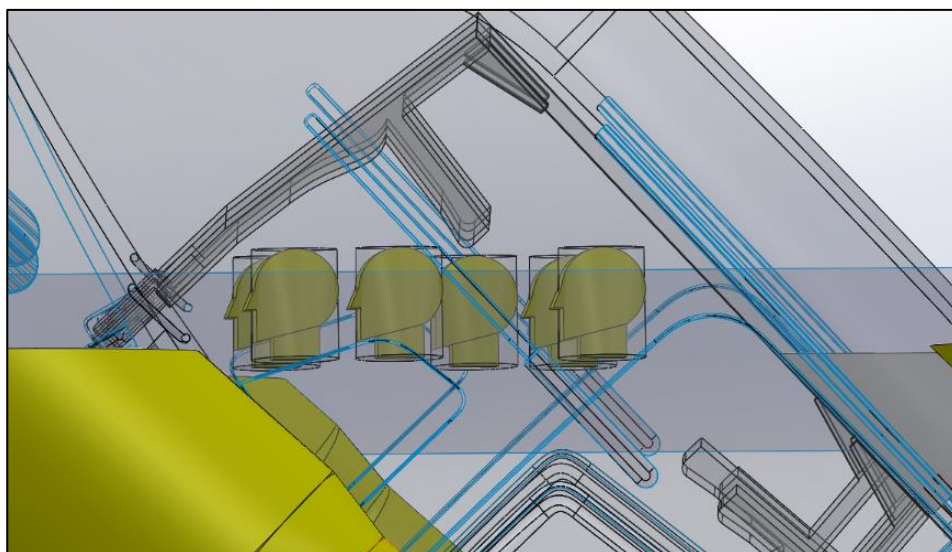
*Figure 32: Tapered air pocket: no collisions with seats, back rests, and floor*

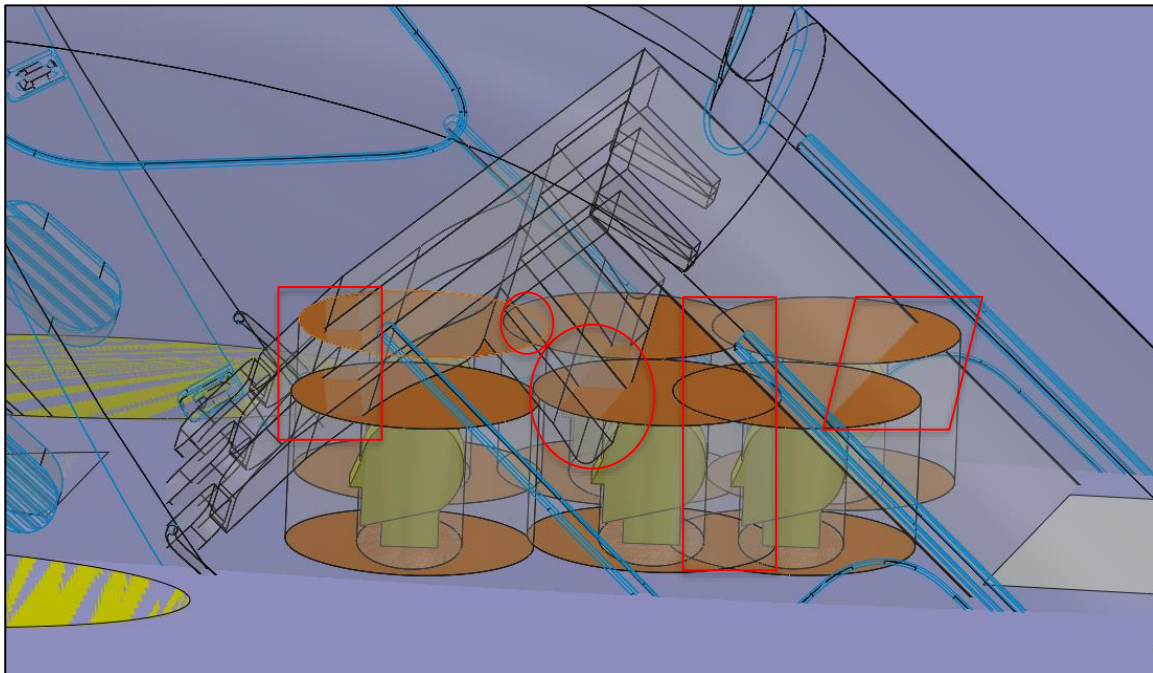
#### 3.3.1 CS27 HEFS, Heavy FWD CG, HEFS LH FWD-Most Compartment Damaged, NPA 2016-01: Fail.

*Figure 33: NPA Air Pocket: collisions with back rest, seats, floor, and other air pockets*

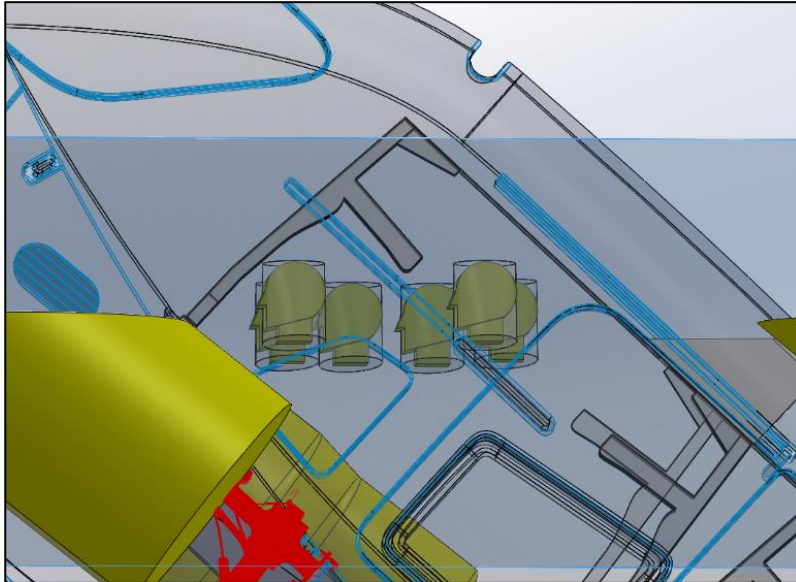
### 3.3.2 CS27 HEFS, Heavy FWD CG, HEFS LH FWD-Most Compartment Damaged, Tapered: Pass.

*Figure 34: Tapered air pocket: no collisions with back rest, seats, and floor*

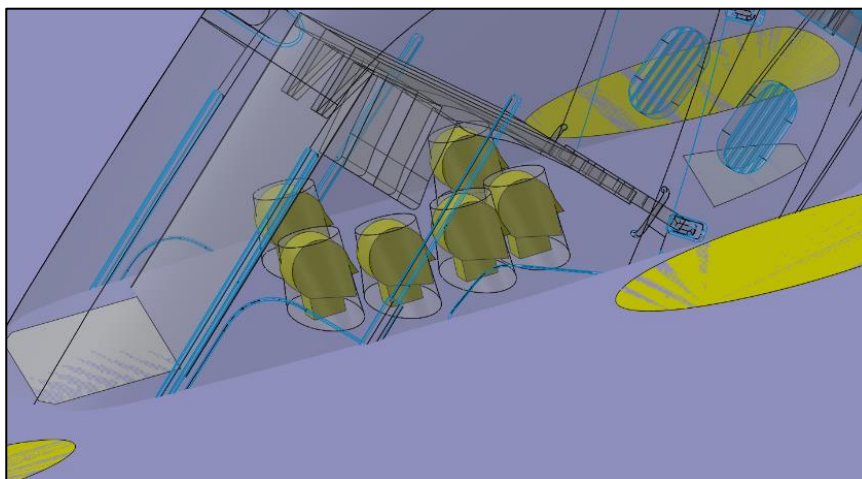
*Figure 35: Tapered air pocket: no collisions with other air pockets*

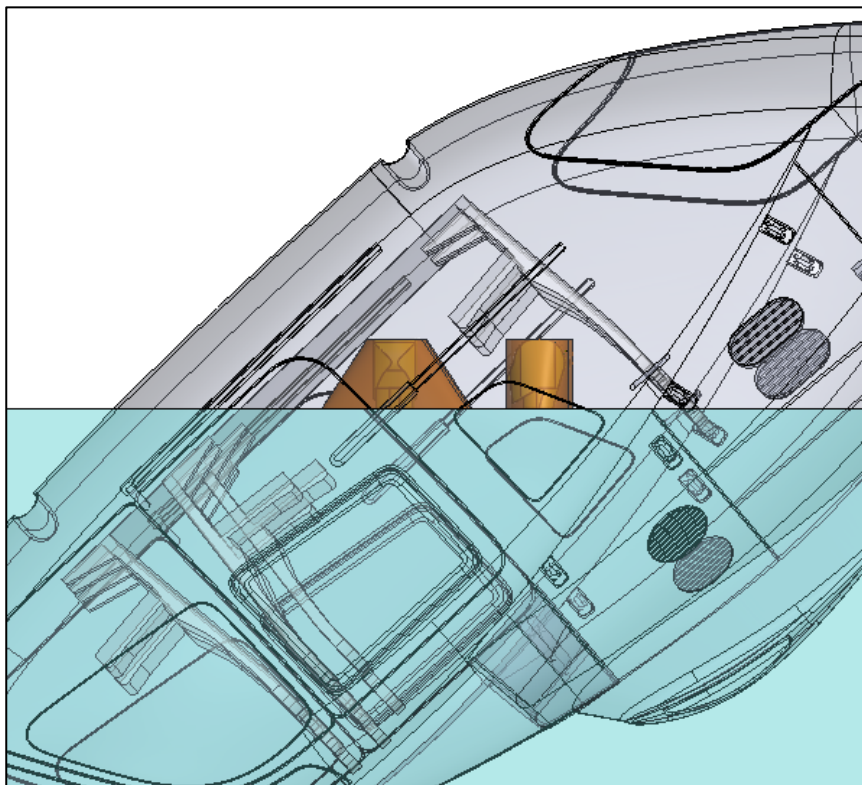
*Figure 36: Revised Tapered air pocket: no collisions with back rest, seats, and floor*

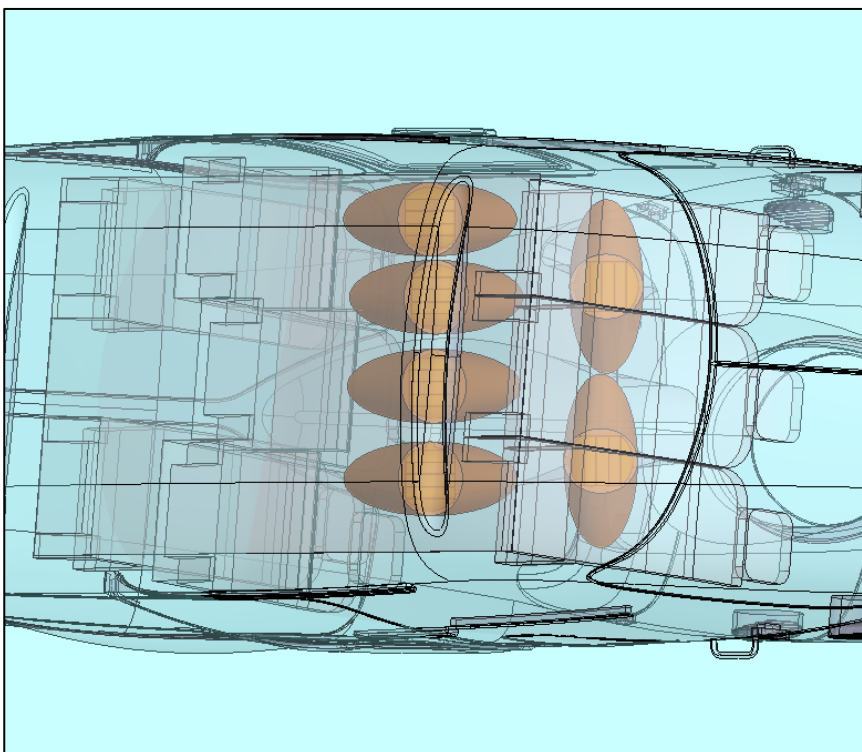
*Figure 37: Revised Tapered air pocket: no collisions with other air pockets*

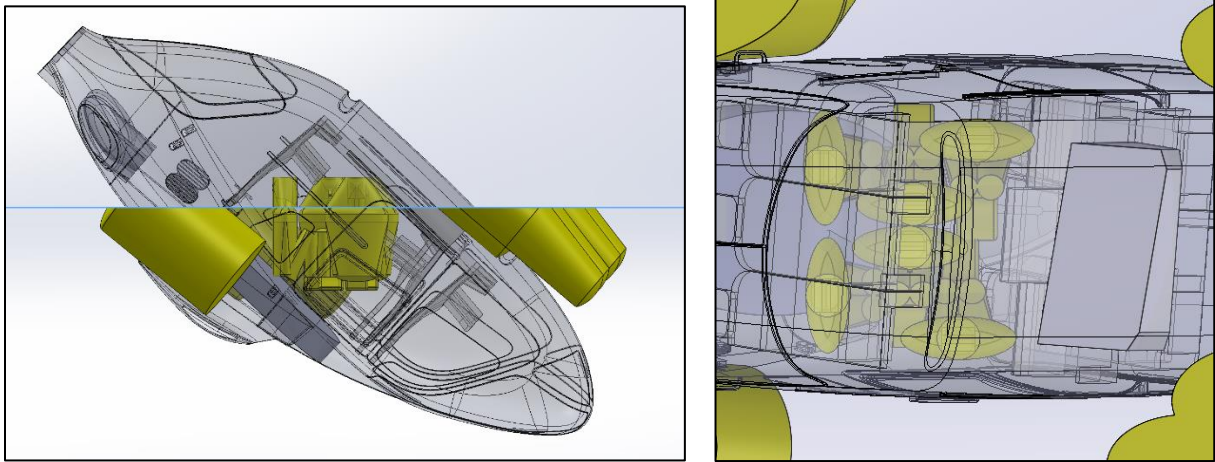
Figure 38: CS27 HEFS Damaged Full Capsize with Body Models
