***EASA REGULATORY IMPACT ASSESSMENT***  
***ENHANCED FUSELAGE BURNTHROUGH PROTECTION***  
***JULY 2009***  
Issue 3

This Regulatory Impact Assessment (RIA) considers the feasibility of introducing a new CS-25 regulation to provide an objective rule for enhanced fuselage burnthrough resistance from pool fires and possibly the deletion of the existing requirements relating to burnthrough resistance being provided by Thermal Acoustic Insulation.

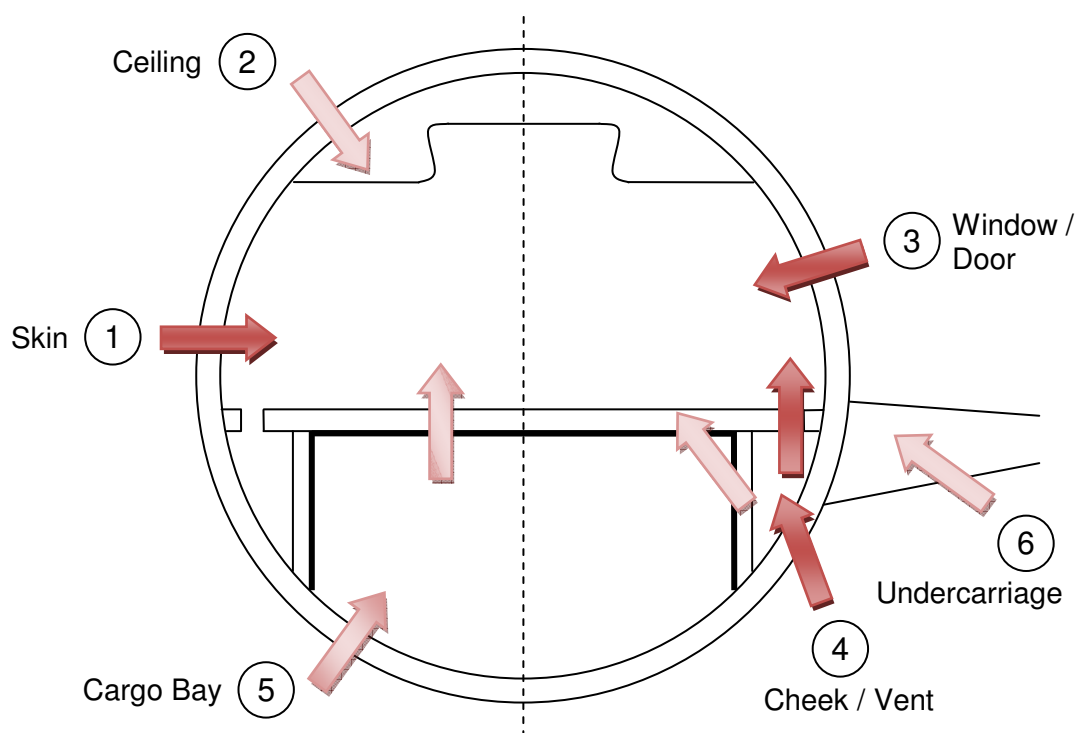
**Figure 1: Typical Fire Paths into the Passenger Cabin**

The fire path indicated by (1) in Figure 1 represents a direct burnthrough in the side of the passenger cabin. The CAA study indicated that the fire would need to penetrate the fuselage skin, insulation system and cabin sidewall panel. In fire path (2), the fire penetrates the upper fuselage skin, insulation system and then ceiling panels or overhead stowage bins. In these areas, smoke is likely to penetrate into the cabin before fire due to the gaps between the cabin interior panels.

Fire paths through the lower fuselage (4) include burnthrough of the fuselage skin and then the insulation bags into the cheek area. The cheek area can often span a significant length of the fuselage (normally only stopped by wing box/main landing gear stowage), allowing fire to spread down the length of the fuselage and follow any path available into the passenger cabin. Once in the cheek area, the primary paths for fire to enter the cabin are either through the main cargo compartment or through the return air grills in the dado panel. For new Part 25 aircraft carrying passengers only, a class C compartment (see CS 25.857) would be used for the main cargo compartment, which consists of sidewall and ceiling cargo liners tested to CS-25 Annex F Part III (see CS 25.855). This presents a significant fire barrier and therefore the immediate threat to the cabin will be through the return air grills. Fire path (5) through the lower fuselage into the cargo compartment would require penetration of the fuselage skin, insulation bags and then the cargo compartment floor and liner. Unlike the sidewall and ceiling liners, the floor liner of a class C cargo compartment needs only meet the less stringent CS-25 Annex F Part I test, however the fire would still need to penetrate the ceiling liner, cabin floor and its covering before entering the passenger compartment. Additionally, full-scale fire testing conducted by the FAA (Reference 10) indicated that the aircraft is less vulnerable to path (5) when the gear is collapsed; however, the exposed cheek area (path 4) is a likely area for flame penetration with gear in either position.

The final fire path (6) identified in the CAA study was through the main landing gear bay. With the landing gear extended, fire may enter the bay and have direct access to the pressure floor. To enter the cabin, the fire would need to burnthrough the pressure floor, insulation system and then cabin floor. The extent of opening into the landing gear bay is dependent on the aircraft design; some aircraft may have the doors open and others may be partially or fully closed when the landing gear is extended. A similar situation would exist for the nose gear bay.

In summary, the fire path of least resistance to the passenger cabin from the upper fuselage is likely to be through the skin (path 1) or a cabin window (path 3). Through the lower fuselage, burnthrough into the cheek area can provide direct entry into the passenger cabin through the return air grills. These are indicated in Figure 1 by the darker arrows. When considering the entire aircraft length, there are additional lower fuselage fire paths in areas without the cargo compartment, which would present a similar fire path as the cheek areas. The FAA testing (Reference 10) indicated that the aircraft is more vulnerable with the gear extended, due to the larger surface area exposed to the fire. This configuration exposes additional paths through the main and nose landing gear bays which may be open. Additionally, the empennage cawltthrough is generally only partially insulated and can provide a direct path through the skin.

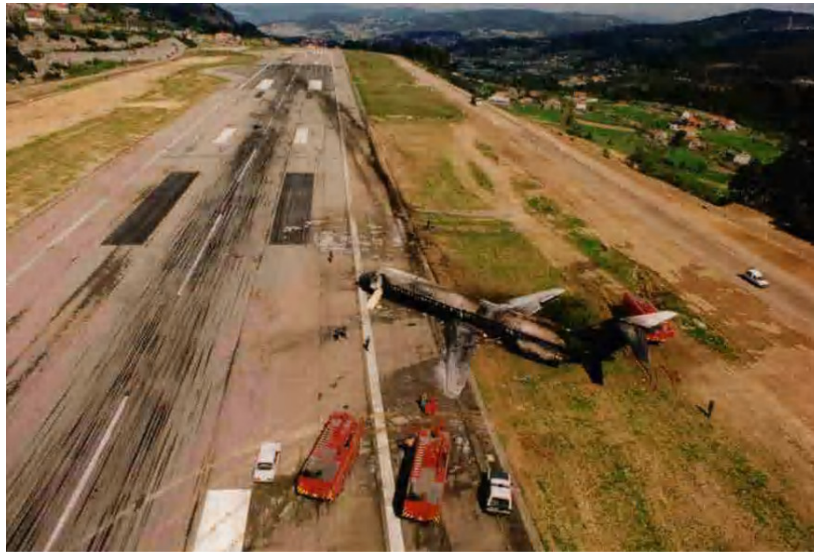
*"This accident occurred at Vigo Airport, Spain on March 21st 1994 and involved a McDonnell Douglas DC 9-32 aircraft. The aircraft was too low on approach. The main undercarriage contacted approach lights and upward sloping ground just ahead of the runway, detaching the main undercarriage legs and part of the right hand wing fuel tank. Leaking fuel ignited and the fire followed the aircraft to where it stopped just to the side of the runway. When the aircraft stopped, the fire passed to the left side and affected practically the whole of the exterior of the plane, causing heavy damage.*

**Figure 3: Burnthrough Accident: DC-9-32, Vigo, Spain, March 21st 1994**

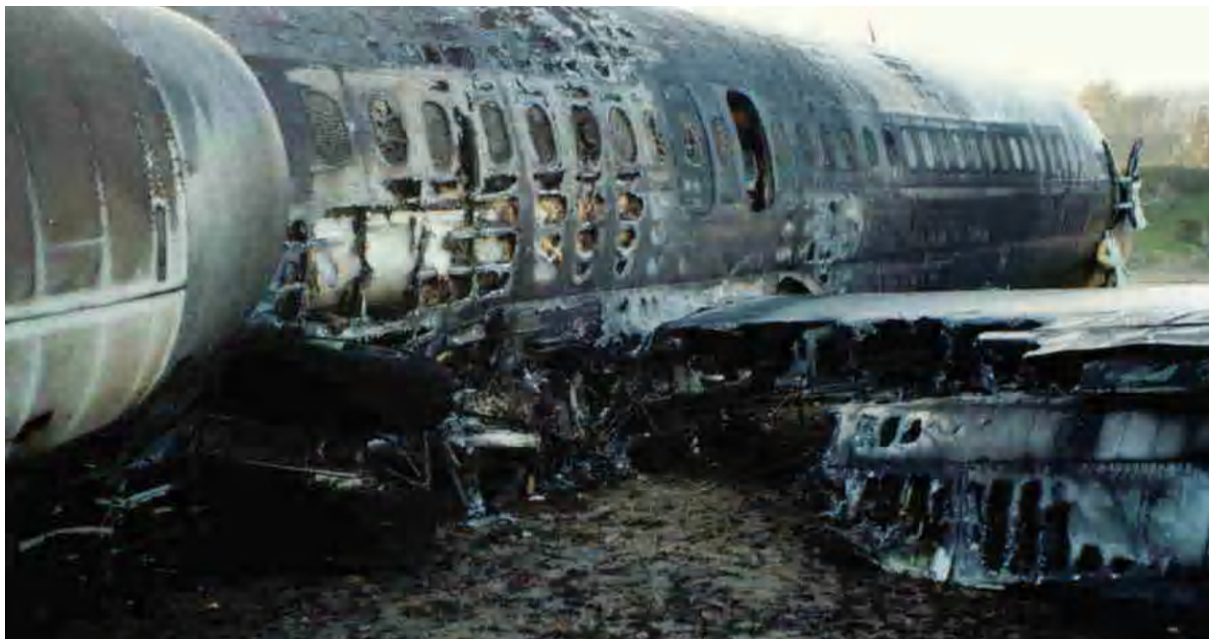
The extent of fire damage to the exterior of the starboard rear fuselage is shown in Figure 4 and Figure 5. The intense fire burned through the lower fuselage skin revealing the thermal acoustic insulation. Two of the fuselage frames were burned through. The upper half of the fuselage was burned through around and above the cabin windows. However, the extent of burnthrough of the upper fuselage is significantly less than through the lower fuselage.

**Figure 4: Vigo DC-9-32 Skin Burnthrough of Lower and Upper Fuselage**

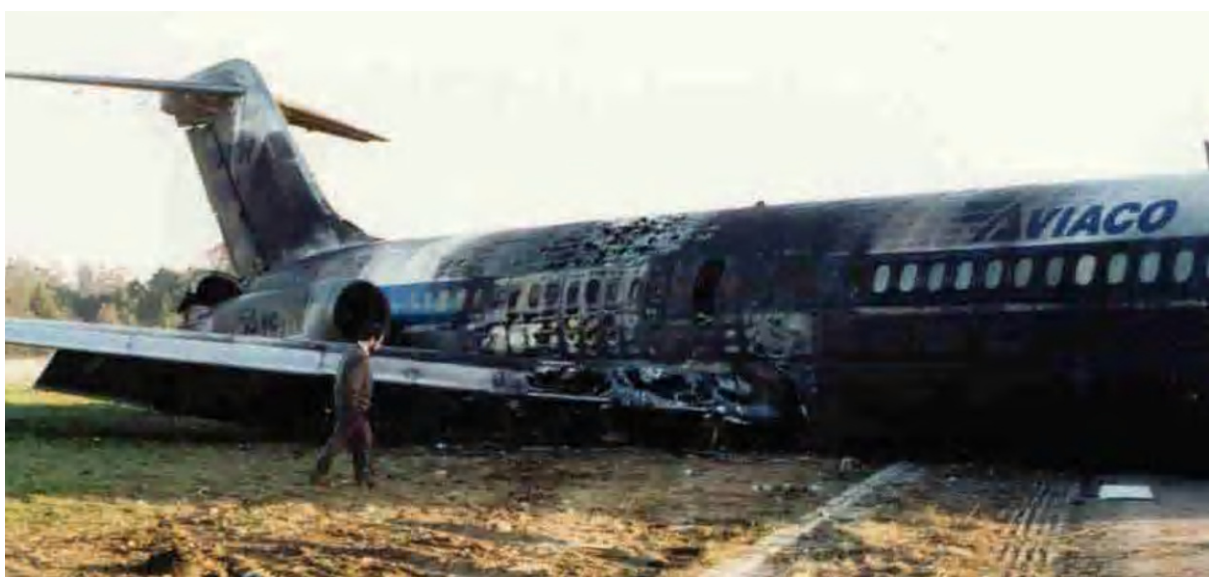
**Figure 5: Vigo DC-9-32 External Fire Damage Starboard Side**

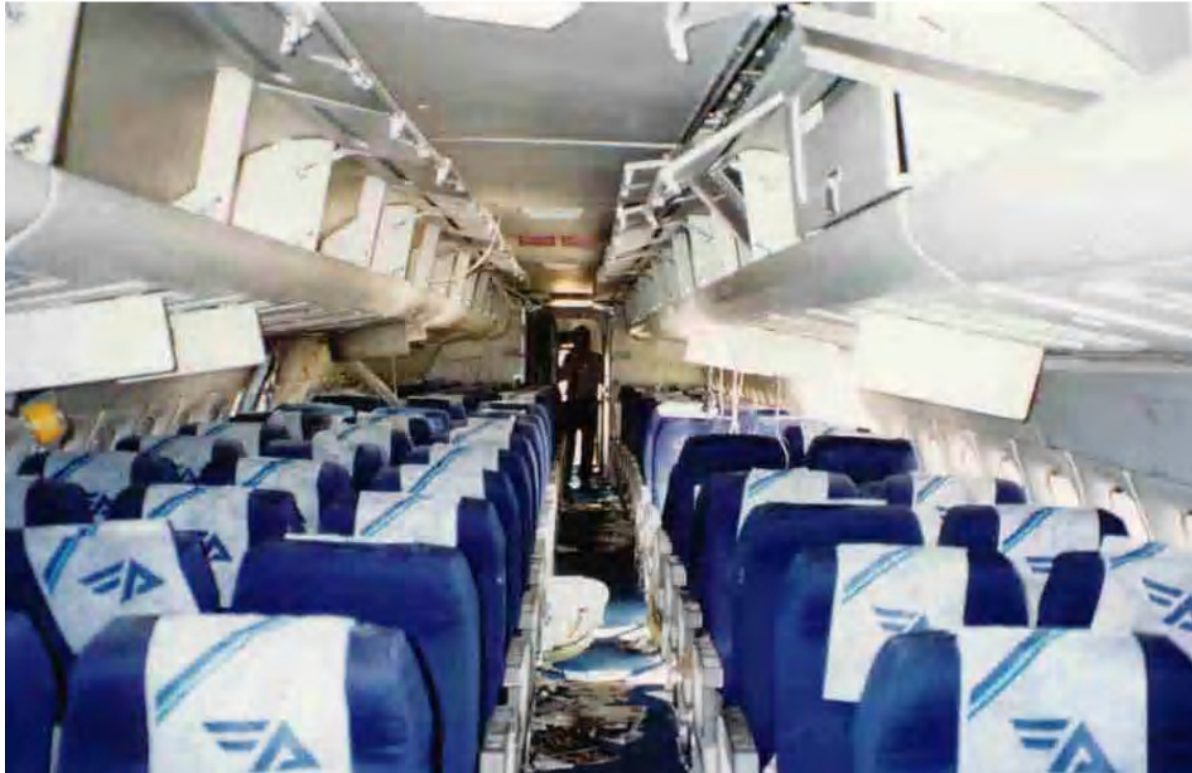
The cabin interior suffered minimal damage considering the intensity of the fire - see Figure 6. The interior fire damage would have been worse had the fire not been extinguished so rapidly.

**Figure 6: Vigo DC-9-32 Minimal Fire Damage to Cabin Interior**

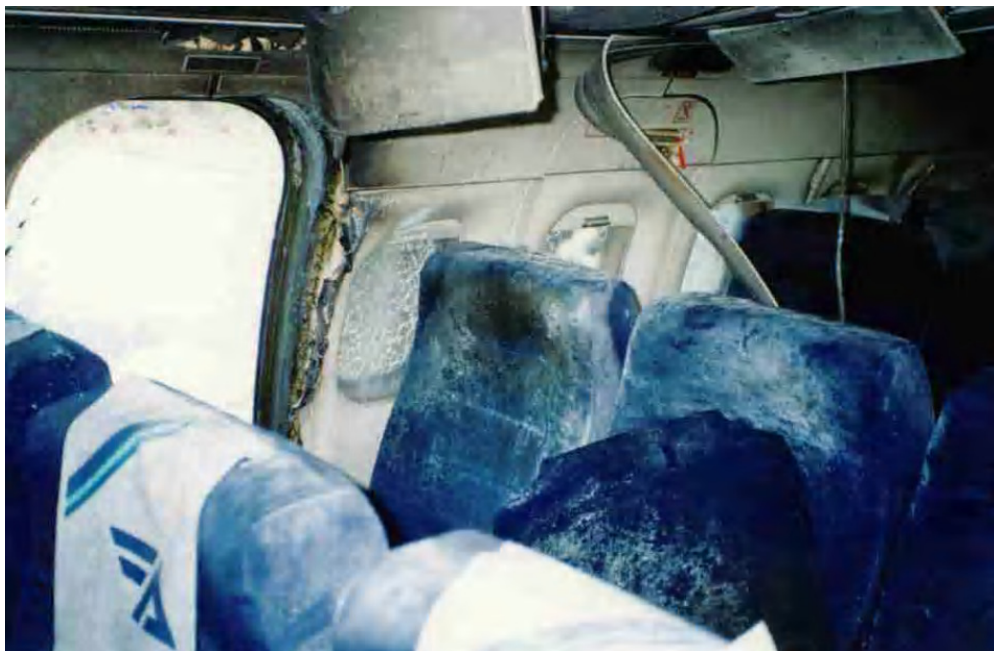
The starboard Type III overwing exit, opened during the evacuation, allowed fire to enter the cabin and locally scorch the interior materials - see Figure 7.

**Figure 7: Vigo DC-9-32 Scorching Near Starboard Overwing Emergency Exit**

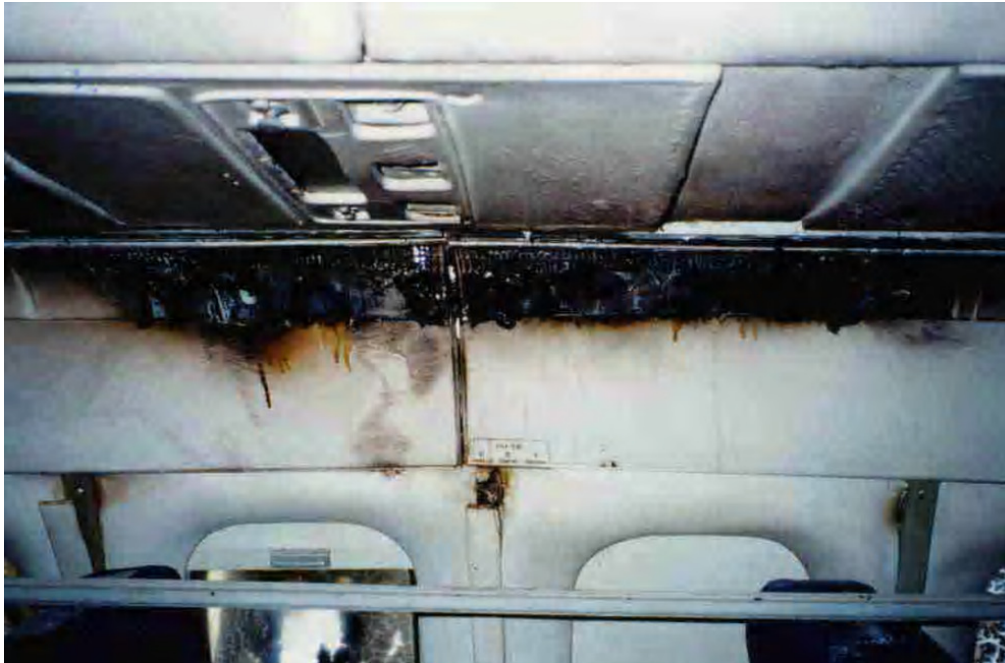
Figure 8 shows fire damage to the interior cabin materials above the level of the cabin windows. The Spanish accident investigation authority CIAIAC has confirmed the internal fire damage was caused by the external burnthrough above the windows and not from fire entering the Type III Overwing Exit opened during the evacuation.

**Figure 8: Vigo DC-9-32 Localized Fire Damage Due to Upper Fuselage Burnthrough**

It is evident that in this accident the fire burned through the upper fuselage skin, burned some of the cabin lining materials, and penetrated the cabin in significantly less than 5 minutes.

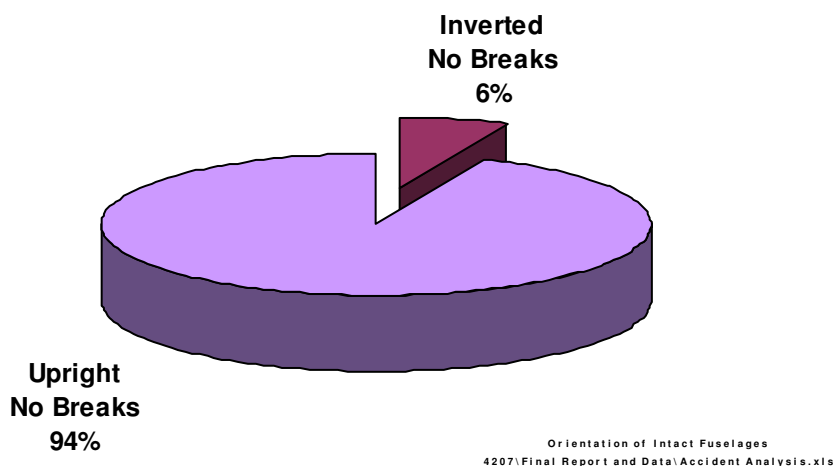
As shown in Figure 9, for pool fire accidents where the fuselage remains substantially intact as a result of the impact, 6% involve an inverted fuselage.

**Figure 9: Proportion of Inverted Fuselages in Ground Pool Fire Accidents Not Involving Fuselage Breaks**
