Notice of Proposed Amendment 2017-06

Loss of control or loss of flight path during go-around or other flight phases

RMT.0647

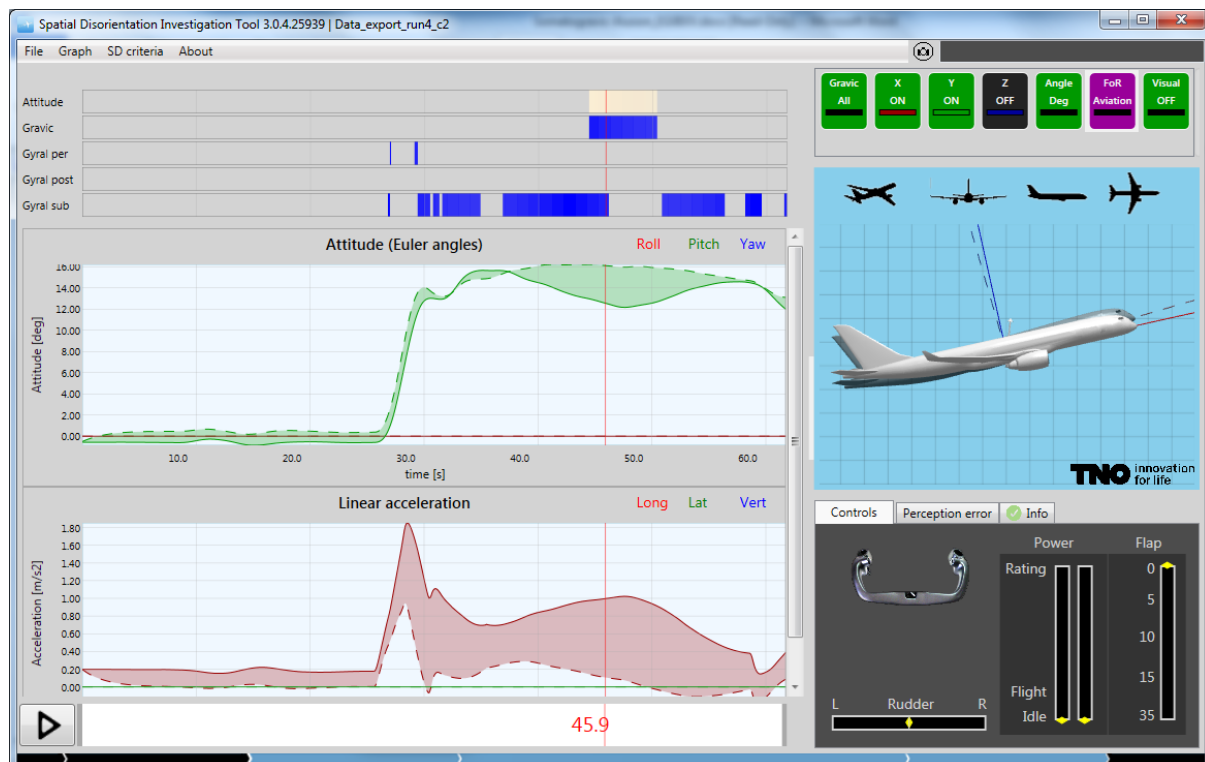
- The second profile represented a G/A with higher performance: the mass/thrust ratio was set at a low level, taking a GW of 55t and applying full G/A thrust. In this case, after the rotation there is no pitch reduction applied by the autopilot (because of the highest performance). However, after some time, the perceived pitch angle increases while the real pitch angle starts to decrease. A potential risk of somatogravic illusion is thus evidenced also in this case. Furthermore, this situation is maintained over a longer time period (more than 25 seconds) than in the reduced G/A thrust case above (approx. 15 seconds). See the figure below:

Legend: Full lines represent the actual values; dashed lines represent the perceived values.

Keeping in mind the limitations of this experiment (flight data from a fixed simulator processed through a tool simulating the somatogravic illusion), the analysis of the two cases concluded that:
