#### Project EASA.2008.C18

Study on CS-25 Cabin Safety Requirements

#### STUDY ON CS-25 CABIN SAFETY REQUIREMENTS

Issue 6

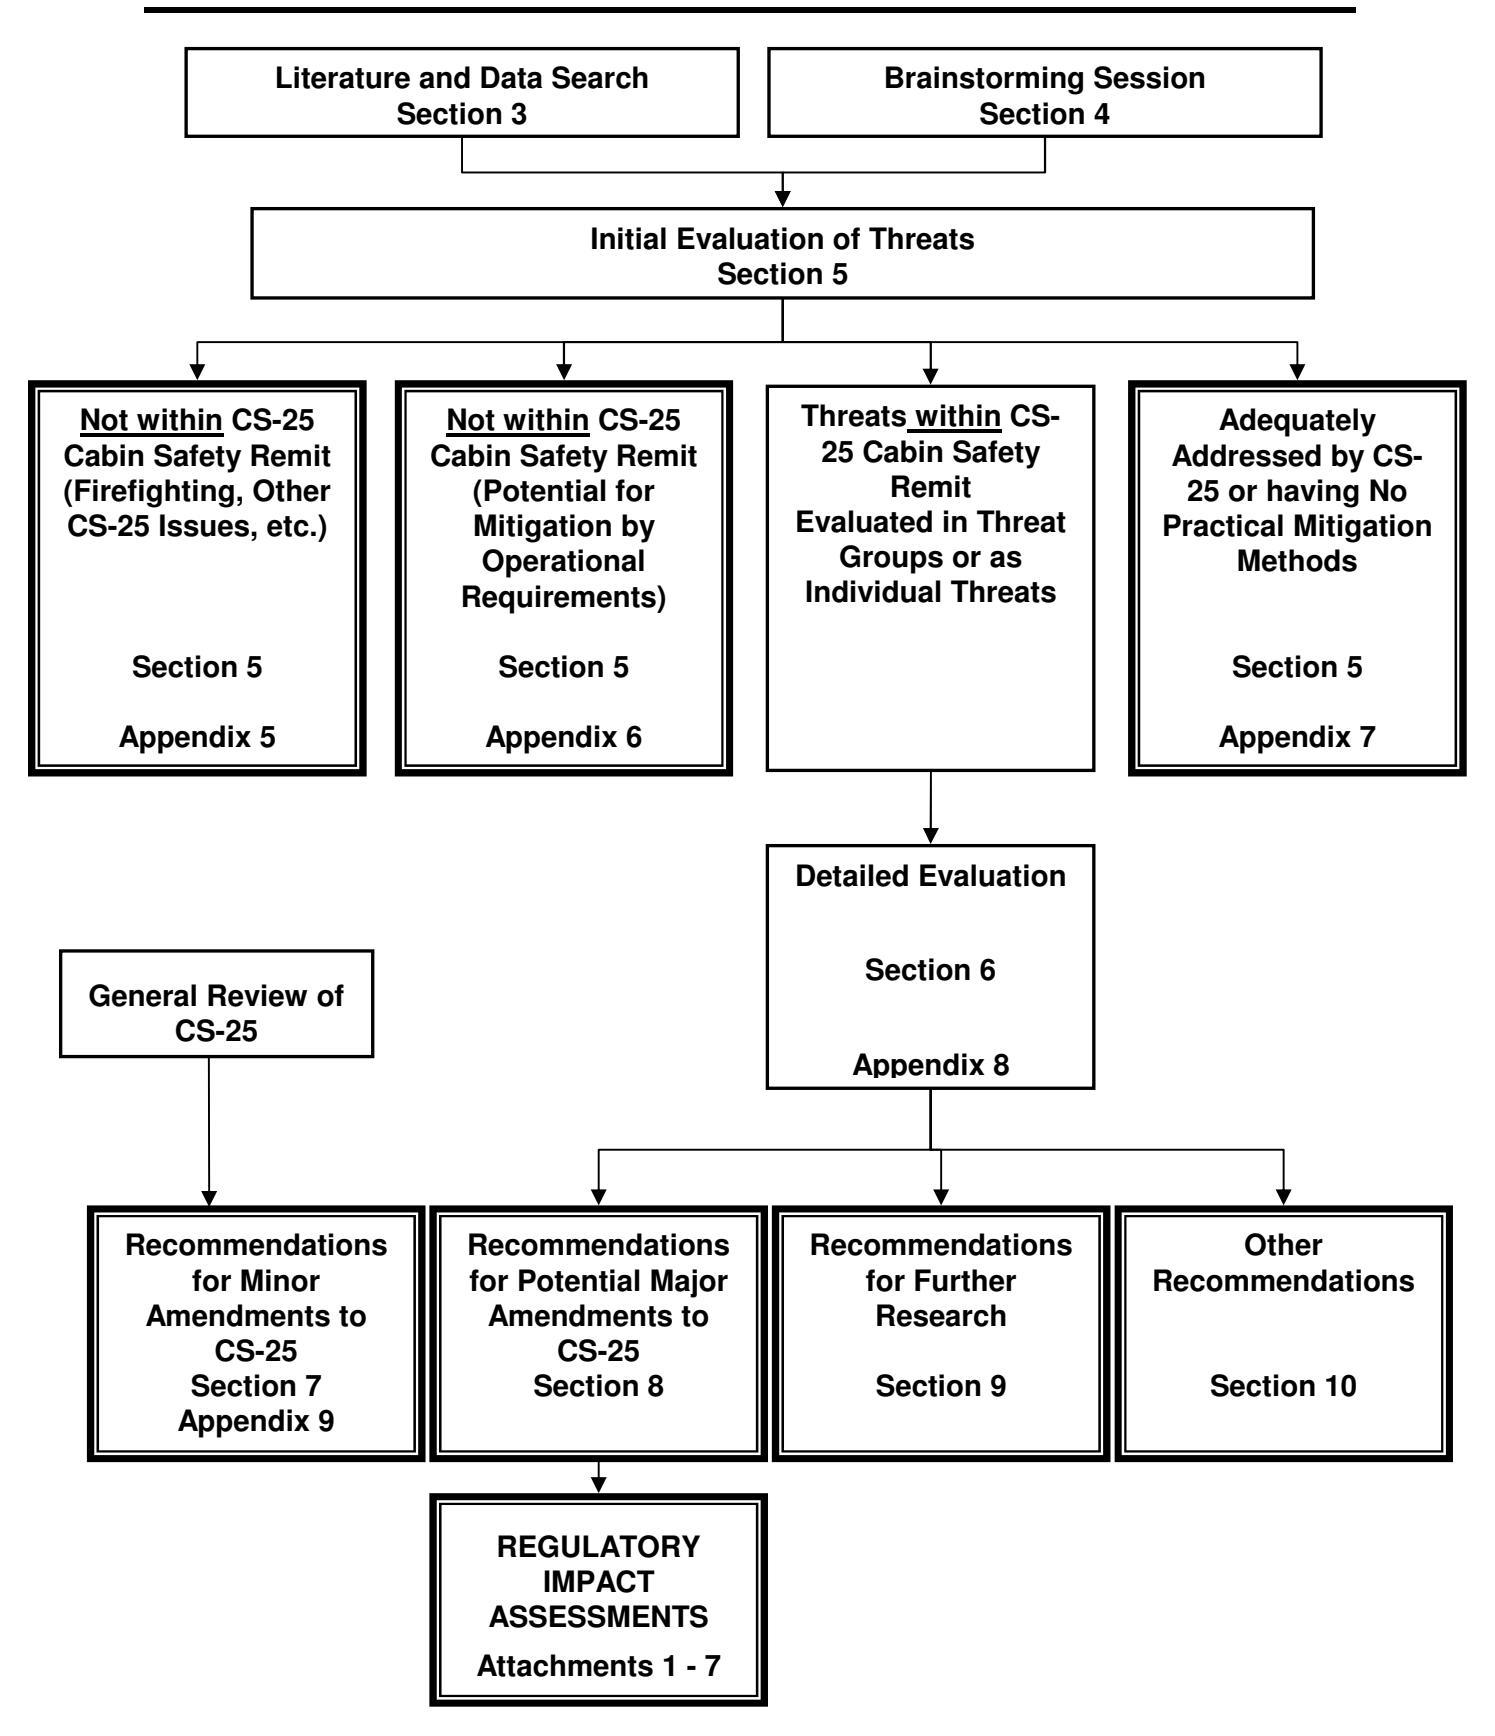
Figure 1 Overview of methodology and the associated sections of the report

The methodology adopted in this study is illustrated in Figure 1. Figure 1 also references the sections of the report that provide a more detailed description of the methods adopted and the results of the evaluations carried out during the study.

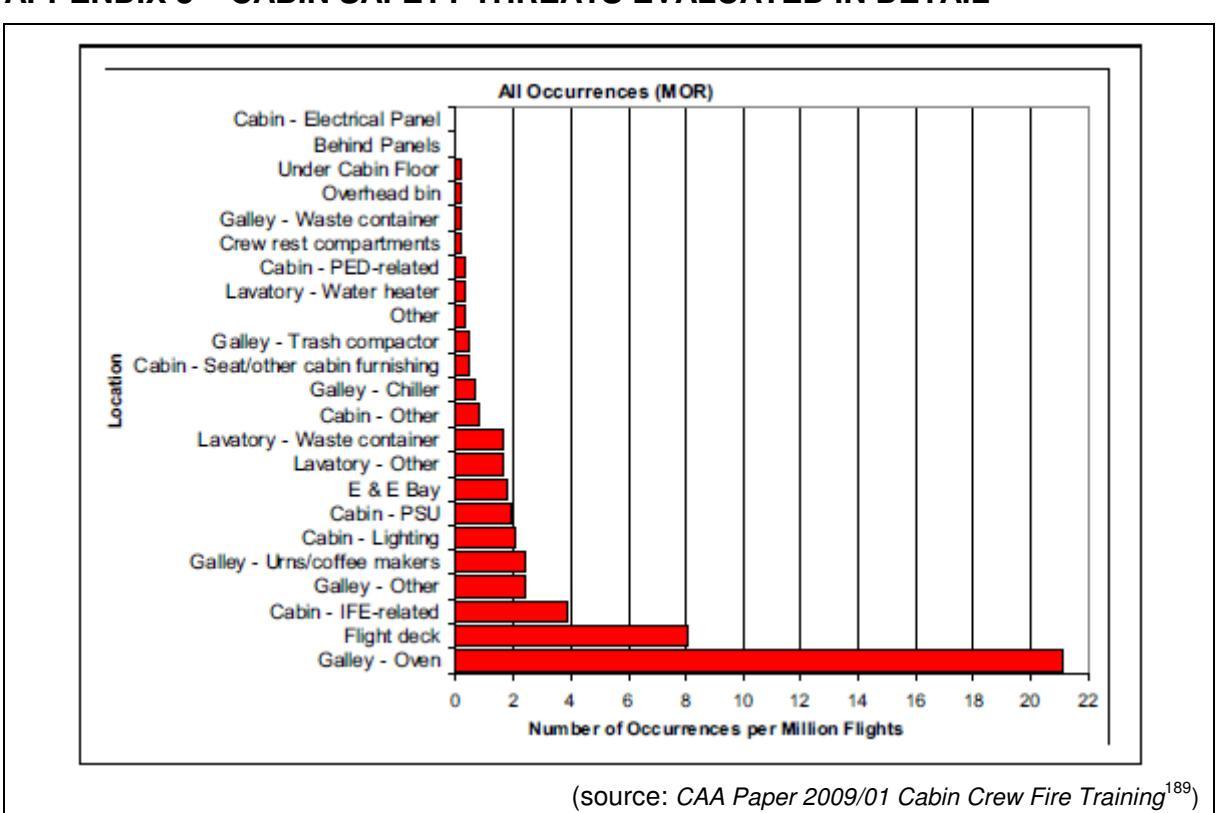
The accident review did not identify the other in-flight fire threats addressed in this section. Most of the other types of in-flight fires such as cabin fires (e.g. galley fires, IFE/seat fires, lavatory fires, etc) were reported as incidents. A study on cabin crew fire training carried out on behalf of the UK CAA found that over the period of 2002-2006, there were 316 in-flight fire occurrences (incidents) on UK registered aeroplanes<sup>189</sup>. The bar chart below describes the rate of the occurrences (note: UK fleet accumulating approximately 6,204,000 flights in the analysis period):
