## Annex B: Results on composite plates

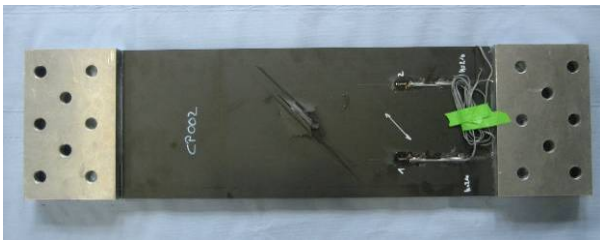
| Notch damage + large delamination | |

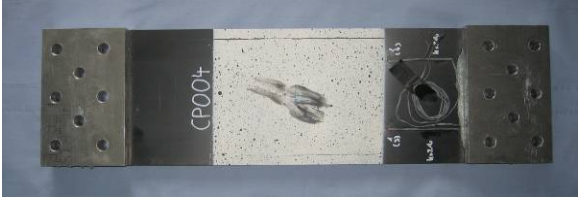
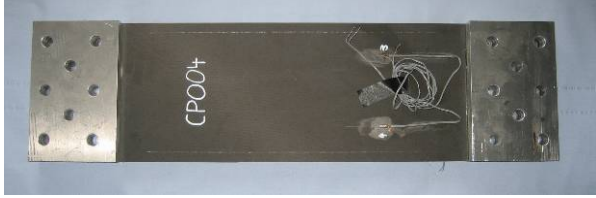
| No visible damage | |

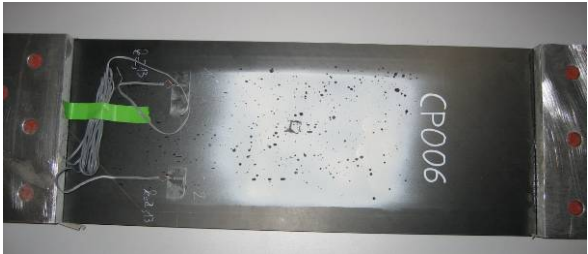
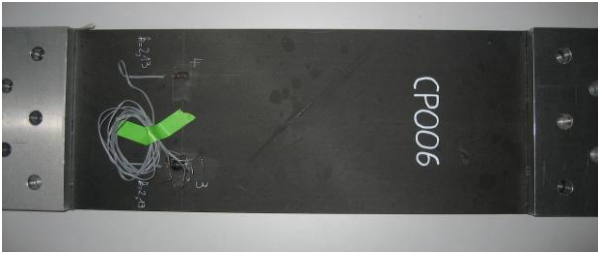
| Cube rebounded / Square flap damage with delamination | |

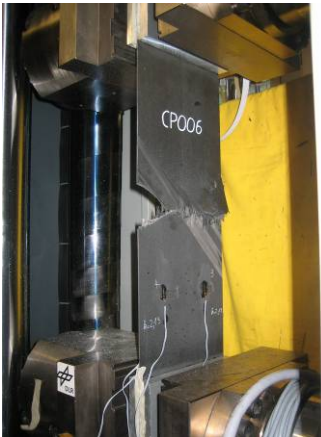
| | <p>Failure load= 233 kN</p> <p>Residual strength factor = 0.53</p> |

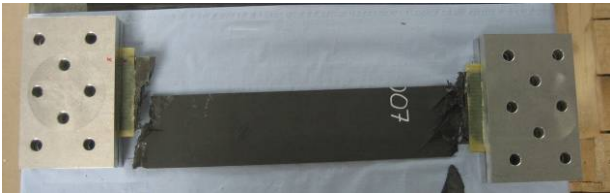
| <b>CP007b (cut from CP007)</b> | |
|---|---|
| | <p>A new “tabs/bonding” concept has been investigated in order to be able to conduct the test until the failure of a 200 mm wide undamaged plate. One of these concepts consists in including a GRP tabs insert between the carbon test plate and the original aluminium tabs in order to attenuate the constraints concentration at the tabs edge. In comparison to the concept used for CP007a.</p> <p>Failure at GRP tab/composite interface.</p> <p>Failure load= 195.6 kN (1.45% strain) for a 100 mm wide test plate</p> <p>Estimated failure load (200 mm wide test plate) = 391.2 kN</p> |

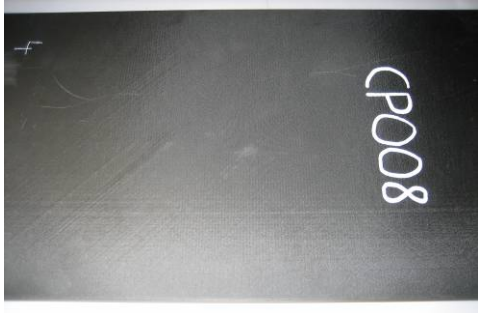
| <p style="text-align: center;">Impact side</p> | <p style="text-align: center;">Rear side (zoom)</p> |

| No damage at front, delamination damage back | |

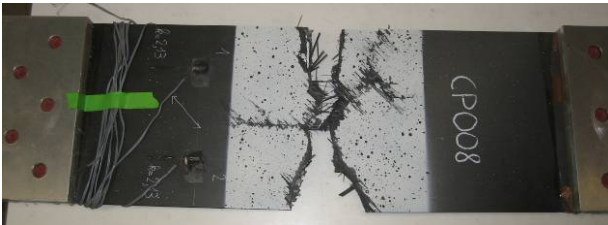
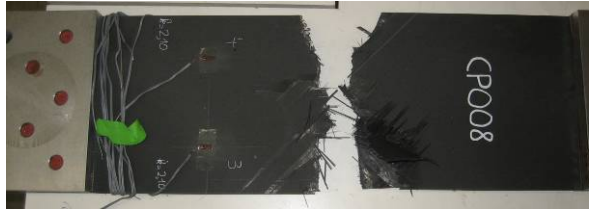
| <p>Failure load= 328.6 kN</p> <p>Residual strength factor = 0.75</p> | |

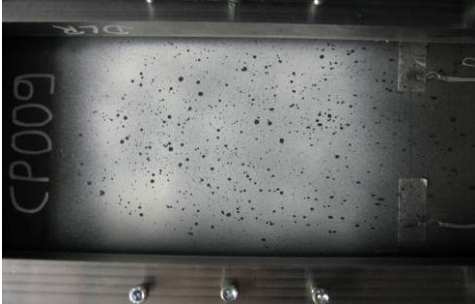
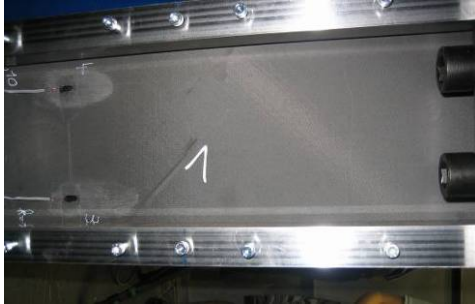
| <p>Impact side</p> | <p>Rear side</p> |

| Dent at front, delamination damage back | |

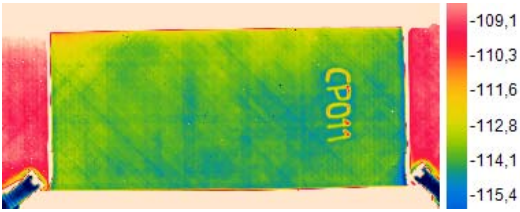
| <b>CP011</b> | |

| <p><u>Average thickness:</u> 3.10 mm</p> <p><u>Visual inspection:</u> alright</p> <p><u>Lock-in thermography:</u> Uniform picture / No pre-damage</p> | |

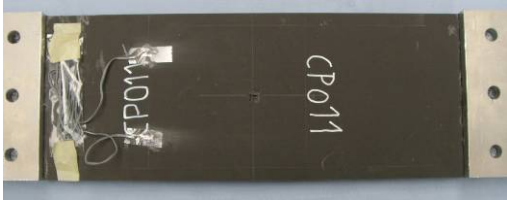
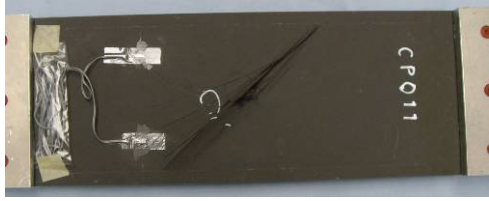
| <b>Impact on convex face / Cube passed through / notch damage, large delamination at back face</b> | |

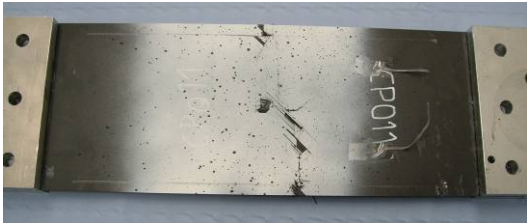
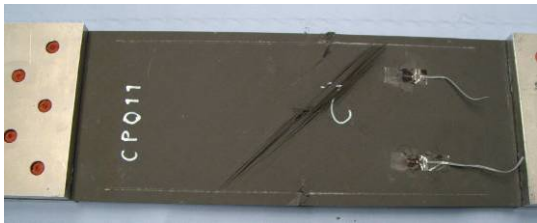
| <b>Residual strength test (compression)</b> | |

| <p>Failure load= 135.6 kN</p> <p>Residual strength factor = 1.02</p> | |

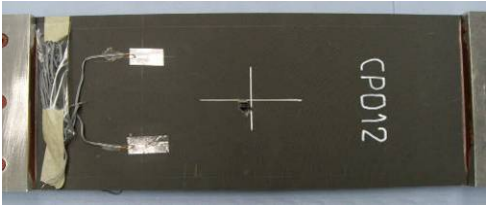
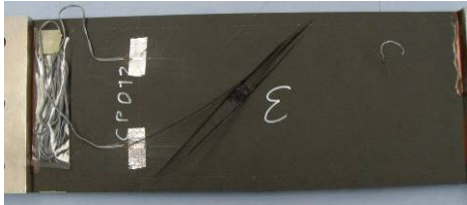
| <b>Impact on convex face / Cube passed through / notch damage, large delamination at back face</b> | |

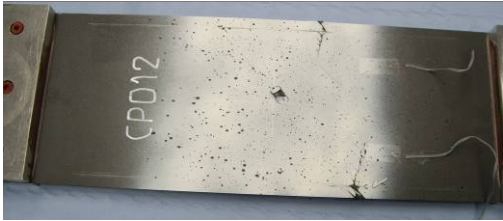
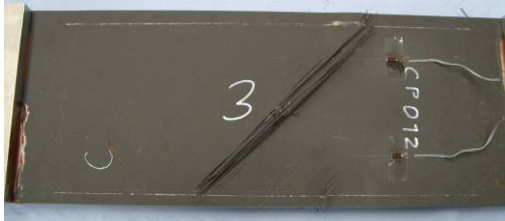
| <b>Residual strength test (compression)</b> | |

| <p>Failure load= 127.2 kN</p> <p>Residual strength factor = 0.96</p> | |

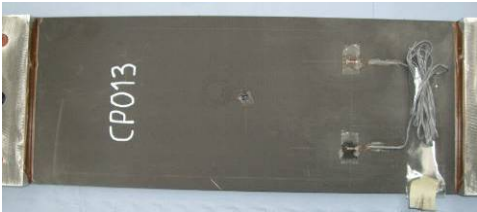
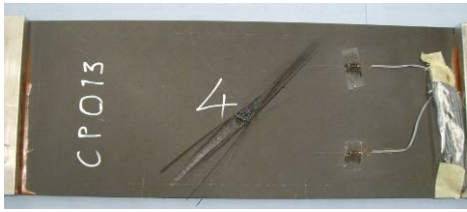
| Cube passed through / notch damage, delamination at back face | |

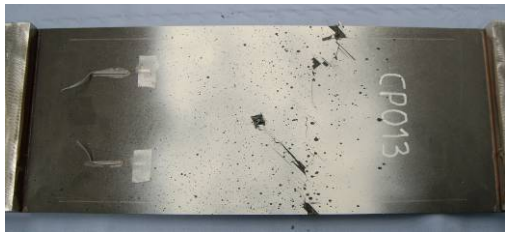
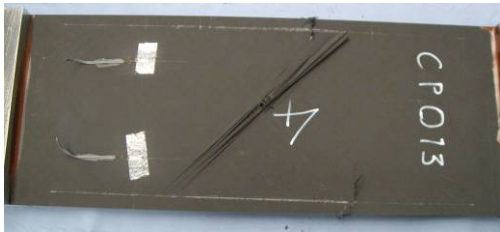
| <b>Residual strength test (compression)</b> | |

| <p>Failure load= 132.8 kN<br/> Residual strength factor = 1.00</p> | |

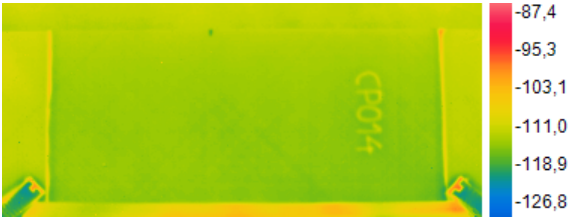
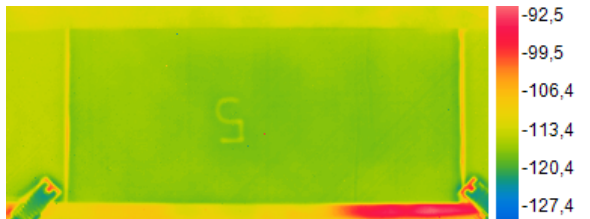
| <b>CP014</b> | |

| <p><u>Average thickness:</u> 3.1 mm</p> <p><u>Visual inspection:</u> alright</p> <p><u>Lock-in thermography:</u> Uniform picture / No pre-damage</p> | |

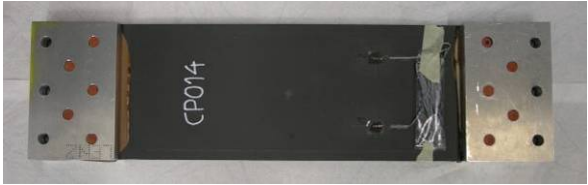
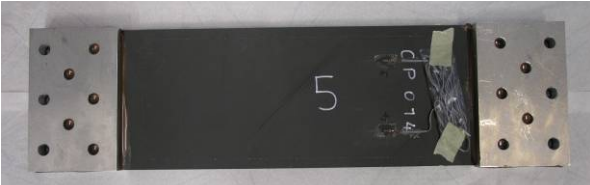
| Glass ball rebounded / Dent on front face, delamination damage on back face | |

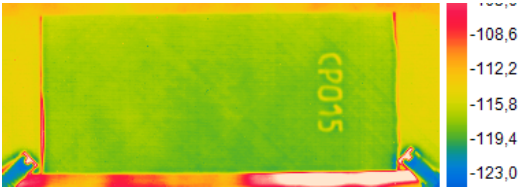
| <p><u>Average thickness:</u> 3.11 mm</p> <p><u>Visual inspection:</u> alright</p> <p><u>Lock-in thermography:</u> Uniform picture / No pre-damage</p> | |

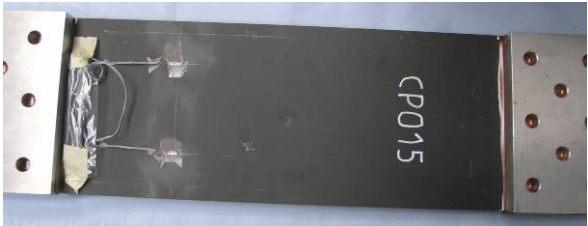
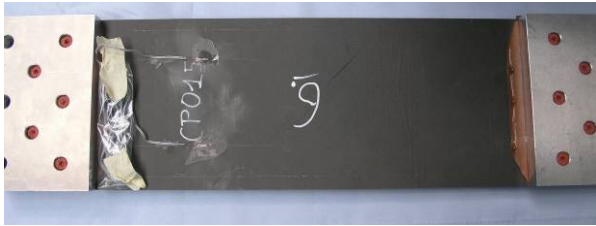
| <p><b>Impact on convex face</b> / Glass ball rebounded / Dent on front face and delamination on back face</p> | |

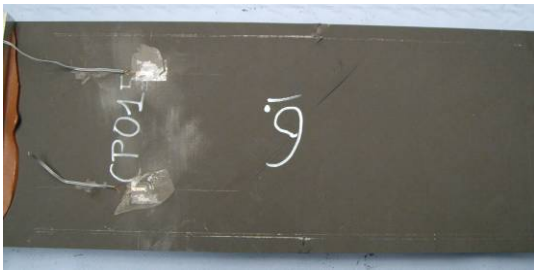
| <p>Failure load= 88.4</p> <p>Residual strength factor = 0.67</p> | |

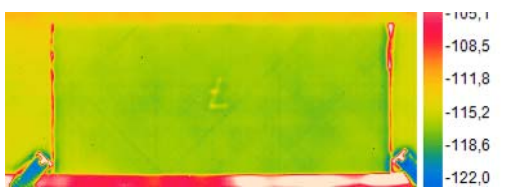
| <b>C016</b> | |

| <p><u>Average thickness:</u> 3.14 mm</p> <p><u>Visual inspection:</u> alright</p> <p><u>Lock-in thermography:</u> Uniform picture / No pre-damage</p> | |

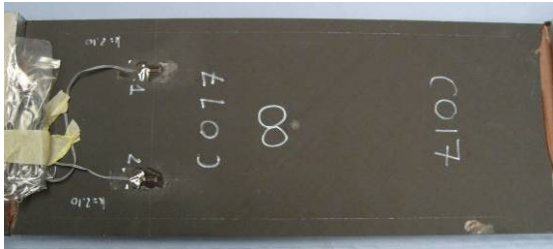
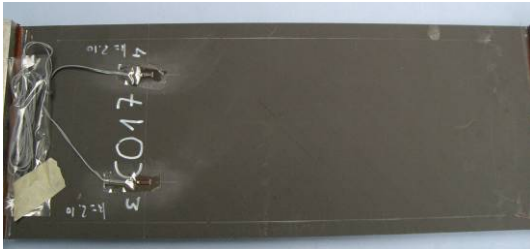
| <p>Impact side</p> | <p>Rear side</p> |

| <p><b>Impact on convex face</b> / Glass ball rebounded / Dent on front face and delamination on back face</p> | |

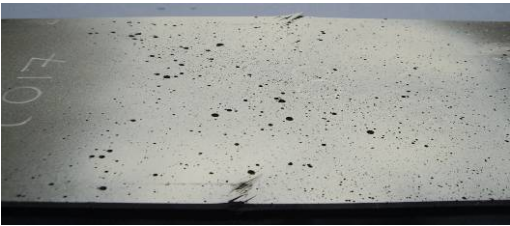
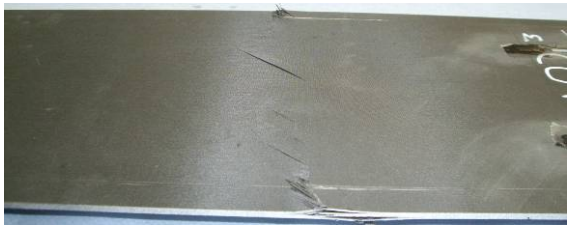
| <p>Failure load= 85.1 kN</p> <p>Residual strength factor = 0.64</p> | |

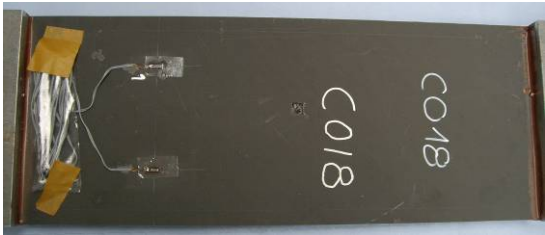
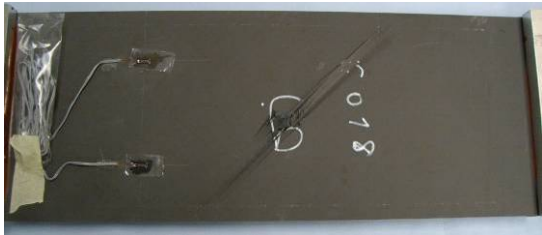
| <p>Impact side</p> | <p>Rear side</p> |

| Cube passed through / Dent on front face and delamination on back face | |

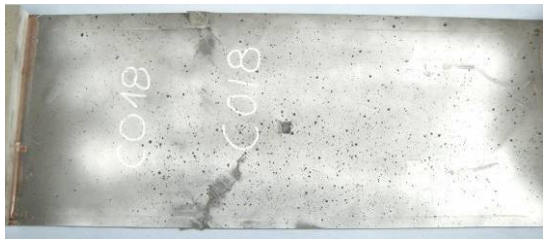
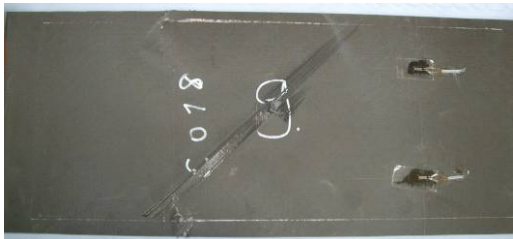
| <p>Failure load= 126.8 kN</p> <p>Residual strength factor = 0.96</p> | |

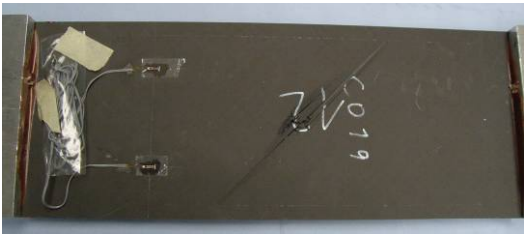
| <p>Impact side</p> | <p>Rear side</p> |

| Cube passed through / Dent on front face and delamination on back face | |

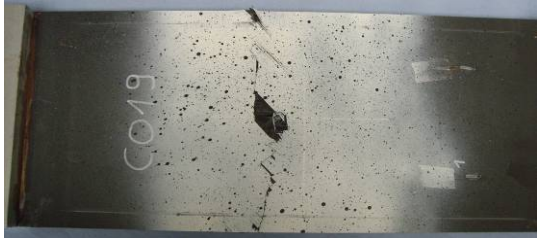
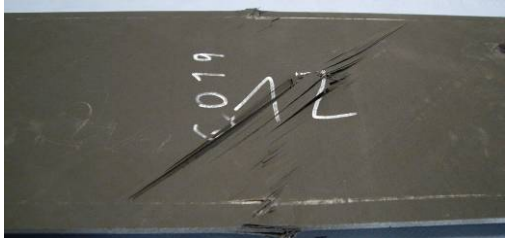
| <p>Failure load= 127 kN</p> <p>Residual strength factor = 0.96</p> | |

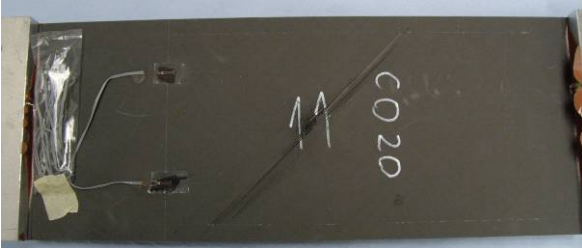
| <p style="text-align: center;">Impact side</p> | <p style="text-align: center;">Rear side</p> |

| <p><b>Impact on convex face</b> / Cube passed through / Dent on front face and delamination on back face</p> | |

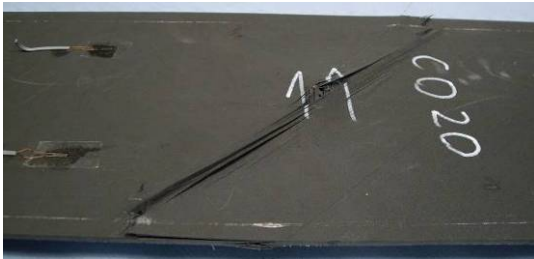
| <p>Failure load= 117.6 kN</p> <p>Residual strength factor = 0.89</p> | |

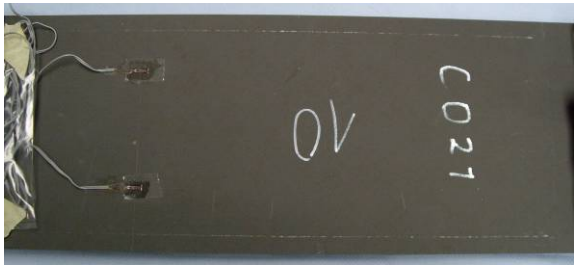
| <p>Impact side</p> | <p>Rear side</p> |

| <b>Impact on concave face / Cube stopped / Front face damage and delamination at back face</b> | |

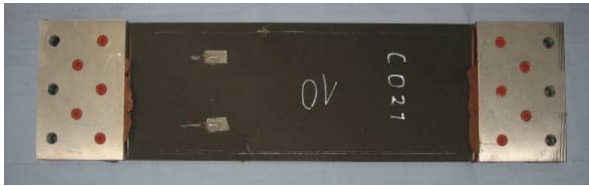
| <p>Failure load= 124.9 kN</p> <p>Residual strength factor = 0.94</p> | |

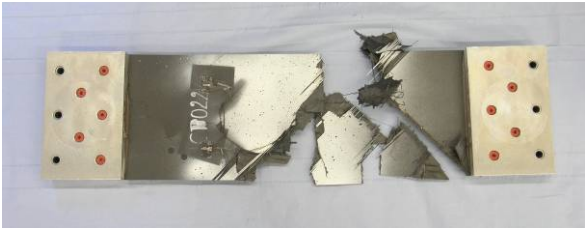
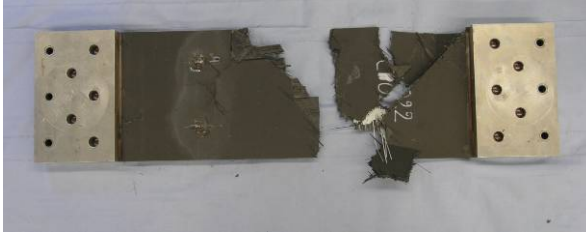
| Failure load= 431.6 kN | |

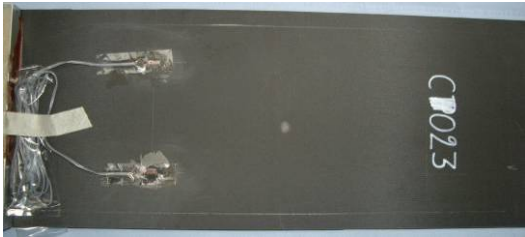
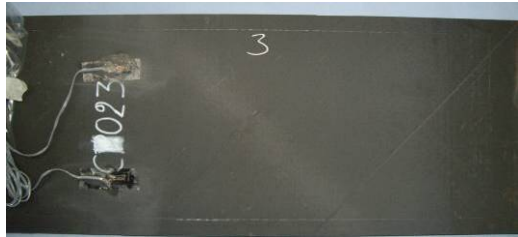
| Rebound with small mark at front / delamination at back face | |

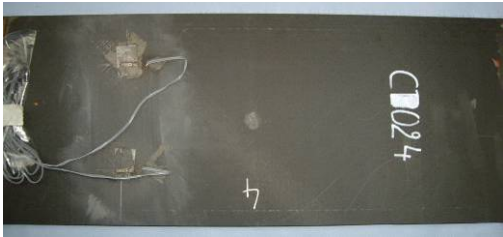
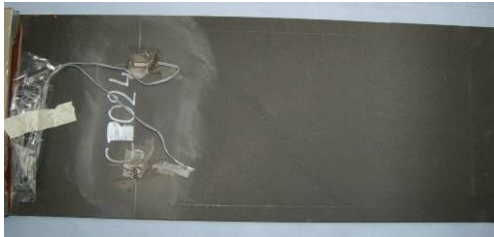
| <b>C024</b> | |

| Rebound with small mark at front / delamination at back face / No film | |

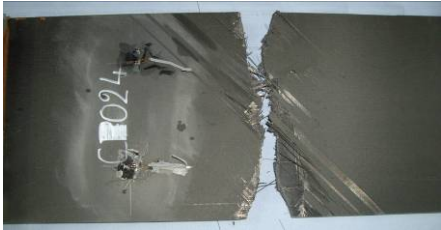
| <p>Failure load= 273.1 kN</p> <p>Residual strength factor = 0.63</p> | |

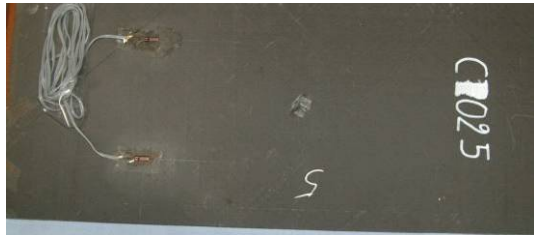
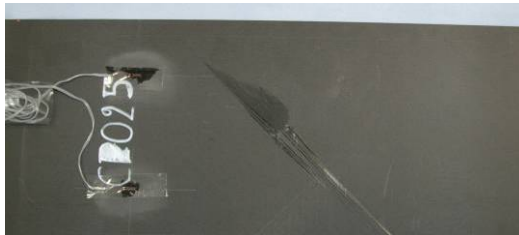
| <b>C025</b> | |

| Cube passed through / Square hole notch damage, delamination at back face | |

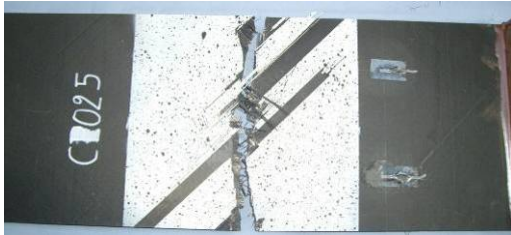
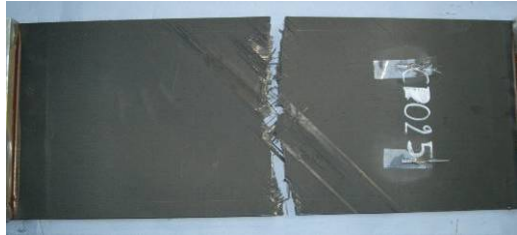
| <p>Failure load= 215.7 kN</p> <p>Residual strength factor = 0.50</p> | |

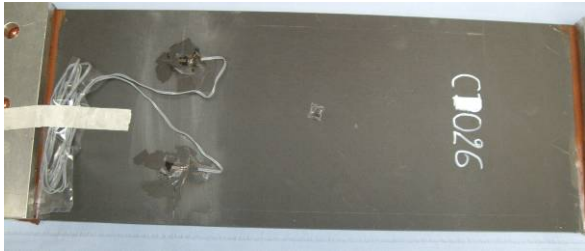
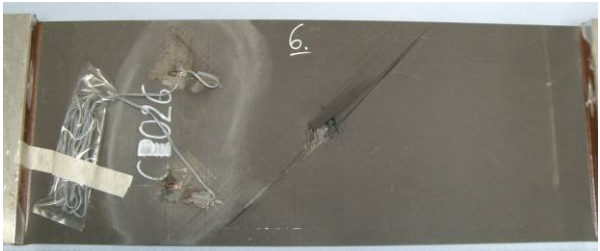
| <b>C026</b> | |

| Cube passed through / Square hole notch damage, delamination at back face | |

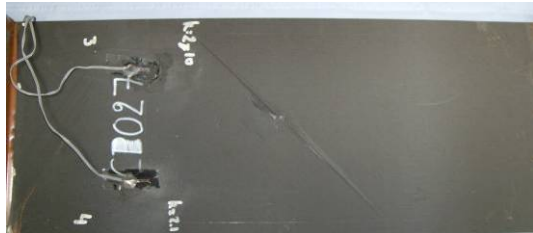
| <b>C027</b> | |

| Cube passed through / Square hole notch damage, delamination at back face | |

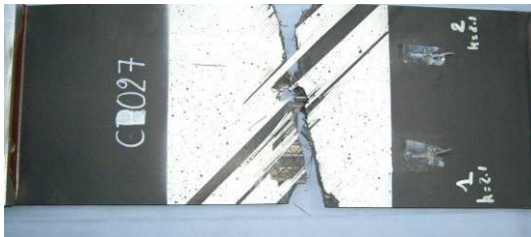
| <p>Failure load= 248.7 kN</p> <p>Residual strength factor = 0.58</p> | |

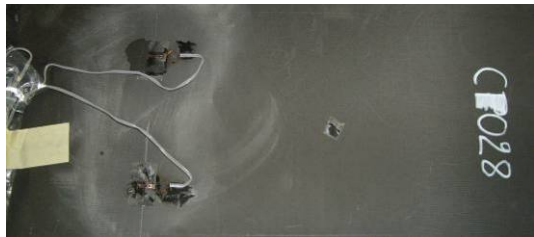
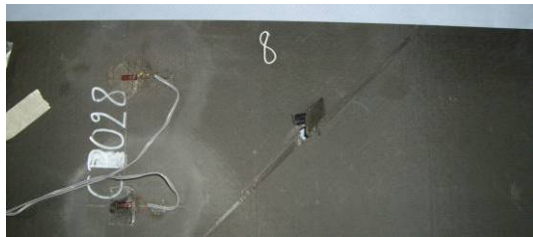
| <b>C028</b> | |

| Cube passed through / Square hole notch damage, delamination at back face | |

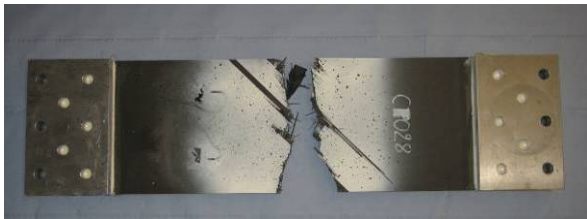
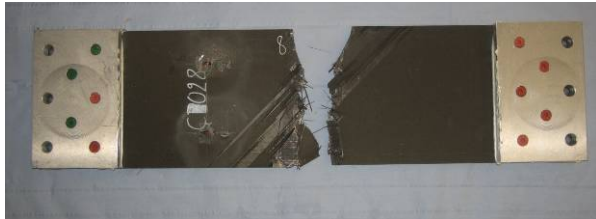
| <p>Failure load= 259.5 kN</p> <p>Residual strength factor = 0.60</p> | |

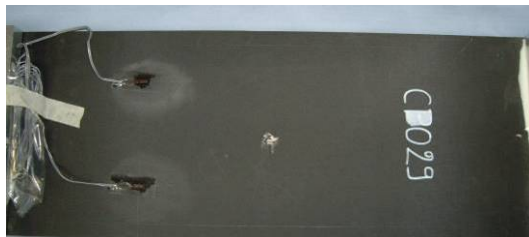
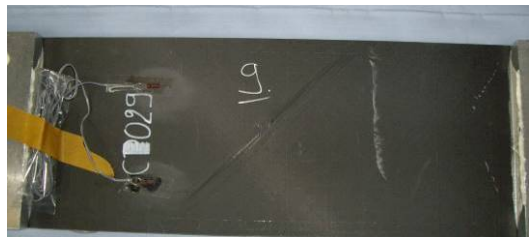
| <p>Impact side</p> | <p>Rear side</p> |

| Cube passed through / Square hole notch damage, delamination at back face | |

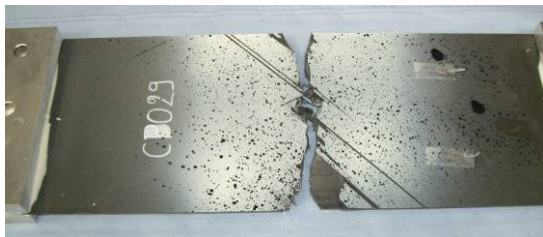
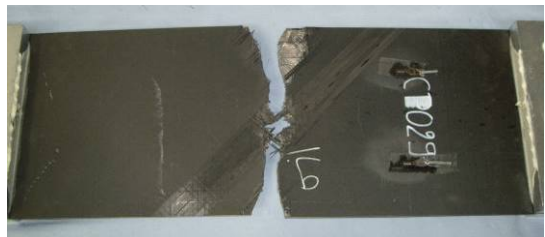
| <p>Failure load= 220.3 kN</p> <p>Residual strength factor = 0.51</p> | |

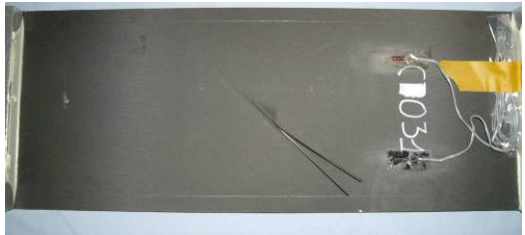
| <p>Impact side</p> | <p>Rear side</p> |

| Rebound with delamination damage at back face | |

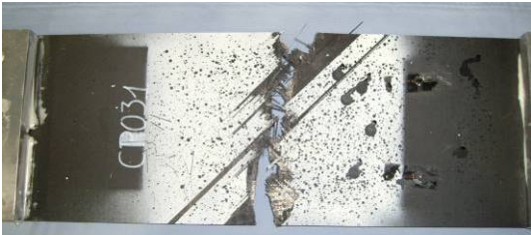
| <p>Failure load= 225.2 kN</p> <p>Residual strength factor = 0.52</p> | |

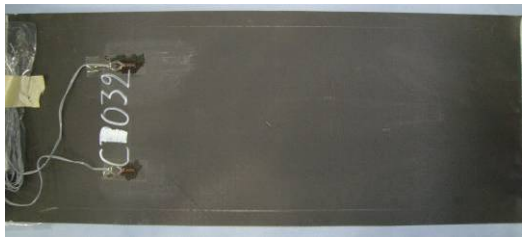
| <p>Impact side</p> | <p>Rear side</p> |

| Rebound with delamination damage at back face | |

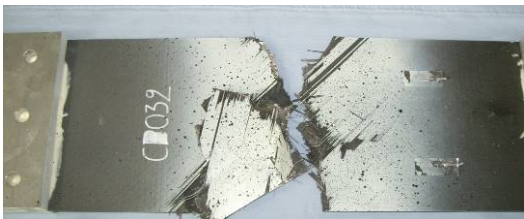
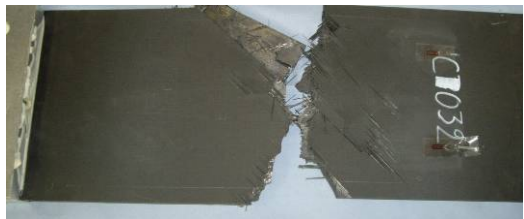
| <p>Failure load= 326.9 kN</p> <p>Residual strength factor = 0.76</p> | |

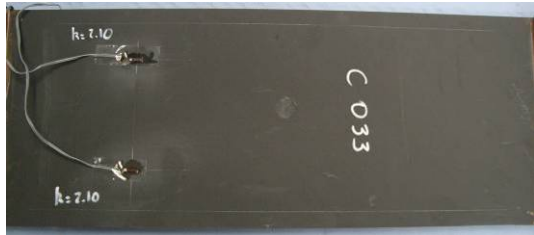
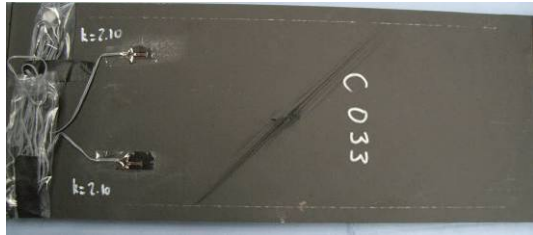
| <p>Impact side</p> | <p>Rear side</p> |

| <b>Impact on concave face / Rebound, dent on front face , delamination damage at back face</b> | |

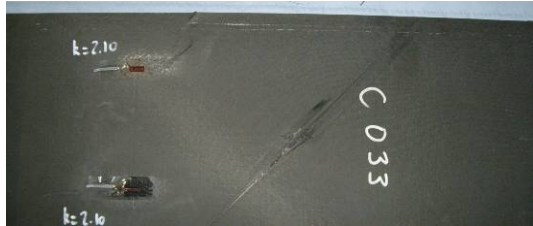
| <p>Failure load= 87.7 kN</p> <p>Residual strength factor = 0.74</p> | |

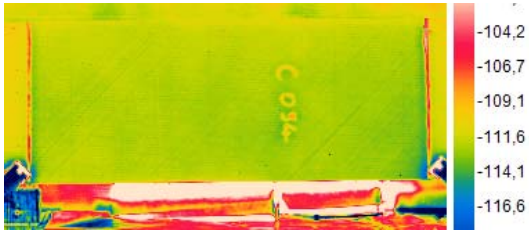
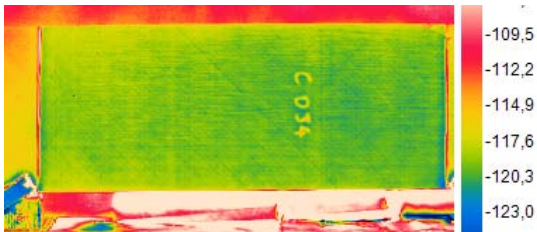
| <b>C034</b> | |

| <p><u>Average thickness:</u> 3.04 mm</p> <p><u>Visual inspection:</u> alright</p> <p><u>Lock-in thermography:</u> Uniform picture / No pre-damage</p> | |

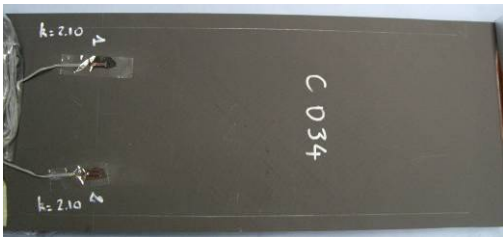
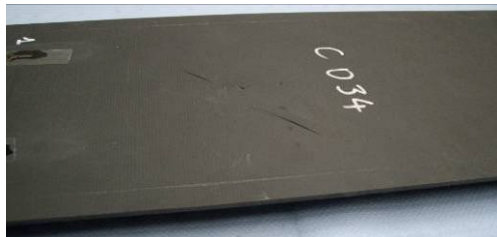
| <b>Impact on convex face / Rebound, dent on front face , delamination damage at back face</b> | |

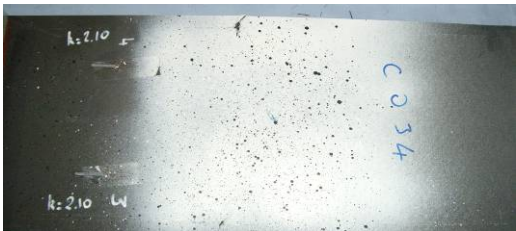
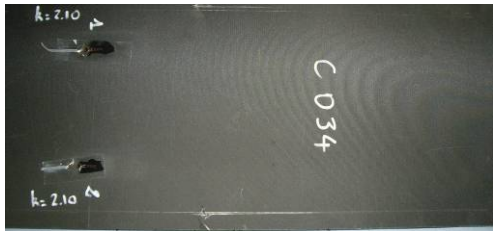
| <p>Failure load= 58.7 kN</p> <p>Residual strength factor = 0.49</p> | |

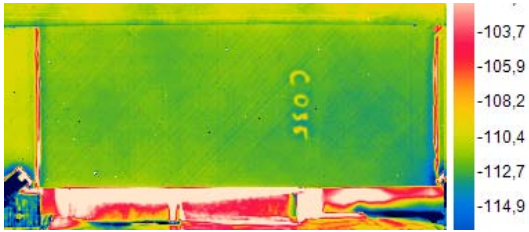
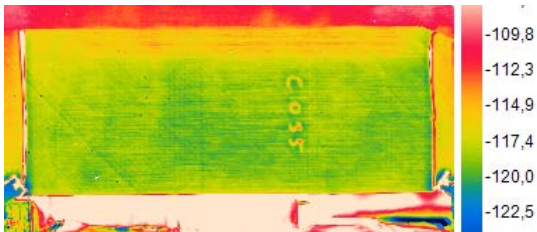
| <b>C035</b> | |

| <u>Average thickness:</u> 3.06 mm<br><u>Visual inspection:</u> alright<br><u>Lock-in thermography:</u> Uniform picture / No pre-damage | |

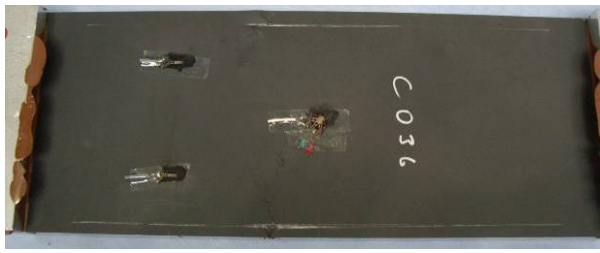
| Failure load= 118.8 kN | |

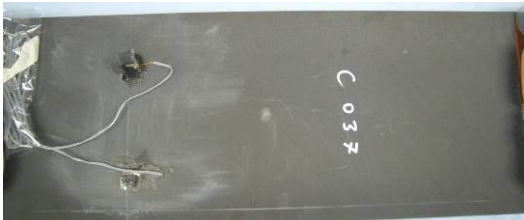
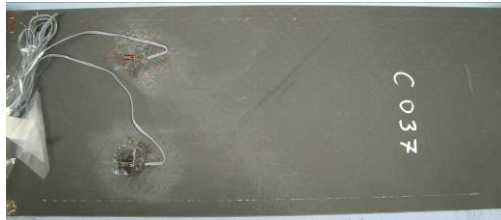
| Rebound, dent at front, delamination damage at back face | |

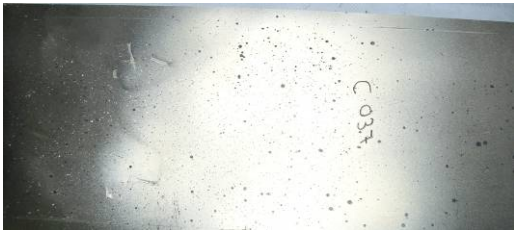
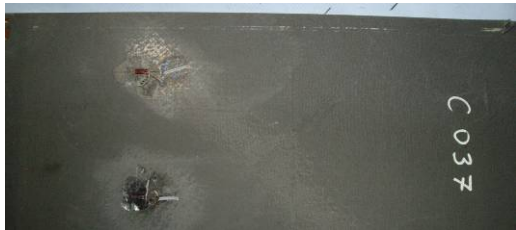
| <p>Failure load= 100.5 kN</p> <p>Residual strength factor = 0.85</p> | |

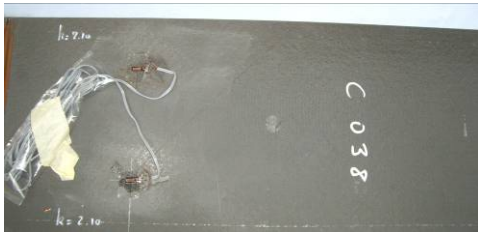
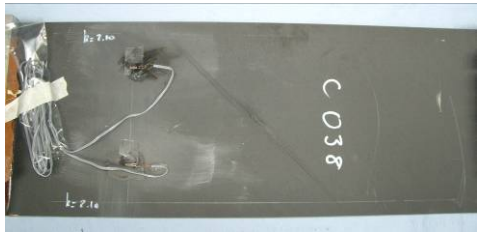
| <b>Impact on concave face / Rebound / dent on front face, delamination damage at back face</b> | |

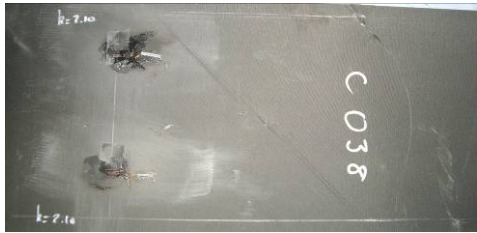
| <p>Failure load= 96.9 kN</p> <p>Residual strength factor = 0.82</p> | |

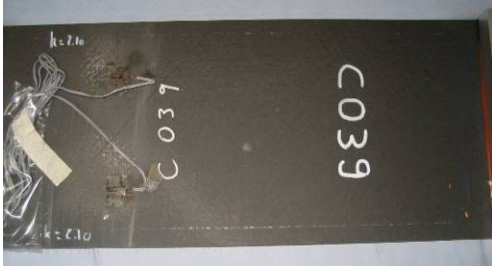
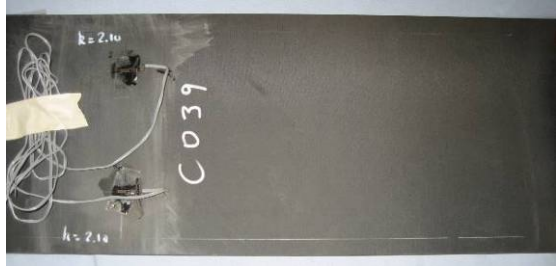
| <b>Impact on convex face / Rebound with dent on front face / delamination at back face</b> | |

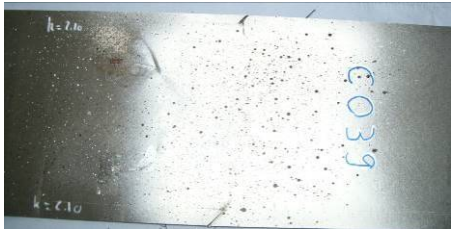
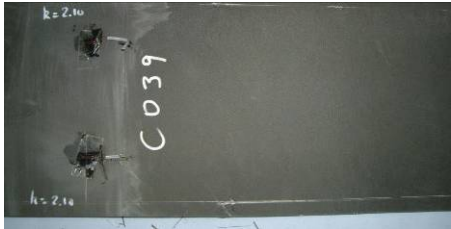
| <b>Residual strength test (compression)</b> | |

| <p>Failure load= 80.7 kN</p> <p>Residual strength factor = 0.68</p> | |

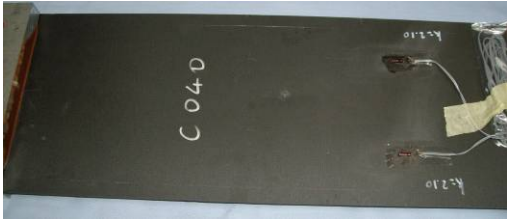
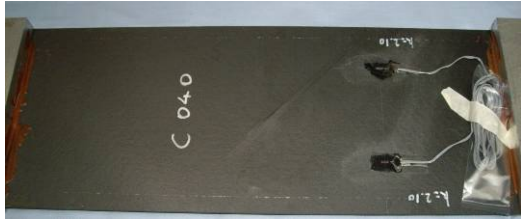
| <p><u>Test conditions:</u></p> <p>Impactor: 17.9 g glass ball (Ø23.9 mm)</p> <p>Pre-loading: 1.4 Pb (53.2 kN), in compression</p> <p>Velocity: 82.4 m/s (60.8 J)</p> | |
| <b>Impact on concave face / Rebound with dent on front face and delamination at back face</b> | |

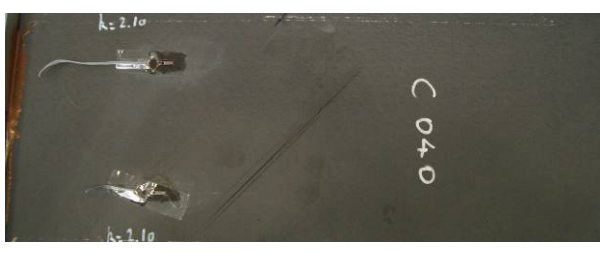
| <b>Residual strength test (compression)</b> | |

| <p>Failure load= 87.0 kN</p> <p>Residual strength factor = 0.73</p> | |

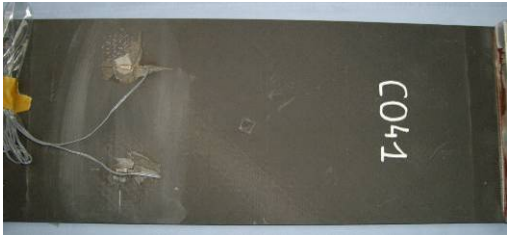
| <p><u>Test conditions:</u></p> <p>Impactor: 13.4 g steel cube</p> <p>Pre-loading: 0.25%, in tension</p> <p>Velocity: 101.8 m/s (69.5 J)</p> | |
| Cube passed through / Square hole notch damage, delamination damage at back face | |

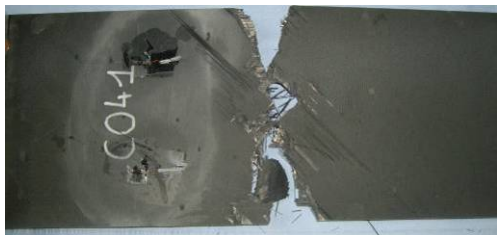
| <b>Residual strength test (tension)</b> | |

| <p>Failure load= 101.8 kN</p> <p>Residual strength factor = 69.5</p> | |

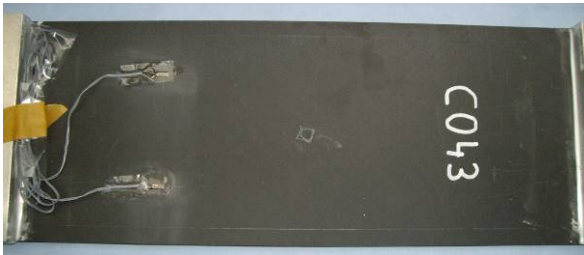
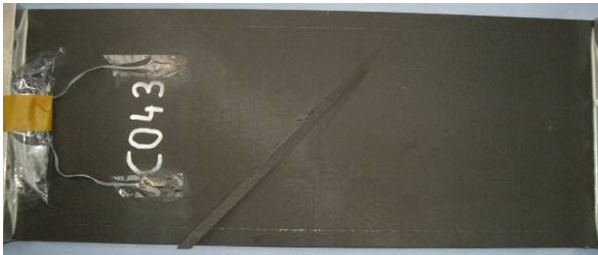
| <p><u>Test conditions:</u></p> <p>Impactor: 13.4 g steel cube</p> <p>Pre-loading: 0.02%, in tension</p> <p>Velocity: 84.5 m/s (47.9 J)</p> | |
| Cube stopped / notch damage, delamination at back face | |

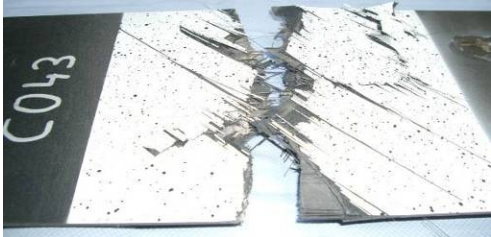
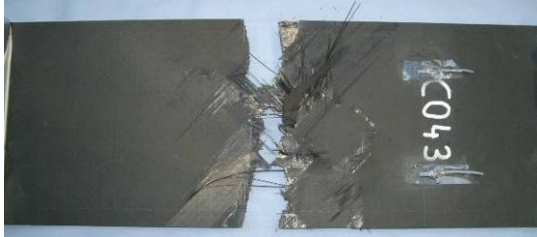
| <b>Residual strength test (tension)</b> | |

| <p>Failure load= 250.1 kN</p> <p>Residual strength factor = 0.60</p> | |

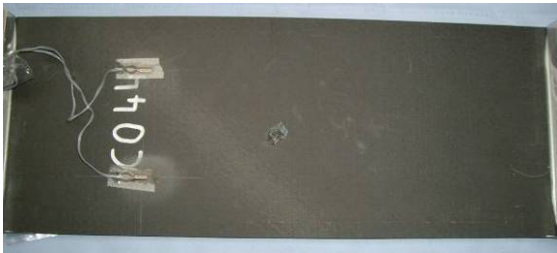
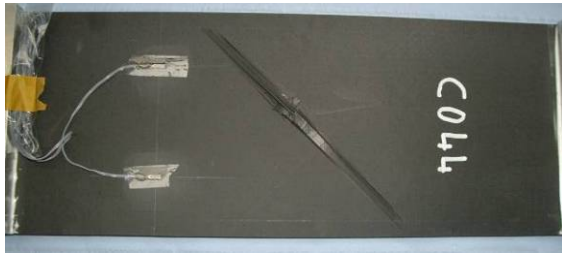
| <p><u>Test conditions:</u></p> <p>Impactor: 13.4 g steel cube</p> <p>Pre-loading: 0.25%, in tension</p> <p>Velocity: 97.8 m/s (64.1 J)</p> | |
| Cube passed through / Square hole notch damage and delamination at back face | |

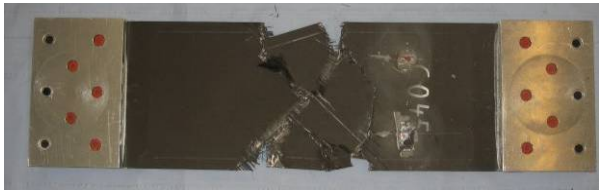
| <b>C045</b> | |
|---|---|
| <b>Residual strength test (tension)</b> | |

| <b>C045</b> | |
|---|---|
| <p>Failure load= 311.1 kN</p> <p>Residual strength factor = 0.76</p> | |

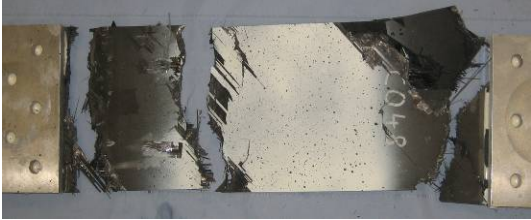
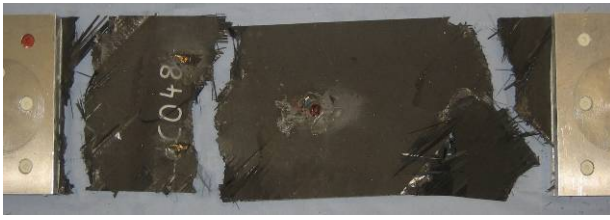
| <b>Residual strength test (tension)</b> | |

| Failure load= 409.4 kN | |

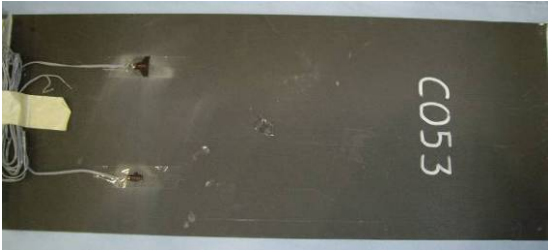
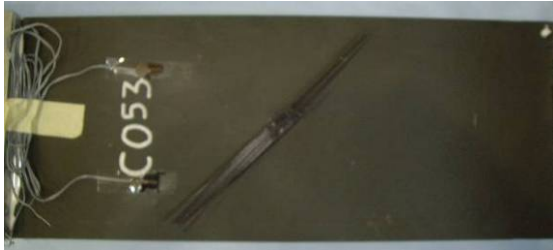
| Light convex buckle (ca. 1 mm) / Notch damage | |

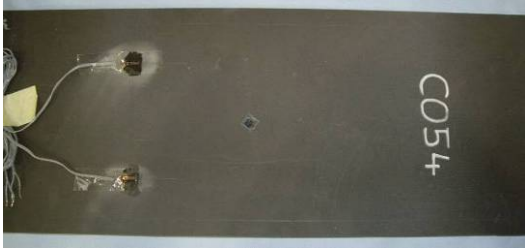
| Light convex buckle (ca. 1 mm) / Notch damage | |

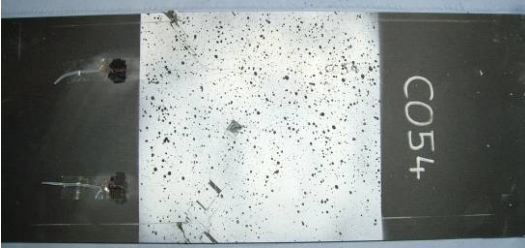
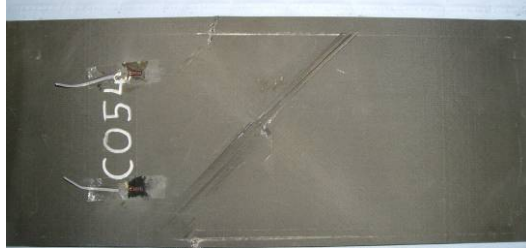
| <b>Residual strength test (compression)</b> | |

| <p>Failure load= 124.1 kN</p> <p>Residual strength factor = 0.93</p> | |

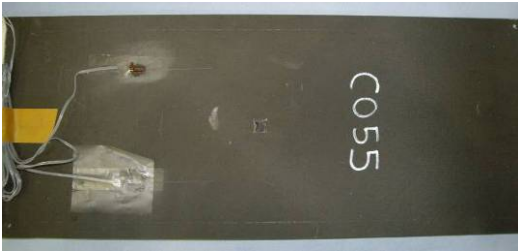
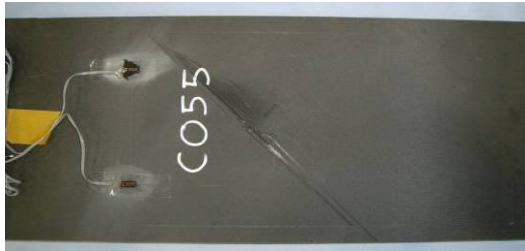
| Light convex buckle (ca. 1 mm) / Notch damage | |

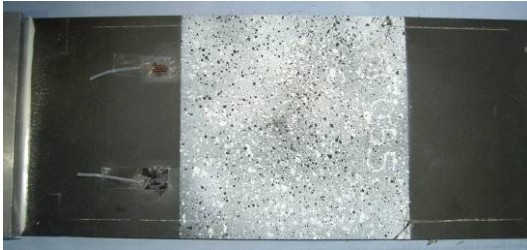
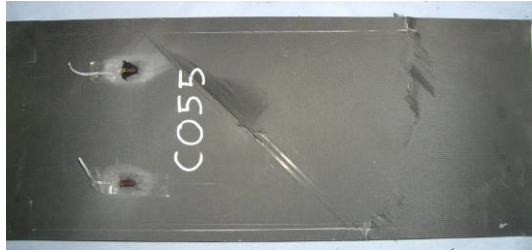
| <b>Residual strength test (compression)</b> | |

| <p>Failure load= 135.9 kN</p> <p>Residual strength factor = 1.02</p> | |

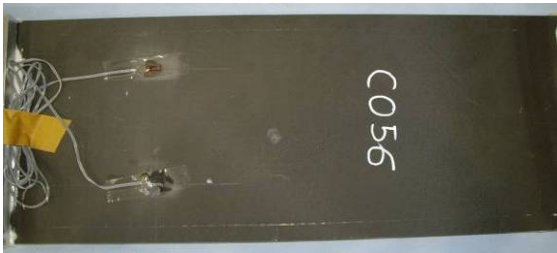
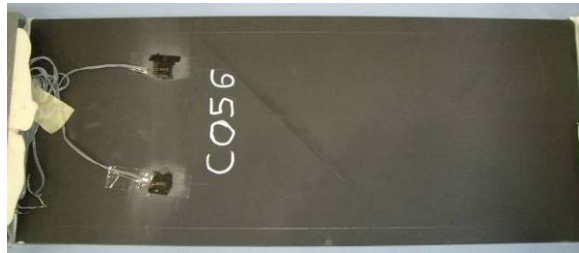
| <b>Light convex buckle</b> / Rebound, dent on front face, delamination at back face | |

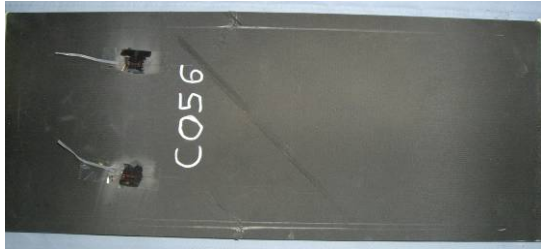
| <p>Failure load=93.9 kN</p> <p>Residual strength factor = 0.70</p> | |

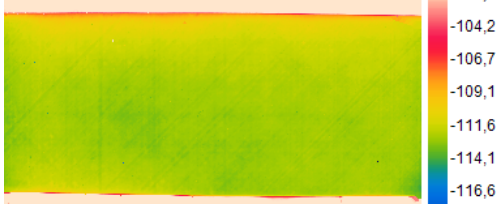
| <p><u>Average thickness:</u> 3.1 mm</p> <p><u>Visual inspection:</u> alright, harmless / Notice: harmless "snowflake" pattern on one side due to superficial air insertion in the plate</p> <p><u>Lock-in thermography:</u> Uniform picture / No pre-damage</p> | |

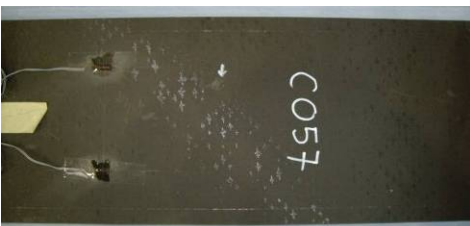
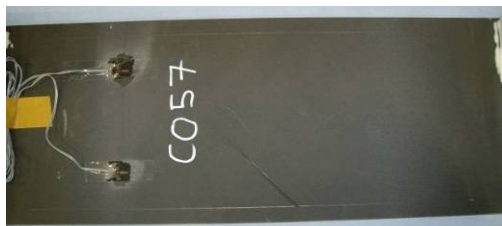
| <p><b>Light convex buckle (ca. 1mm) /</b> Rebound, dent on front face, delamination damage at back face</p> | |

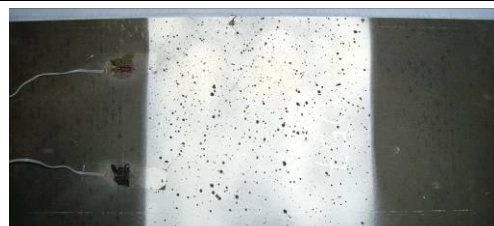
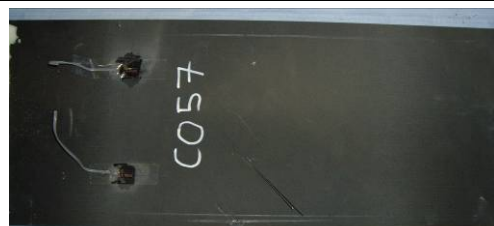
| <p>Failure load= 87.9 kN</p> <p>Residual strength factor = 0.66</p> | |

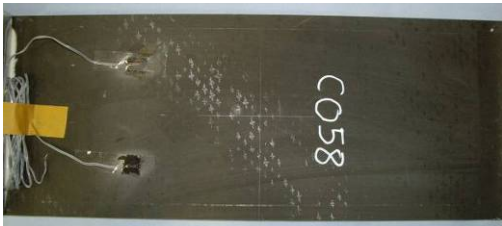
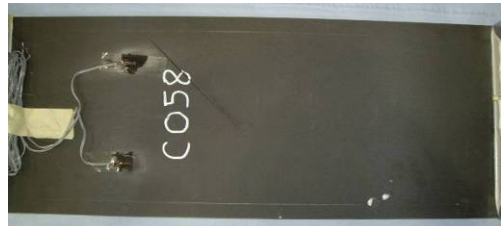
| <p><b>Light convex buckle (ca. 1 mm) / Cube stopped / Front face damage and delamination at back face</b></p> | |

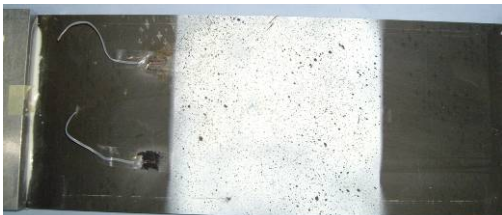
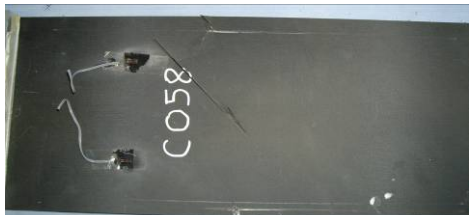
| <p>Failure load= 89.6 kN</p> <p>Residual strength factor = 0.67</p> | |

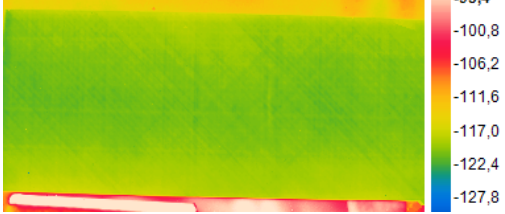
| <p><u>Average thickness:</u> 3.03 mm</p> <p><u>Visual inspection:</u> alright, harmless / Notice: harmless “snowflake” pattern on one side due to superficial air insertion in the plate</p> <p><u>Lock-in thermography:</u> Uniform picture / No pre-damage</p> | |

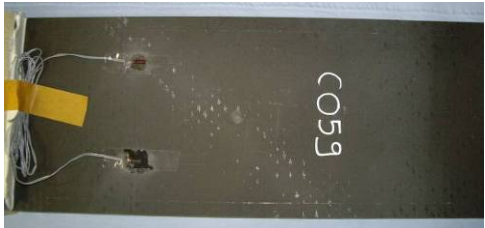
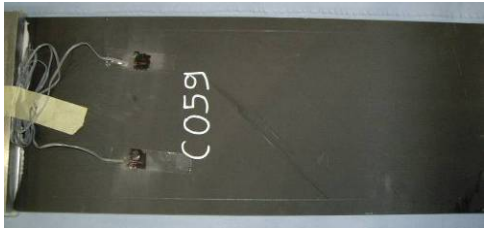
| Rebound / dent on front face, delamination damage at back face | |

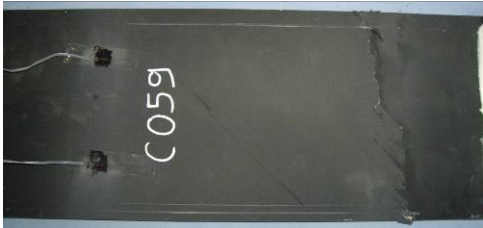
| <p>Failure load= 122.8 kN</p> <p>Residual strength factor = 0.92</p> | |

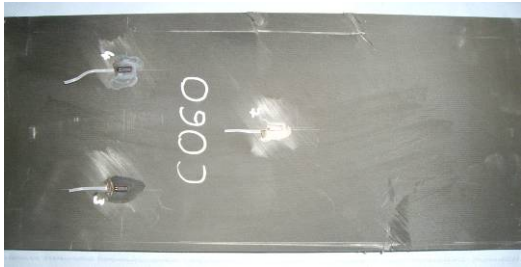
| <b>C060</b> | |
|---|---|
| Failure load= 133.2 kN | |

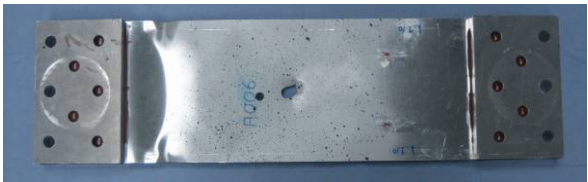
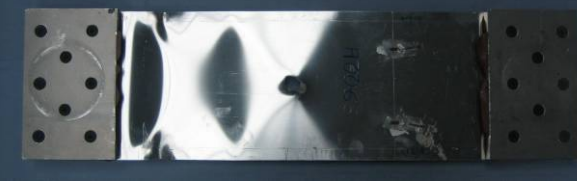
| Max. load = 54.3 kN<br>Residual strength factor = 0.95 | |

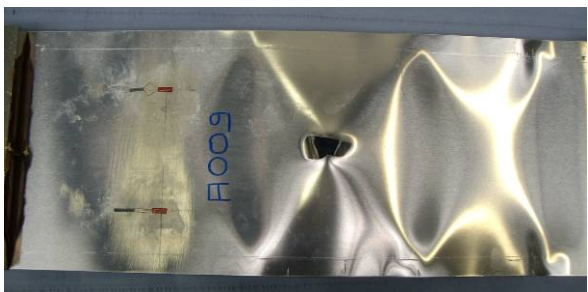
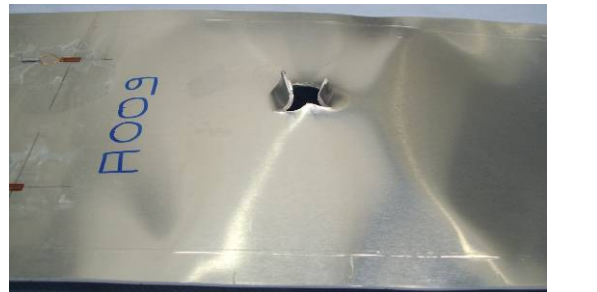
| <b>Residual strength test (compression)</b> | |

| Extended rails<br>Max. load= 57.9 kN<br>Residual strength factor = 1.01 | |

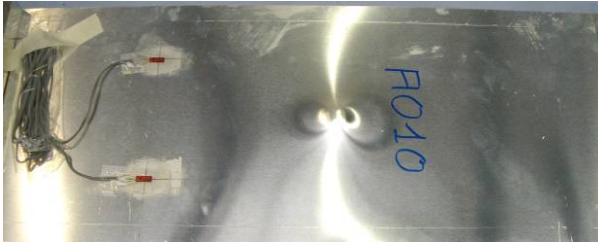
| <b>A010</b> | |

| Impact on convex face / Cube stopped / square indentation in buckle | |

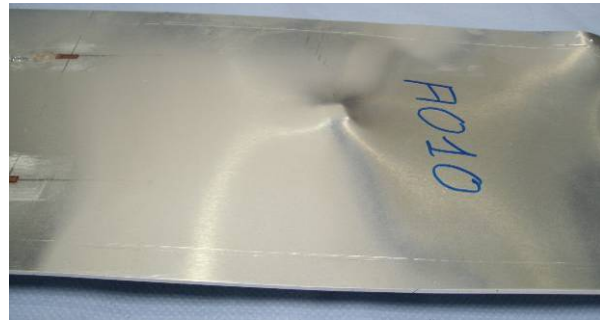
| <b>Residual strength test (compression)</b> | |

| Extended rails<br>Max. load= 55.4 kN<br>Residual strength factor = 0.97 | |

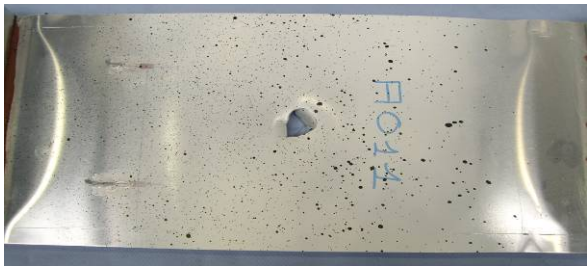
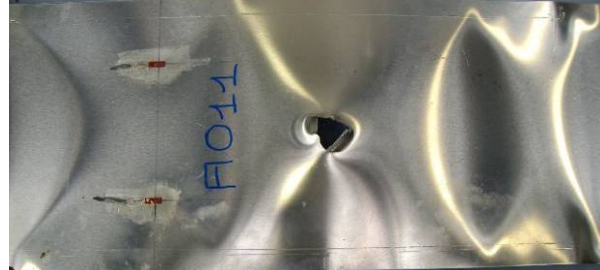
| <b>Residual strength test (compression)</b> | |

| Extended rails<br>Max. load= 56.6 kN<br>Residual strength factor = 0.99 | |

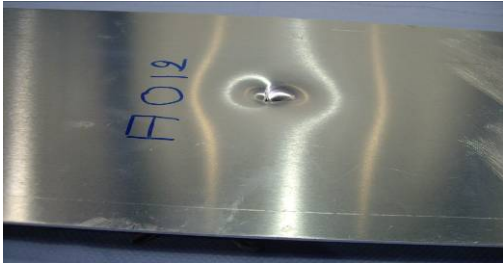
| <b>A012</b> | |

| Cube stopped with rebound/ indentation with very small crack from cube corner | |

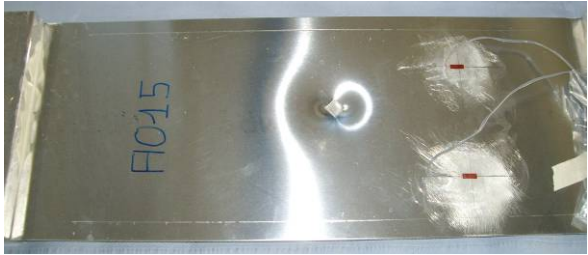
| Rebound / indentation with no crack | |

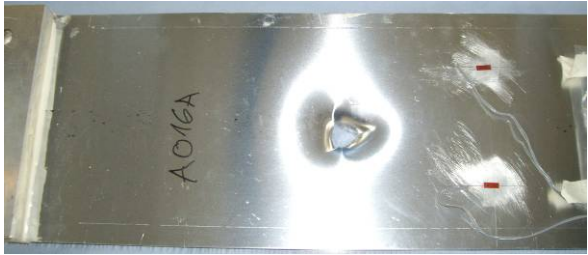
| <b>A016</b> | |

| Cube passed through / Notch damage, square hole (35 mm) | |

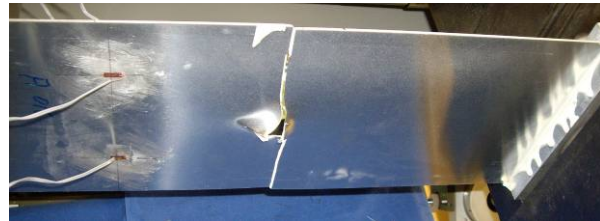
| <b>Residual strength test (tension)</b> | |

| Max. load= 123.7 kN<br>Residual strength factor = 0.70 | |

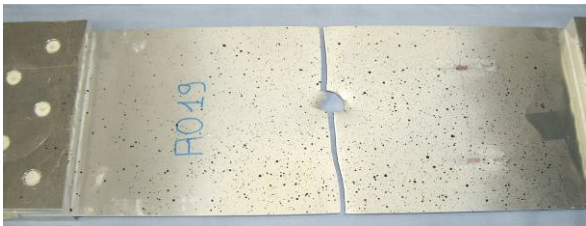
| <b>Residual strength test (tension)</b> | |

| Max. load= 143.8 kN<br>Residual strength factor = 0.82 | |

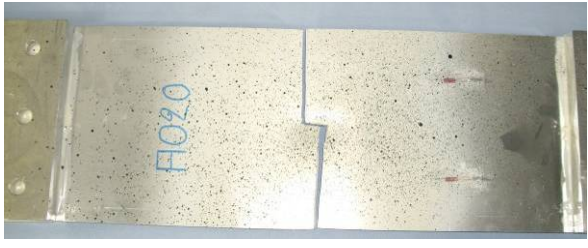
| <b>Residual strength test (tension)</b> | |

| Max. load= 143.8 kN<br>Residual strength factor = 0.82 | |

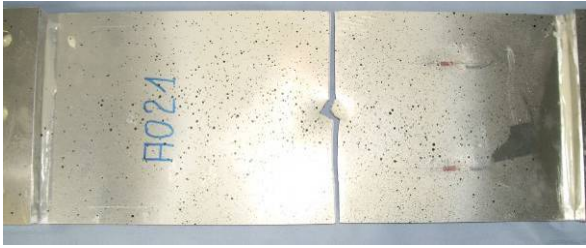
| <b>Residual strength test (tension)</b> | |

| Max. load= 143.8 kN<br>Residual strength factor = 0.82 | |
